iPhone X Says No Service? Here's the fix!

Fix an iPhone X showing No Service by replacing the U_PMIC_E on the signal board!

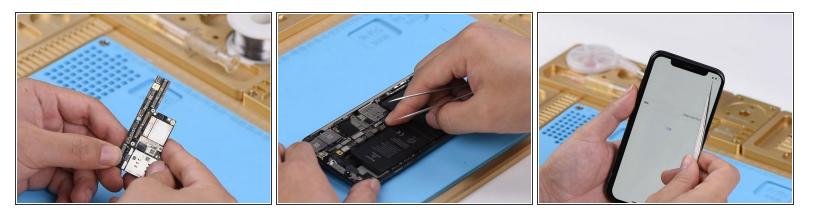
Step 1 — iPhone X Says No Service? Here's the fix!

- First, run a cosmetic inspection of the motherboard. The motherboard is not deformed or water damaged.
- Next, let's install the motherboard and connect the battery and display assembly. Turn on the phone and the phone goes with the activation process. Click the icon at the bottom right corner. Serial number displays normally on the screen. No IMEI number on the screen. The phone shows a No Service error in the upper-right corner.
- (i) Judging by this, the bonding pad might have been pseudo soldered or the lower layer might have malfunctioned. The next thing we need to do is to separate the motherboard.

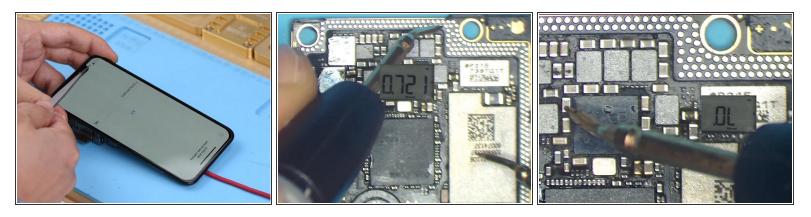
- The phone goes with activation process. Click the icon at the bottom right corner. Serial number displays normally on the screen. No IMEI number on the screen. The phone shows a No Service error in the upper-right corner.
- (i) We can confirm now that the bonding pad has not been pseudo soldered. The fault is related to the lower layer. So we need to further check the lower layer.
- Run diode mode measurement of signal relevant pins on the bonding pad. Nothing goes wrong.
- Continue to run diode mode measurement of capacitors related to the power supply circuit of U_PMIC_E. Nothing goes wrong.

(i) Judging by this, the fault is probably related to U_PMIC_E or U_MDM_E.

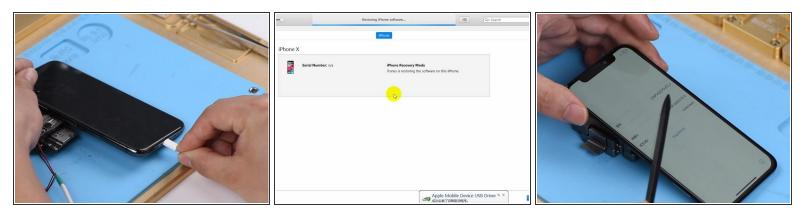
- (i) Please be noted that for iPhones with an iOS 12 system, once baseband relevant IC are replaced, we need to restore the phone and re-write the baseband data to the phone.
- Attach the upper layer and the lower layer to the test fixture. Get the back glass assembly connected. Connect the battery connector with the DC Power Supply.
- Connect the iPhone to the computer with the USB cable. Restore the phone via iTunes. Once done, disconnect the USB cable, the power supply, and the back glass assembly.
- Again, let's get the display assembly installed. Connect the battery connector with the Power Supplier. The phone goes with activation process.
- Click the icon at the bottom right corner. Serial number and IMEI number display normally on the screen. Signal bars in the upper-right corner is back to normal. We can confirm now that the No Service problem is caused by U_PMIC_E.

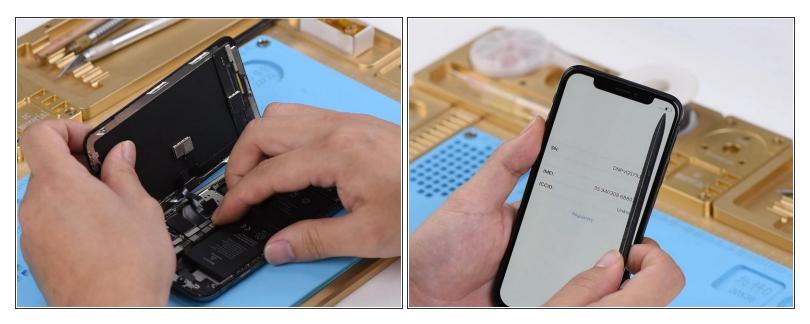
Now we can assemble the phone and test. The phone turns on normally and goes with activation process. Click the icon at the bottom right corner. Serial number and IMEI number display normally on the screen. Signal bars in the upper-right corner is back to normal. The No Service fault has been cleared.
