Repair For MacBook Pro A1989 That Won't Turn On

Fix a MacBook Pro that won't turn on by restoring T2 chip data!

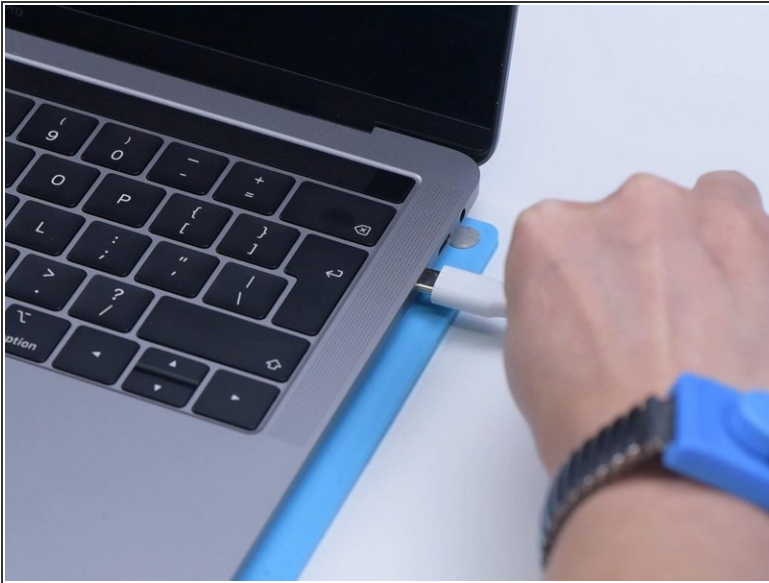
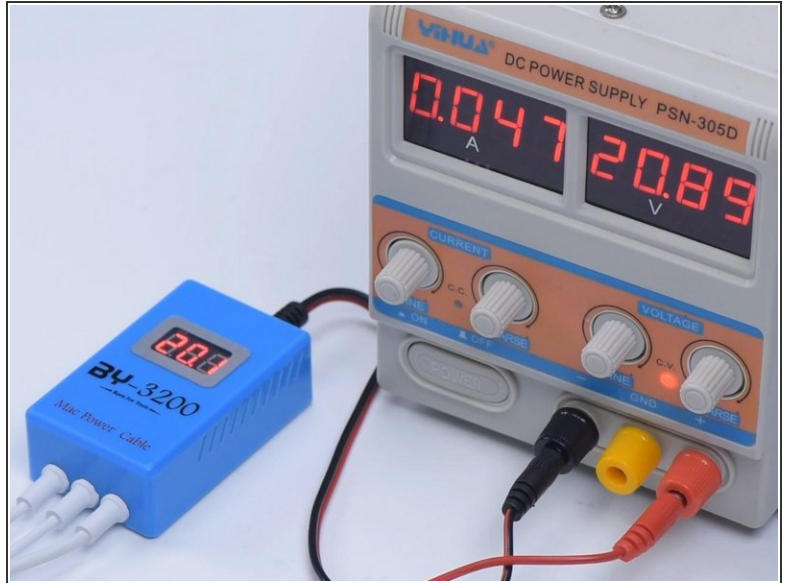
Step 1 — Repair For MacBook Pro A1989 That Won't Turn On

- Press the power button. The MacBook won't turn on.
- Plug in the BY-3200 power cable and the input voltage is 20V.
- The current reading on the DC Power Supply stays at 0.047A.

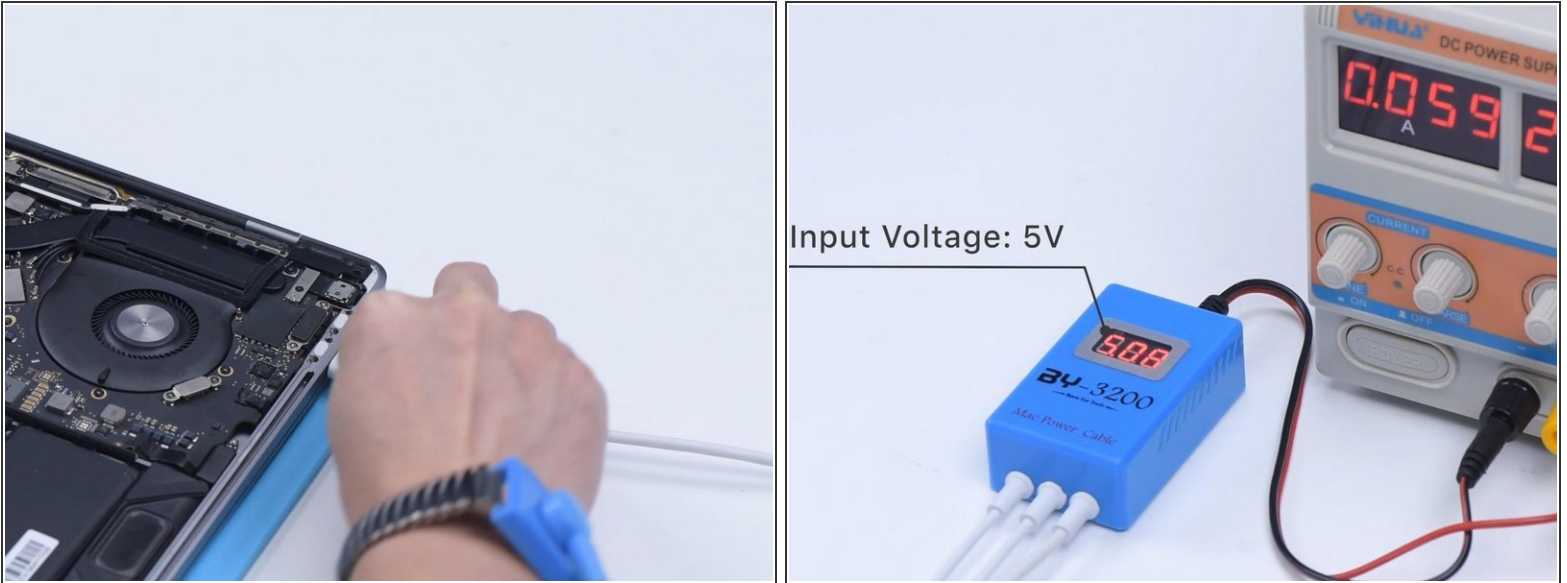
Step 3

- Plug in the BY-3200 and the input voltage is 5V.
- The current reading on the DC Power Supply stays at 0.059A.
- The power supply of the motherboard is only 5V, which is abnormal.
- ❗ The normal power supply should be 20V. It indicates that the motherboard has malfunctioned.

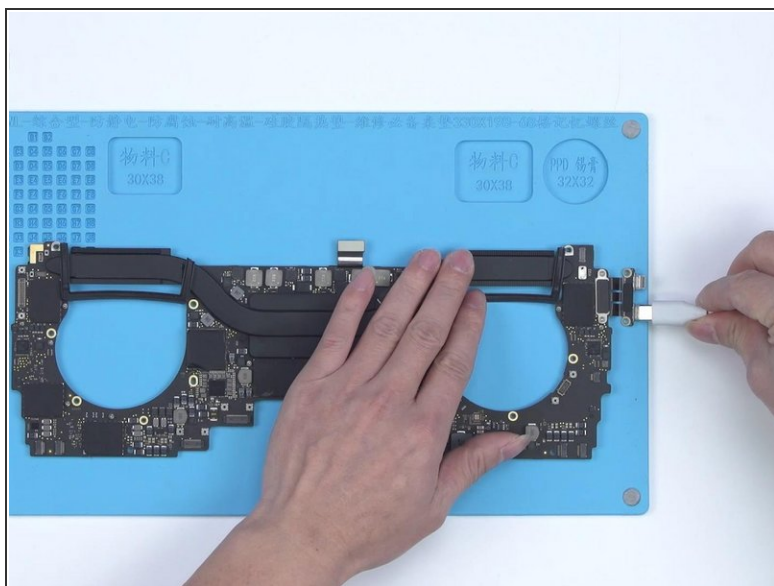
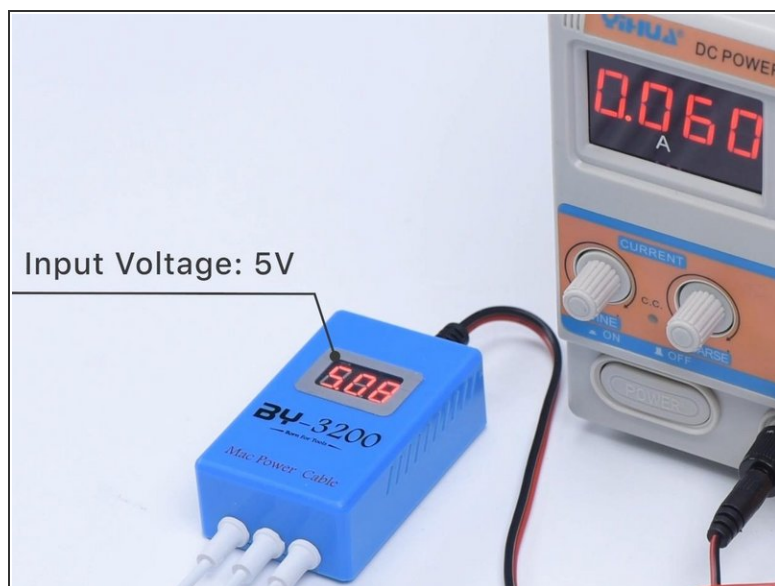
Step 7

- Pug in the power cable.
- The motherboard current stops at 0.06A and the input voltage is only 5V.

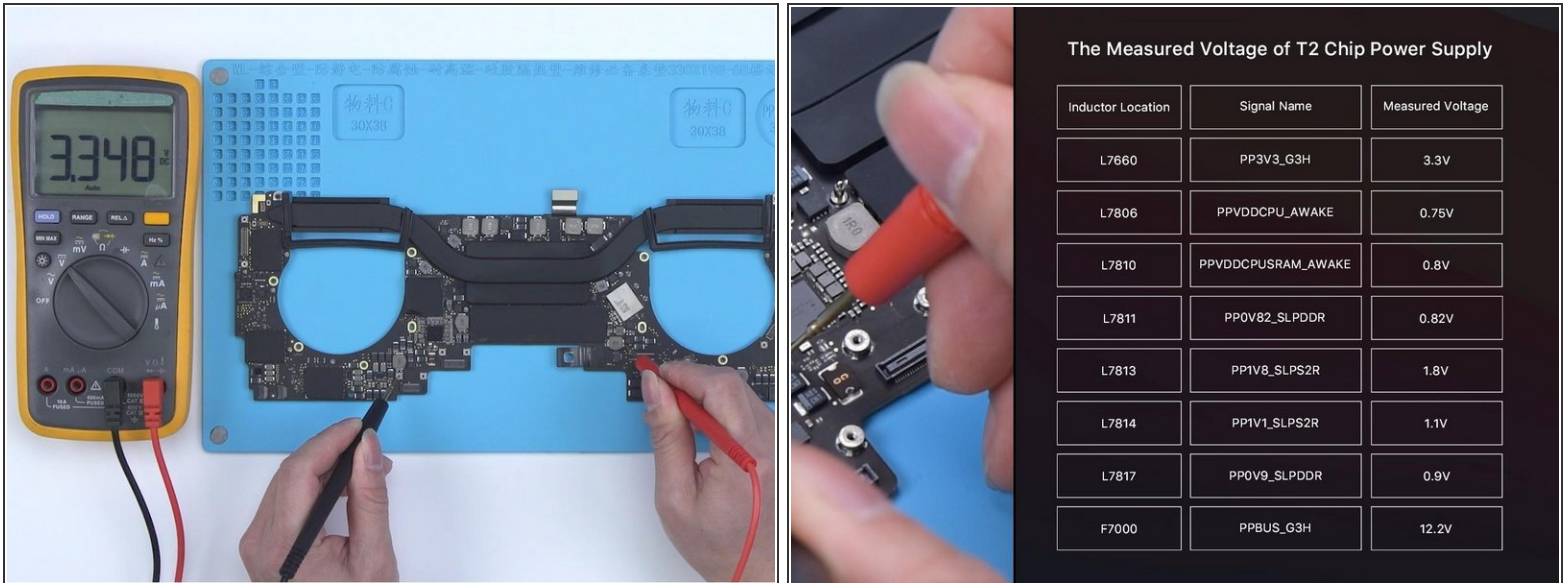
Step 8

- Measure the power supply of the motherboard.
- The measured voltage values are normal. It can be judged that the power supply circuit of the motherboard is good.
- Next, we need to decide if the fault (voltage failing to increase) is caused by T2 chip data problems.
