iMuto 20000mAh Portable Charger Teardown

The iMuto Taurus X4 charger wasn't meant to be disassembled. The micro USB charging port broke on my device, so I decided to use brute force to look inside.

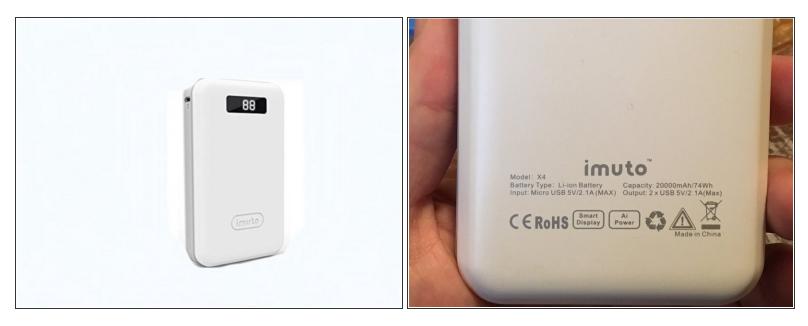
Step 1 — The iMuto 20,000mAh Portable Charger

The iMuto 20,000mAh Portable Charger

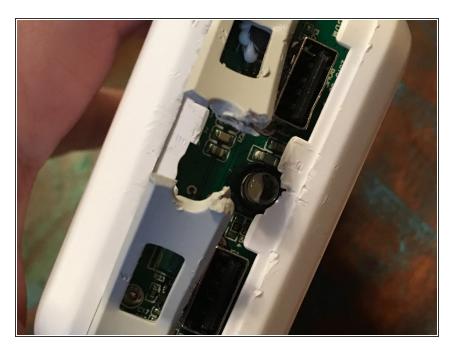
Step 2 — Chop Chop!

Using micro screwdrivers, needlenose pliers, and a diagonal cutter...
Leverage and pry the plastic band

until you can chop it with the diagonal cutters.

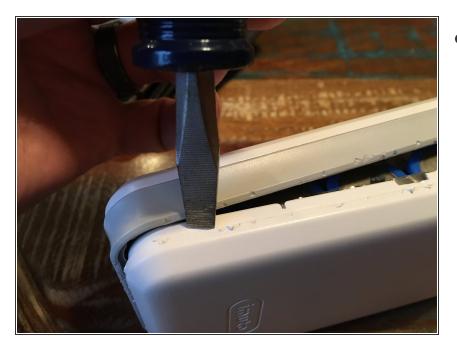
Step 3 — Pry off the case top with a screwdriver.

Using a screwdriver, wedge between the plastic band and the case top, then use a twisting motion in the direction like you would driving a screw to work your way around the case, prying the case top from the middle band of plastic.

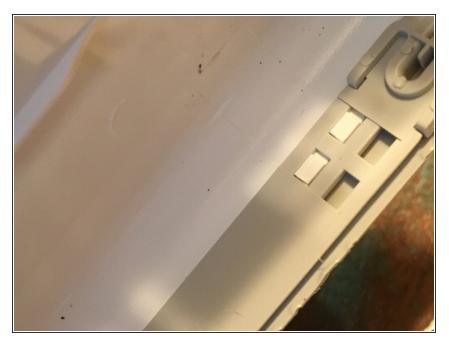
Step 4 — This Charger Isn't Meant For Disassembly.

Once you ungracefully chop and pry the case off of the charger, you can see why it is not meant to be disassembled or repaired. The case has clips that hold the case together and these clips can't be easily unclipped.

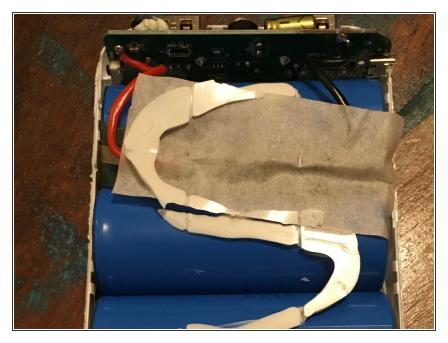
Step 5 — Lots of glue...

• If you have difficulty prying the case off, it's because of all the glue holding it together... Pry harder!

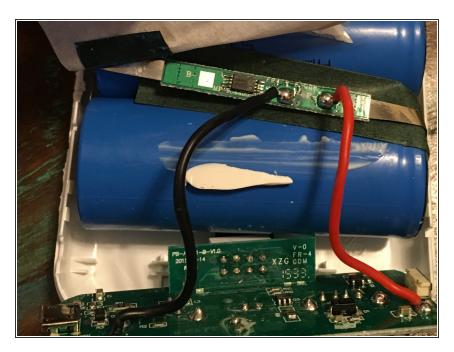
Step 7 — Battery Board

There is a smaller circuit board, presumably for voltage regulation, that connects to the battery bank and then, via red and black wires, to the main circuit board.
