# Pioneer Elite PRO-RO6U Cooling Fan Replacement

Replace a defective power supply cooling fan to prevent the media receiver from overheating.

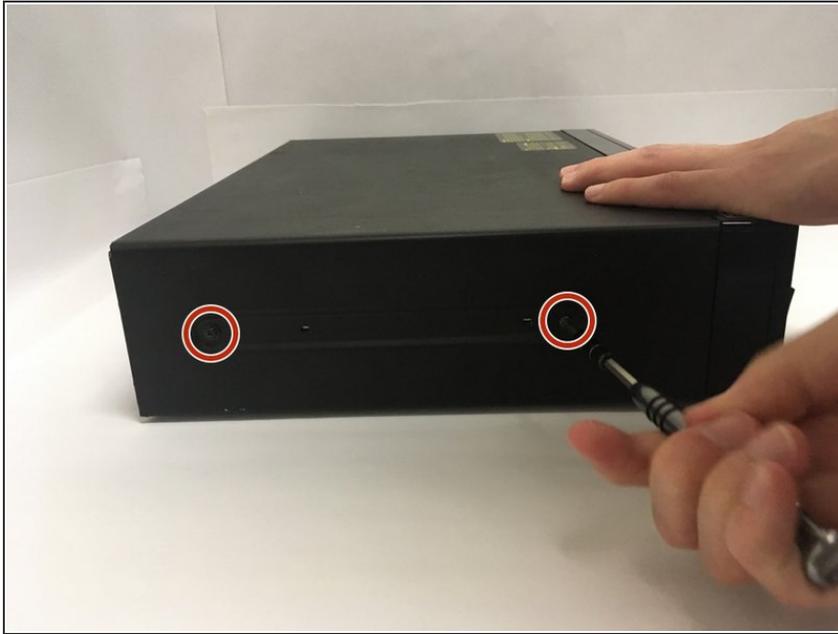
## Step 1 — Power Supply Cooling Fan

- Remove the two 6.4 mm Phillips screws on each side of the device's casing.

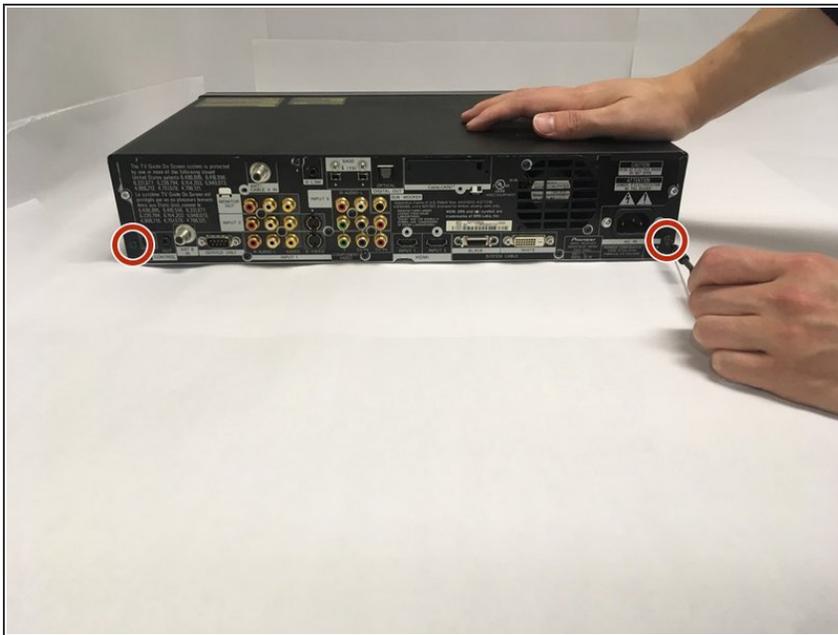
## Step 2

- Remove the two 6.5 mm Phillips screws on the back of the device casing.

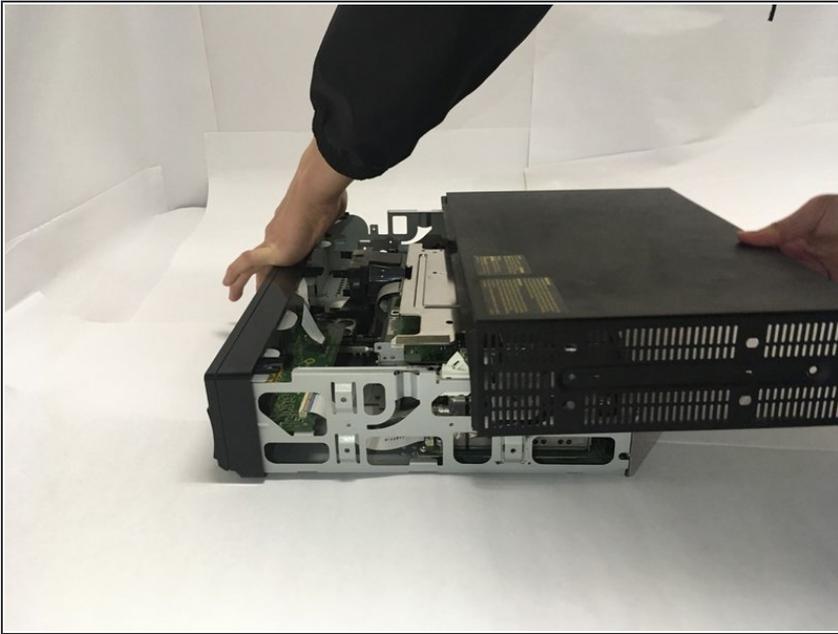
### Step 3

- Grip the front panel in one hand and the back of the casing in the other. Pull the casing back, and slide it up and away from the inner box.
