Pioneer Elite PRO-RO6U Power Supply Board Replacement

Replacing the power supply circuit board may be necessary if the media receiver fails to power on.

INTRODUCTION

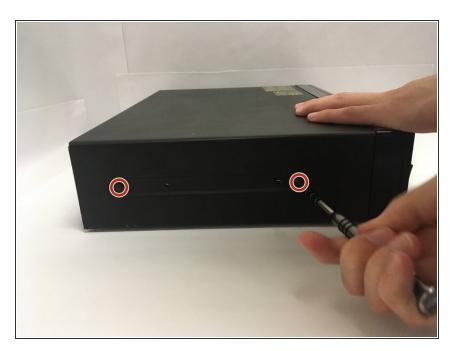
Step 1 — **Power Supply Board**

Remove the two 6.4 mm Phillips screws on each side of the device's casing.

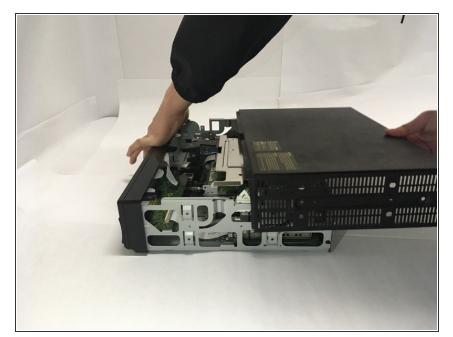
Step 3

Grip the front panel in one hand and the back of the casing in the other.
Pull the casing back, and slide it up and away from the inner box.
