# Altec Lansing Mini Lifejacket 2 Back Panel Replacement

If your Altec Lansing Mini Lifejacket 2's aux input or power jack is faulty or damaged, this guide will show you how to replace the back panel of your device.

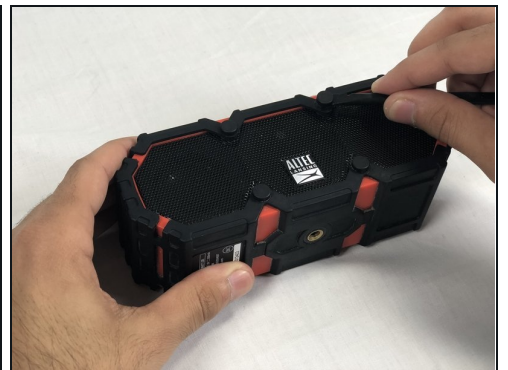
## Step 1 — Back Panel

- Use the spudger to remove the eight black pins from the front and back of the wire screens.

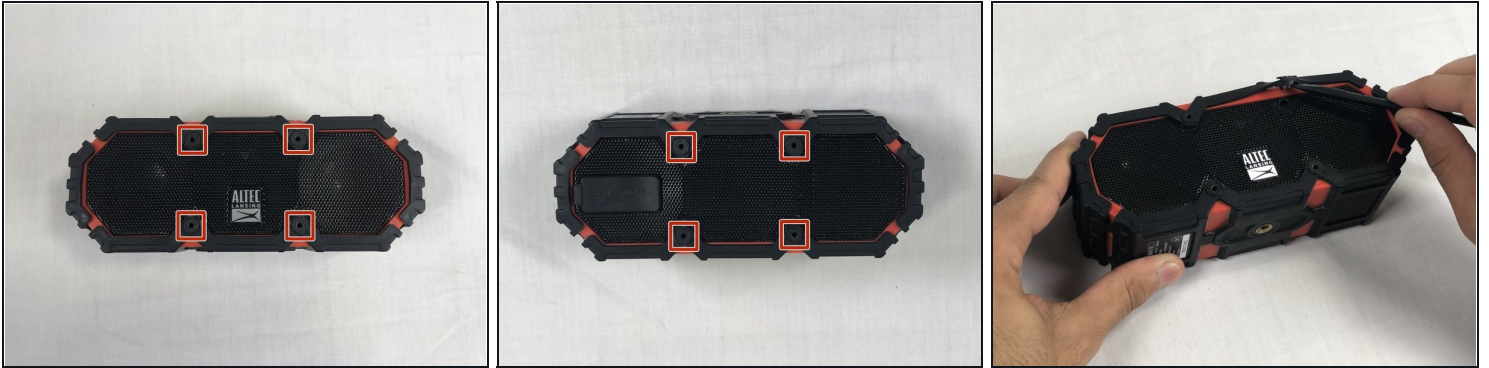
## Step 2

- Detach the eight secondary pins from the front and back of the wire mesh plates with a spudger.
- ① Removing the secondary pins from the rubber casing is optional.

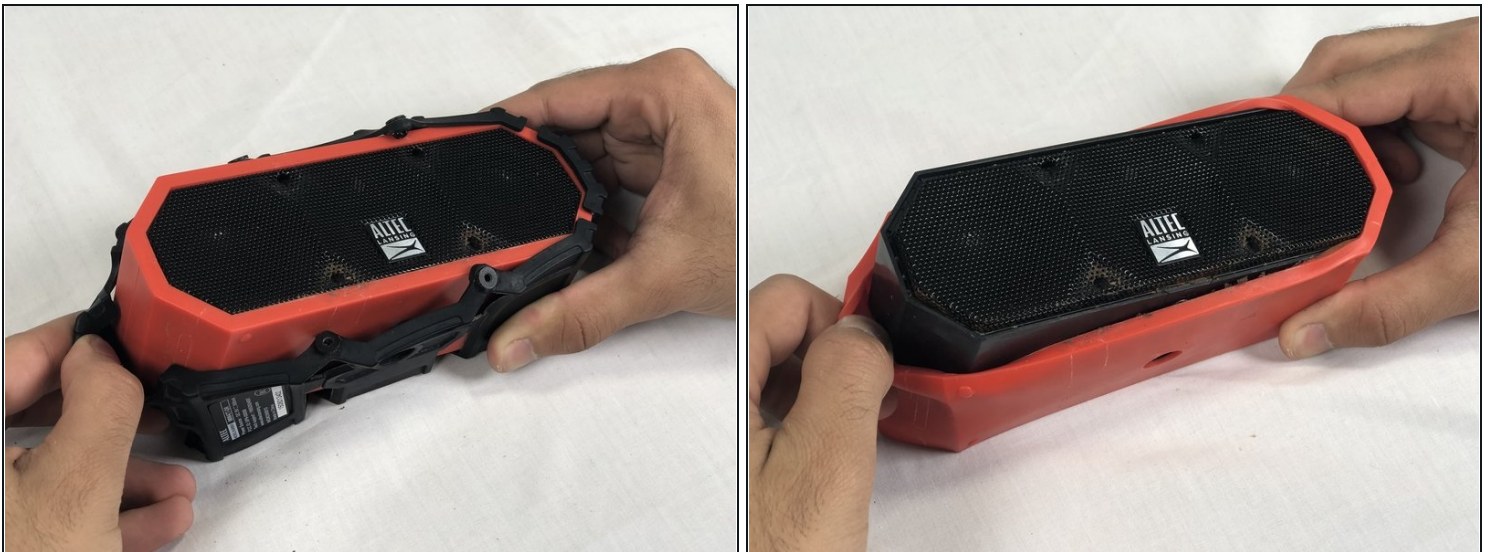
## Step 3

- Remove both black and orange layers from the speaker body.

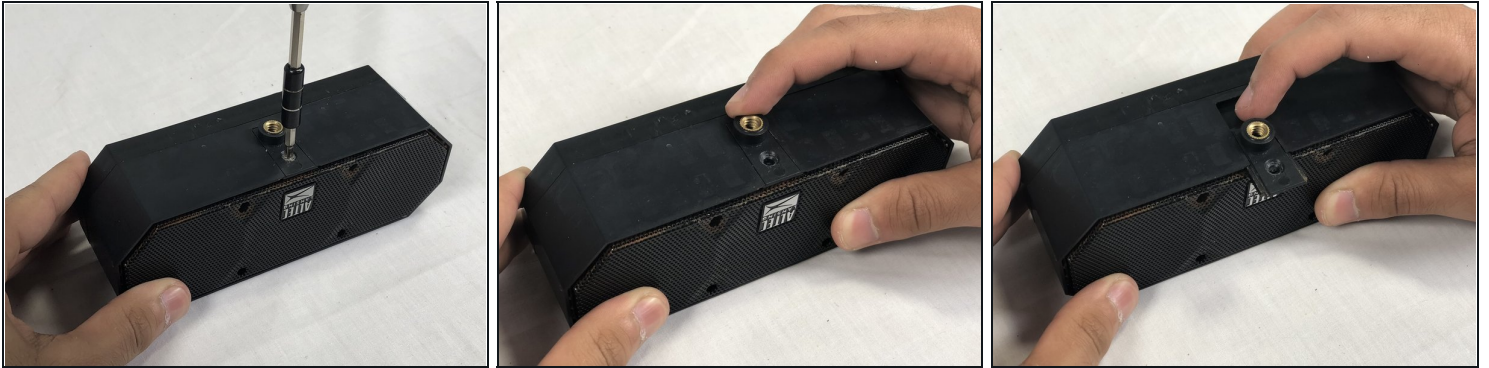
## Step 4

- Remove the single 7.8mm Phillips #2 screw from the mounting plate located under the device.
- Slide the mounting plate out to remove it.

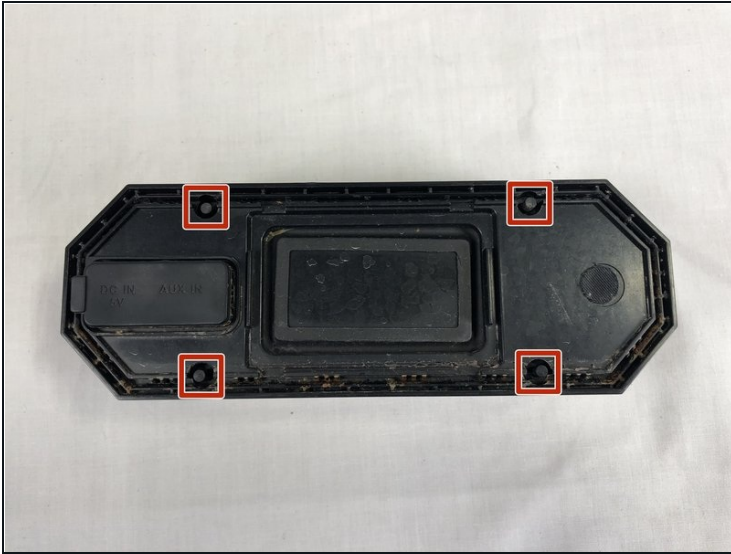
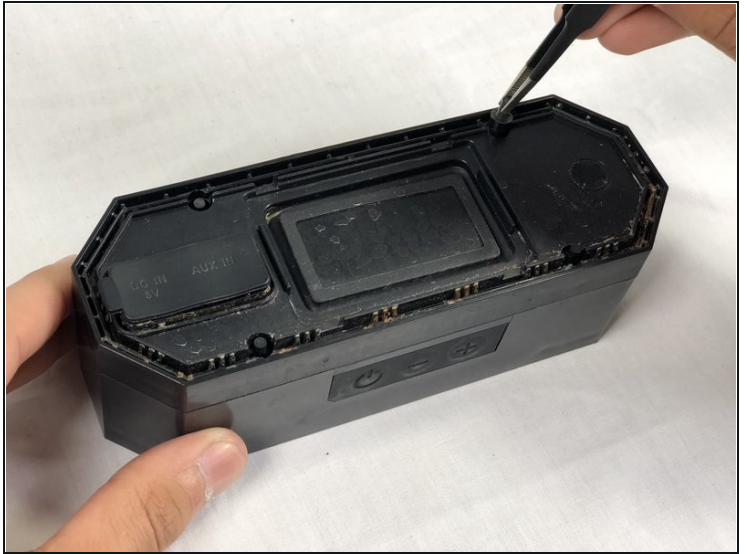
## Step 6

- Using [tweezers](#), remove the four rubber stoppers in each corner of the rear panel.

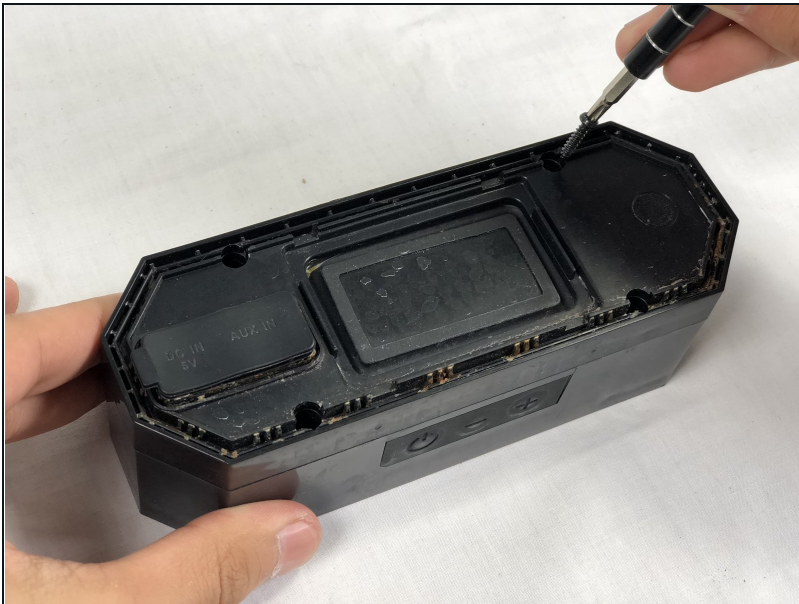
## Step 7

- Remove the four 13.7mm Phillips #1 screws located underneath the rubber stoppers.

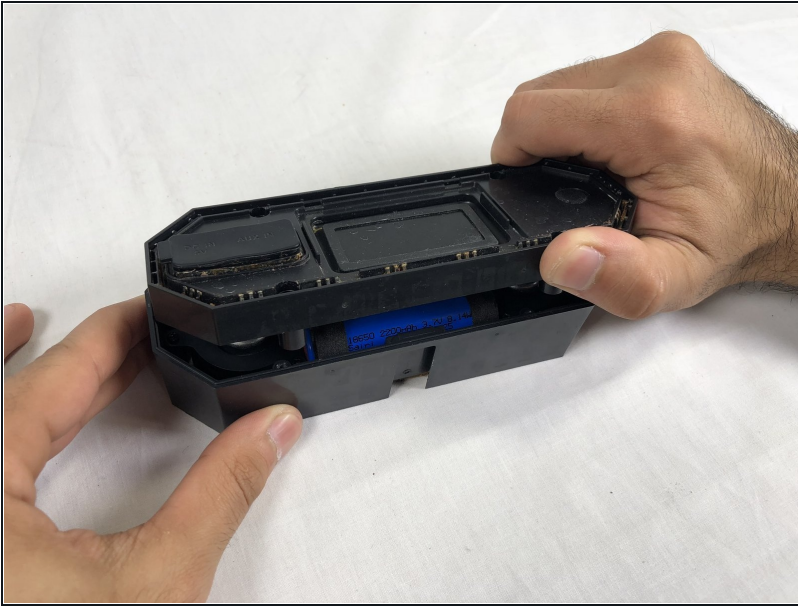
## Step 8

- Pull the case apart to access the interior components.

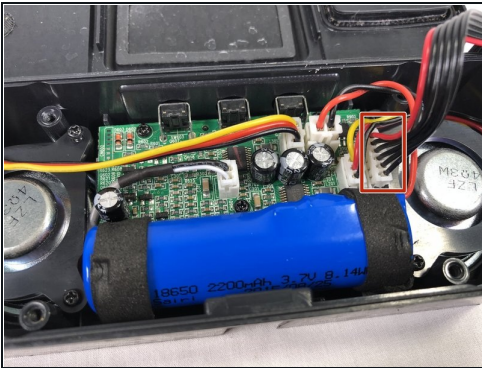
## Step 9

- To remove the back panel, gently pull out its wire harness.
