Dell VRP100 Auxiliary Cord Replacement

This replacement guide will show you how to...

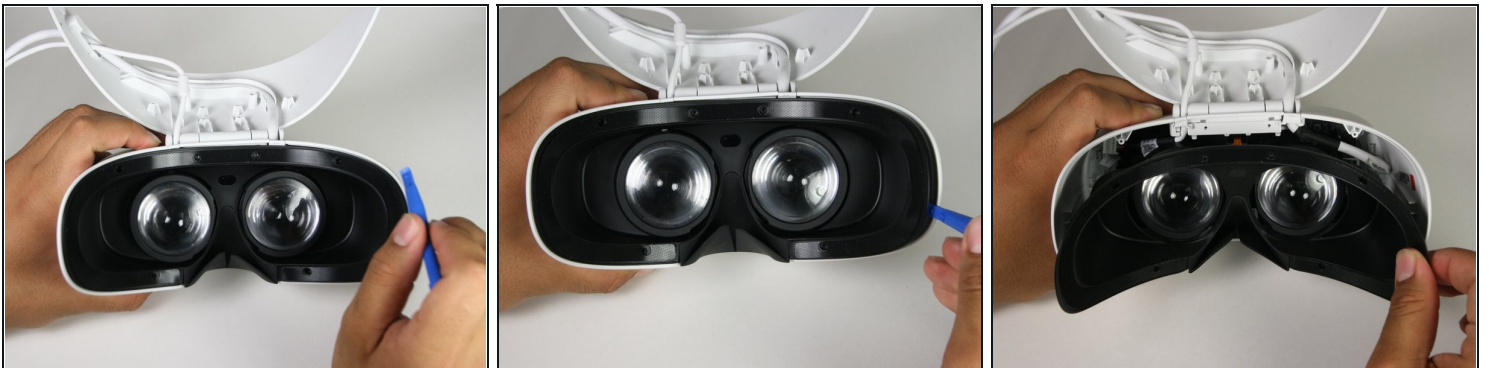
Step 3

- Remove the cover using one of the plastic opening tools, and then carefully pull it from the casing.

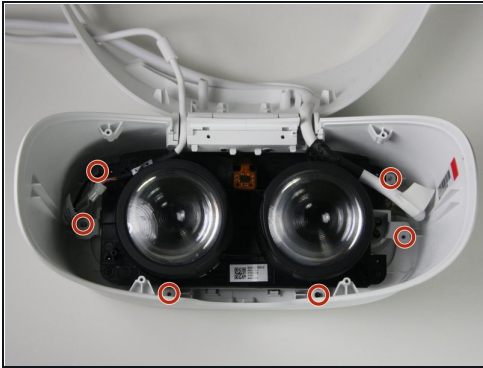
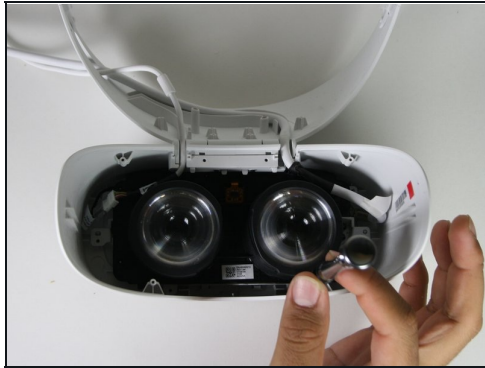
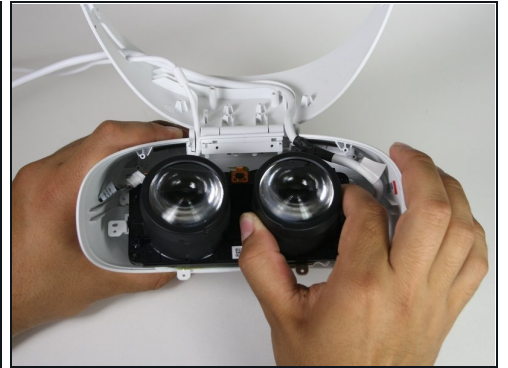
Step 4

- Remove the six 5.5mm PH000 screws from the cover by rotating counter-clockwise.
- Carefully remove the lens and motherboard assembly from the white casing.

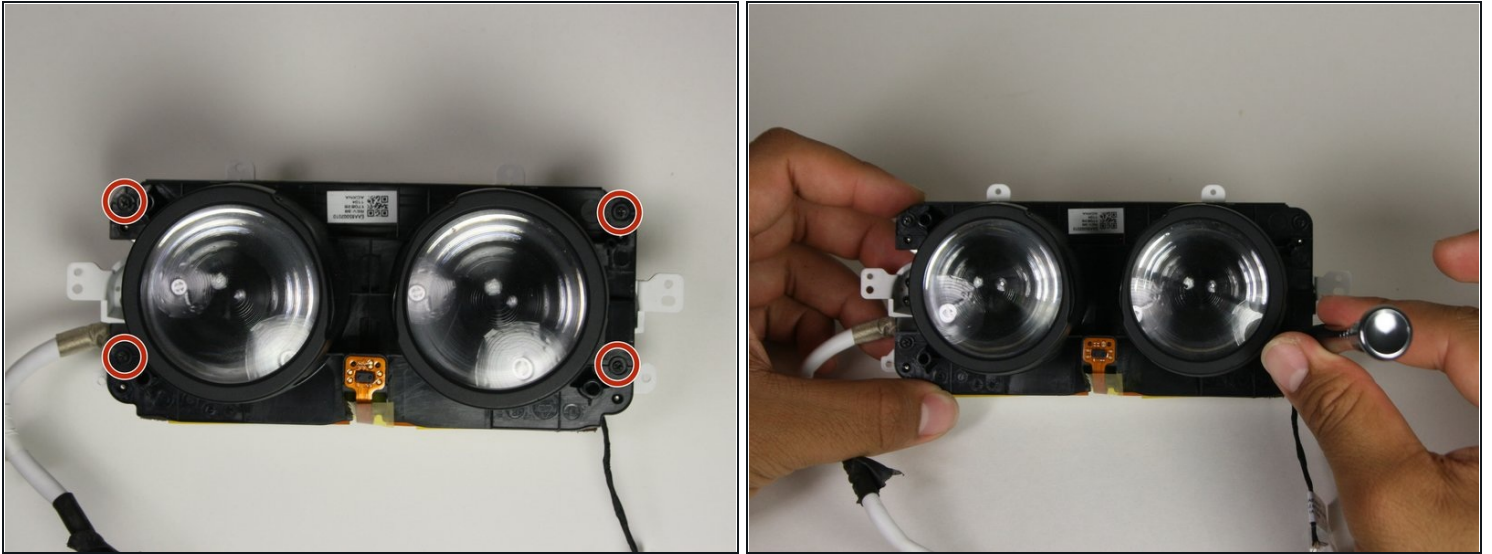
Step 6

- Remove the four 2.5mm PH000 screws by rotating counter-clockwise.
- Separate the lens housing from the motherboard panel.
