# Midland X-tra Talk Radio LXT118 Front buttons Replacement

A common problem with this radio is the buttons...

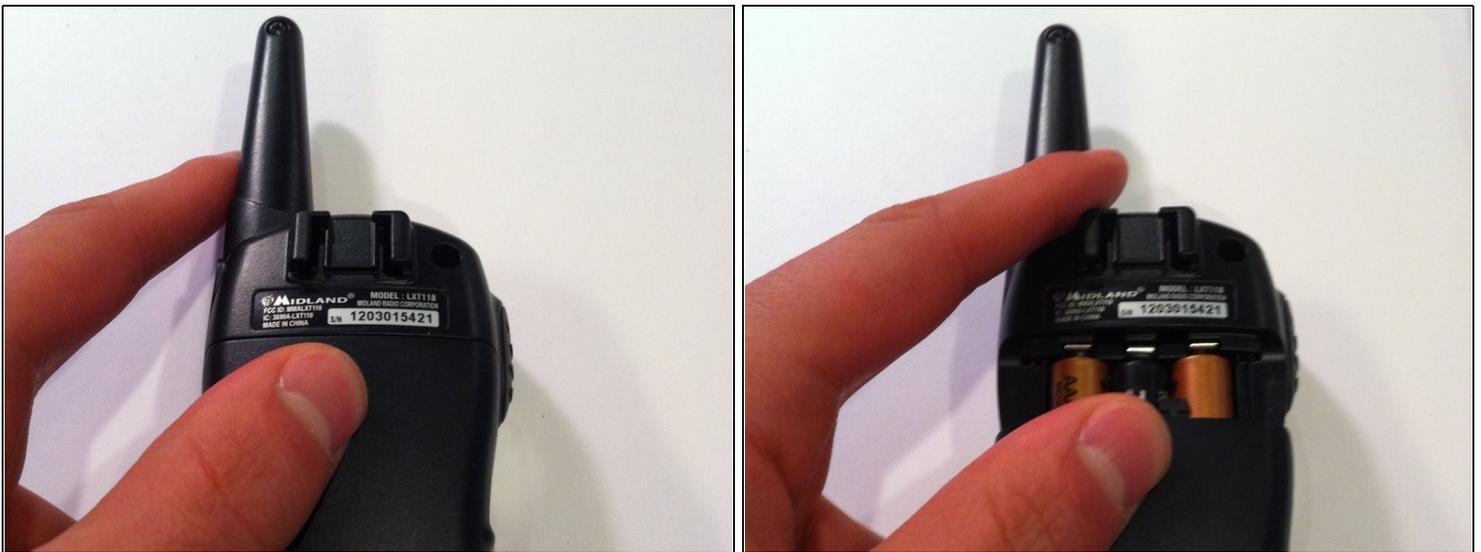
### Step 1 — Batteries

- First, apply pressure with your thumb on the top of the battery cover.
- Next, pull down on the cover until it begins to slide.

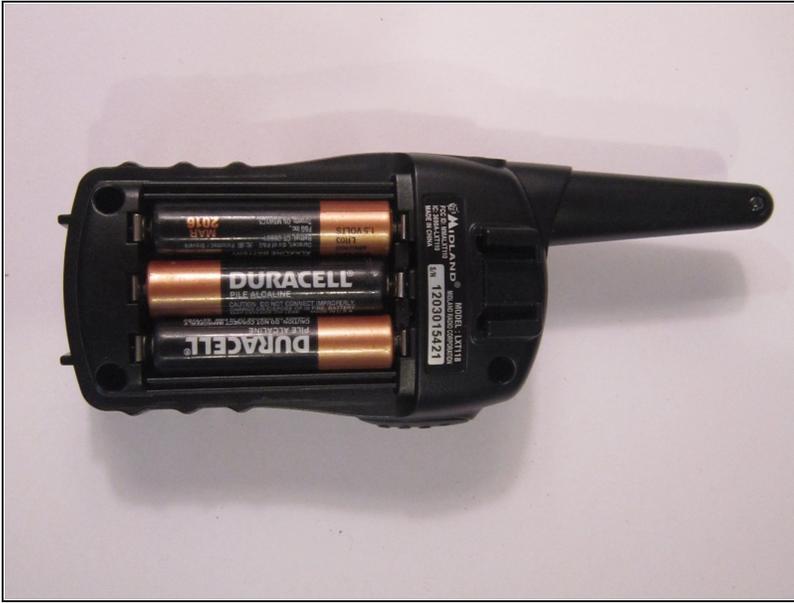
## Step 2

- Finally, once the cover is completely off, pry up the old batteries with your finger or a strong, skinny tool (i.e. spudger).

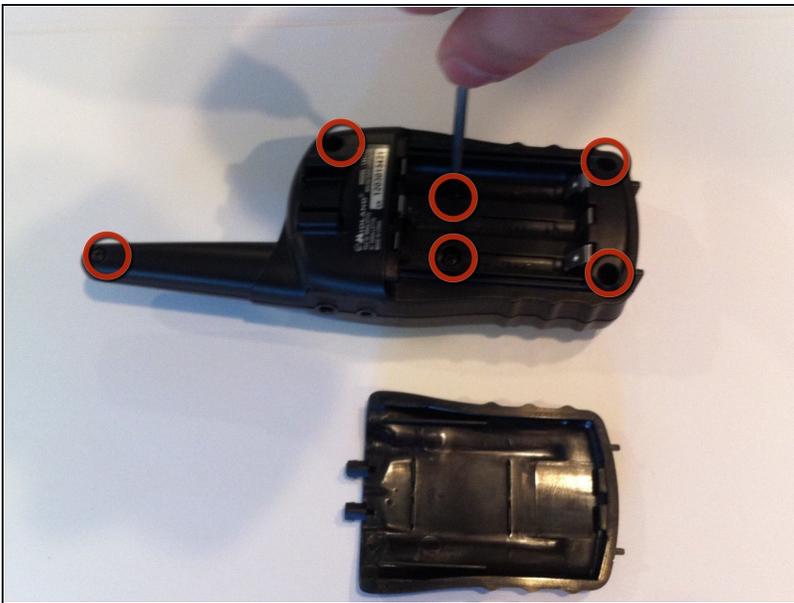
## Step 3 — Case

- Unscrew the six 8.0 millimeter long, #0 screws on the backside of the case using the Phillips #0 screwdriver.

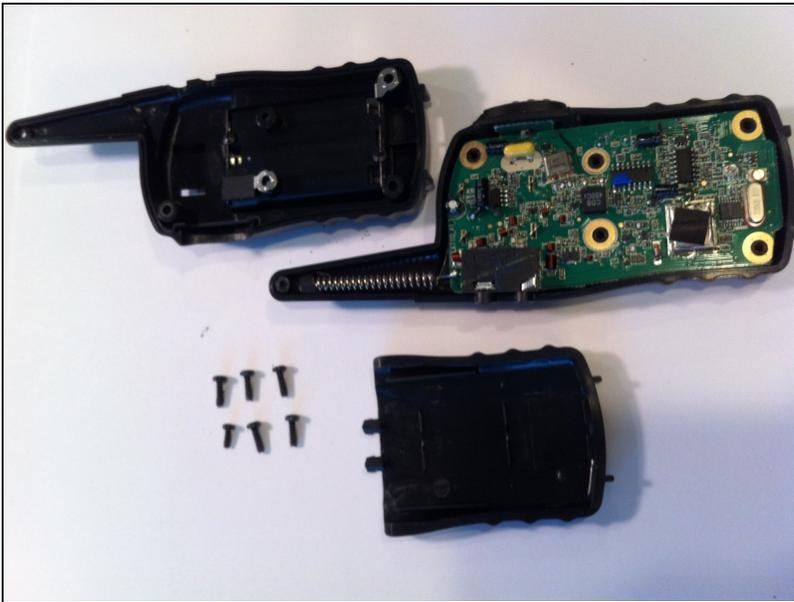
## Step 4

- Detach back part of the case by gently lifting up.

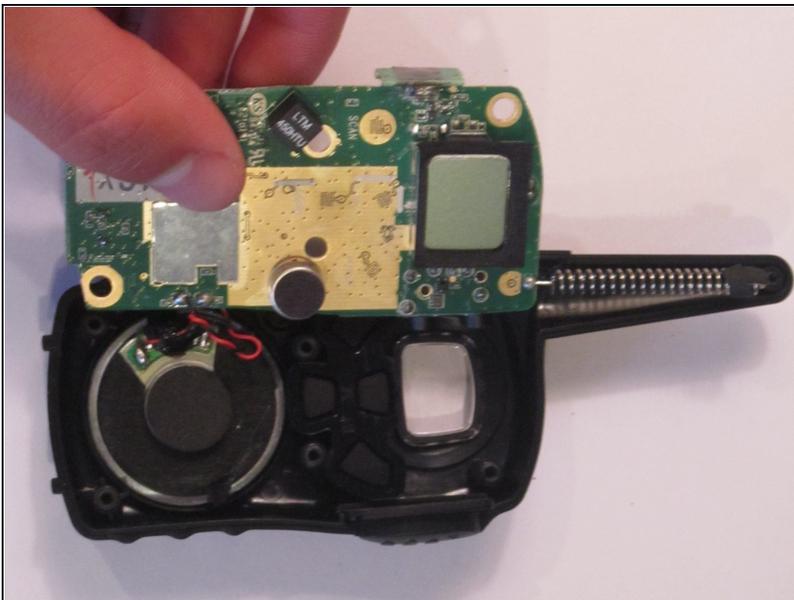
## Step 5 — Front buttons

- Once the back case is already off, use your fingers to lift up the circuit board from the side opposite the antenna.

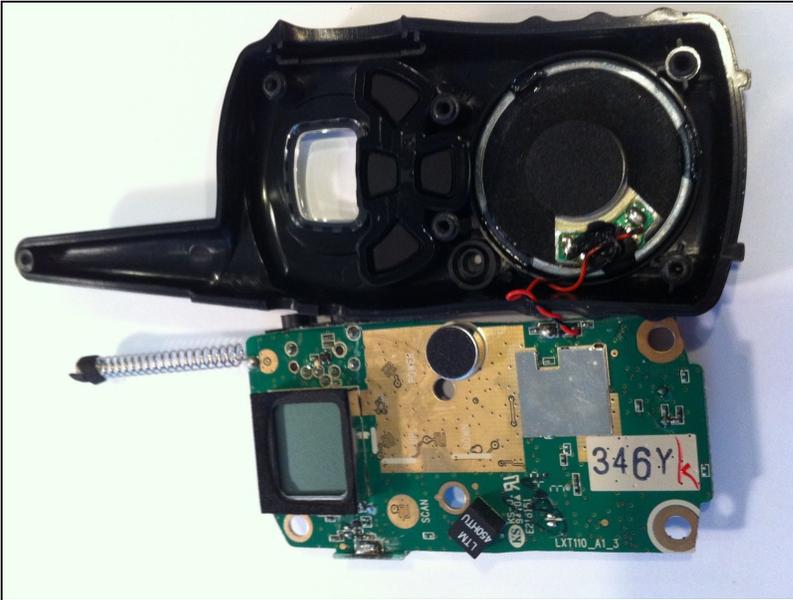
## Step 6

- Lay the circuit board down on the side, as you will not want it interfering with your work on the buttons!

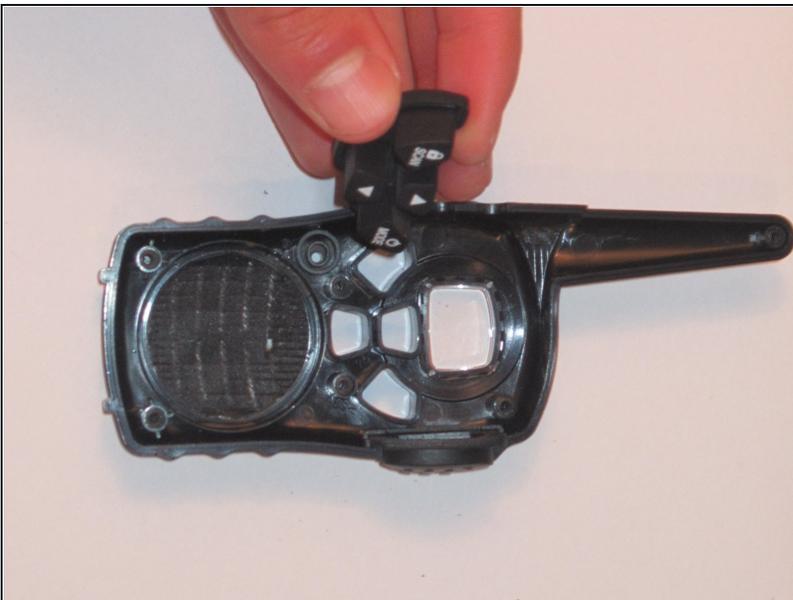
## Step 7

- Grasp the rubber cast around the buttons from one side, and slowly lift upwards. Make note of which way the buttons fit into the plastic casing!
- At this point, the buttons can be cleaned in accordance with the [radio buttons are stuck or sticking](#) troubleshooting guide.
- ⓘ The speaker does not need to be removed in order to get to the buttons.

To reassemble your device, follow these instructions in reverse order.
