# iPhone 11 Pro Max Face ID Not Working Repair

iPhone 11 Pro Max Face ID dot projector repair by replacing the flex cable

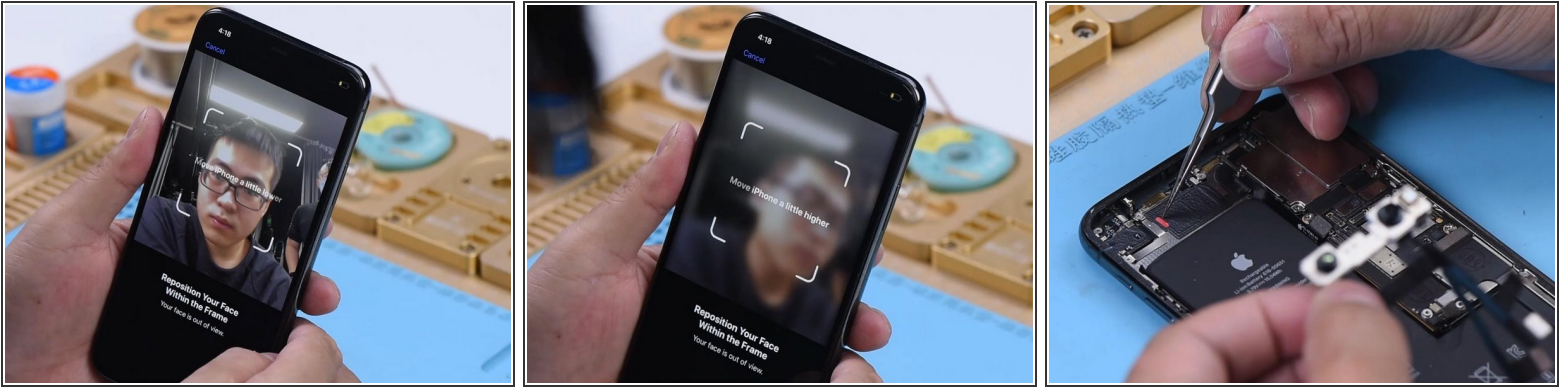
## Step 1 — iPhone 11 Pro Max Face ID Not Working Repair

- Go to Settings > Face ID & Passcode > Set Up Face ID. When trying to set up Face ID, “Move iPhone a little lower/higher” pops up. Face ID cannot be normally set up. It can be judged that the dot projector of the Face ID has malfunctioned.
- Remove the display and then detach the Face ID module. We can see a red mark, which indicates that the phone has water damage.

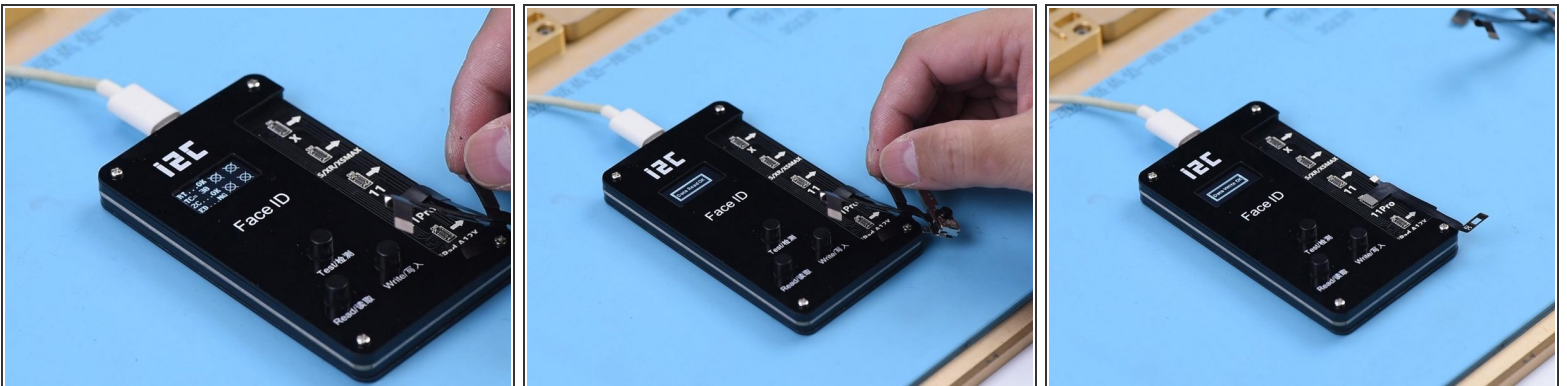
## Step 2

- Connect the dot projector flex cable with the I2C Repair Programmer. The test shows that the dot projector flex cable has malfunctioned.
- Press “Read” and read the data from the dot projector flex cable.
- Connect a new I2C iPhone 11 Pro Max flex cable to the programmer. Press “Write” and write the data that has been read on the new flex cable.
