Sennheiser HD 4.50 Volume Control Button Replacement

Use this guide to replace a faulty volume control function button on your Sennheiser HD 4.50 headphones.

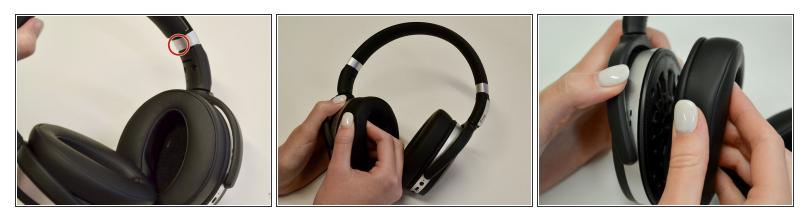
Step 1 — Motherboard

- Locate the side designation on the headband-earpiece junction.
 (i) The motherboard is located on the right side.
- Remove the right side ear pad.
- (i) Refer to the <u>Ear Pad Removal guide</u> for more guidance.

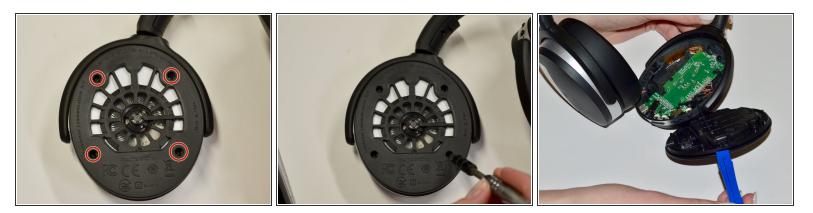
Step 2

- Use the Phillips #00 screwdriver to remove the four 10 mm screws holding the ear cup cover in place.
- Use an opening tool to pry off the cover.

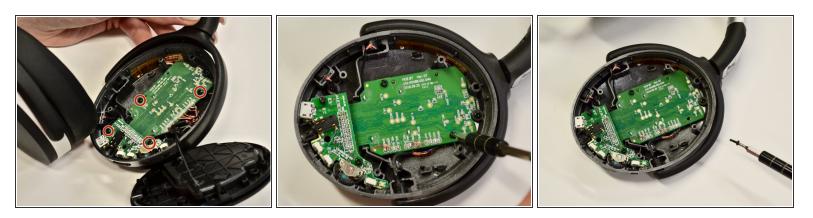
Step 3

Use a Phillips #000 screwdriver to remove the four 6 mm screws holding the motherboard in place.

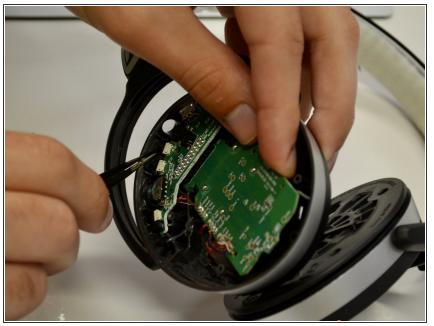
Step 5

- Use the iFixit opening tools to lift up on the motherboard.
- While lifting up with the tool, grab and pull the motherboard with your free hand away from the button functions until it disconnects.
- (i) There may be some resistance in this step.

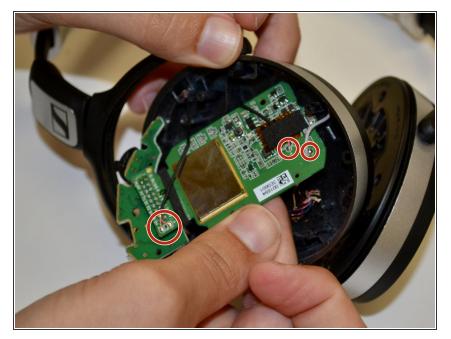
Step 6

- Desolder the three wires that are on the underside of the motherboard now that it is free.
- Remove the motherboard.

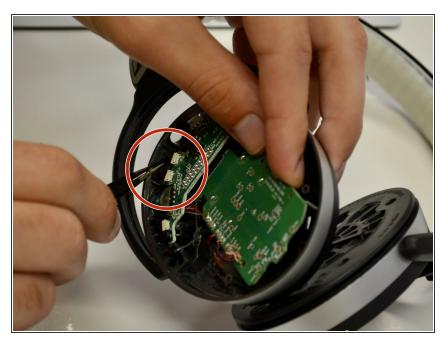
Step 7 — Volume Control Button

• Use a pair of tweezers to push the outer portion of the volume control button through the opening.
