Stripped Thermomix TM31 Blade Assembly Repair

This guide shows how to fix the Thermomix TM31 blades back to their shaft if they become loose or free-spinning (or "stripped").

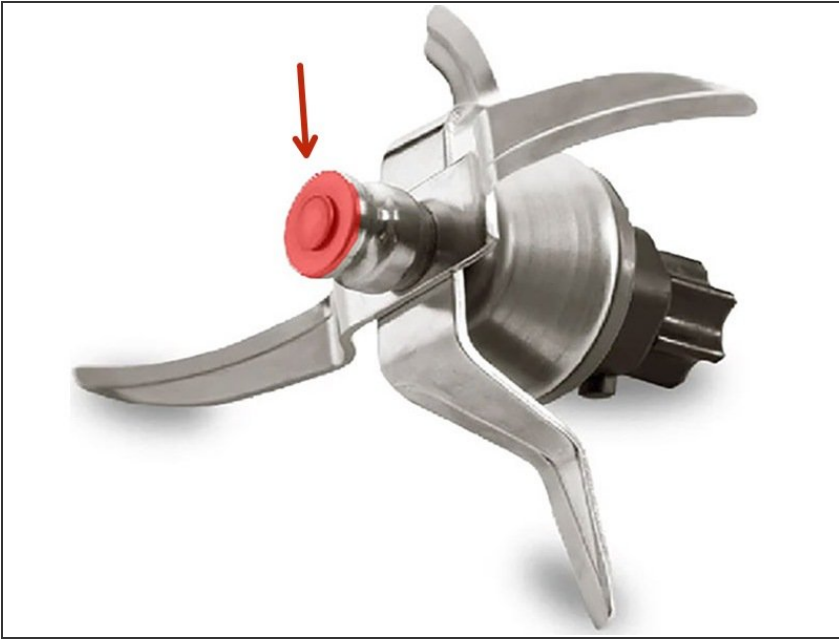
Step 1 — Remove top 2mm of metal from the head

- First make sure the blade assembly is removed from the Thermomix.
 - Next file (or angle grind) away approximately 2mm of metal from the top of the blade shaft head (the metal to be removed is highlighted in red in this picture).
- ⓘ You want to remove enough metal so that the 6mm shaft is visible from the top of the head..

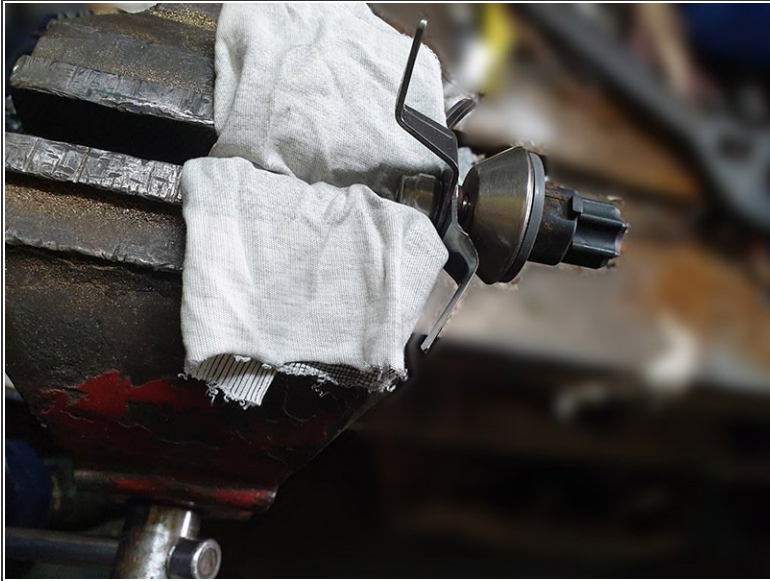
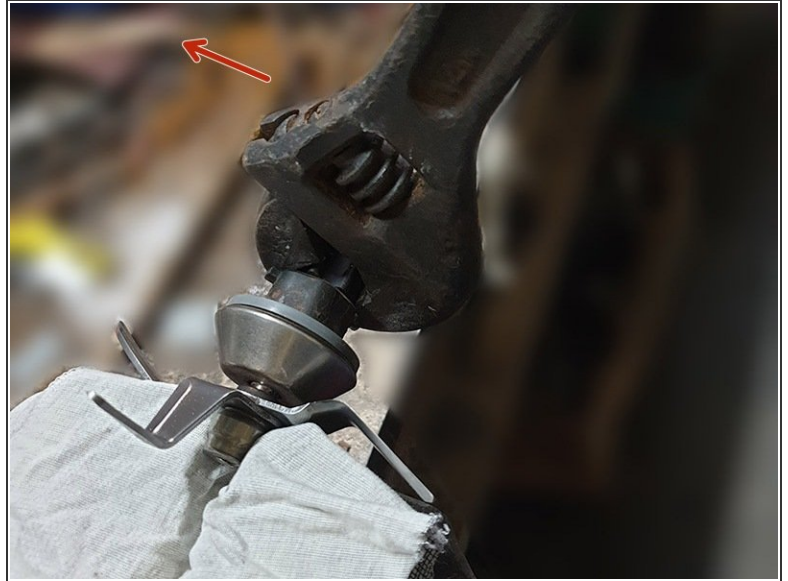
Step 2 — Clamp head in vice and unscrew head

- ⓘ Note the head shown here has already been worked on a bit and may appear a bit different.
- Clamp the head tightly into a vice (also use a piece of cloth or two in between to minimize damage to the head).
- ⓘ The head has a left handed thread (opposite to what is normally used).
- Unscrew the head using a wrench on the base and turn clockwise (left handed thread) until the head is detached. If there is considerable resistance then go back to the previous step and remove more metal from the head.

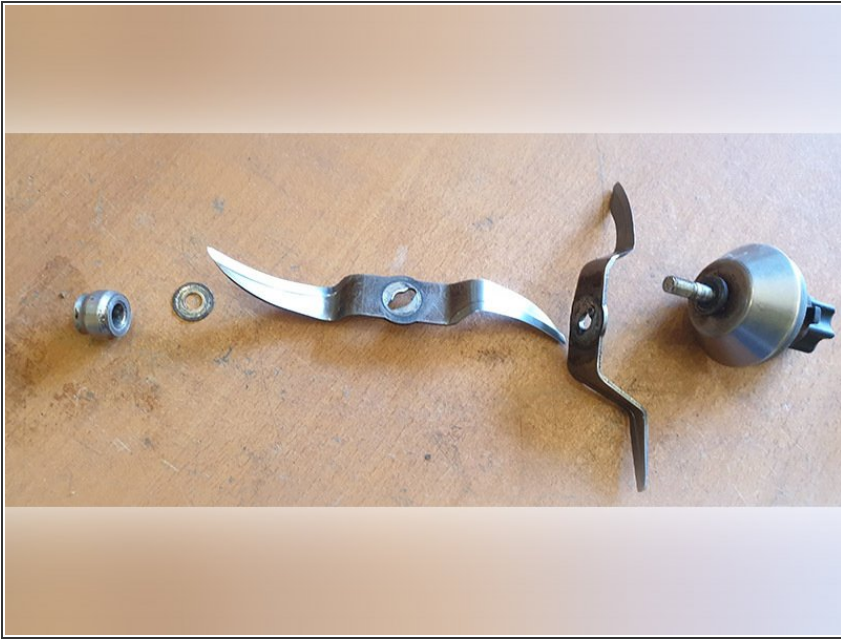
Step 3 — Dissassembled blade shaft assembly and inspect for damage

- Once the head is loosened and removed take apart the blade assembly. Note the blade orientation.

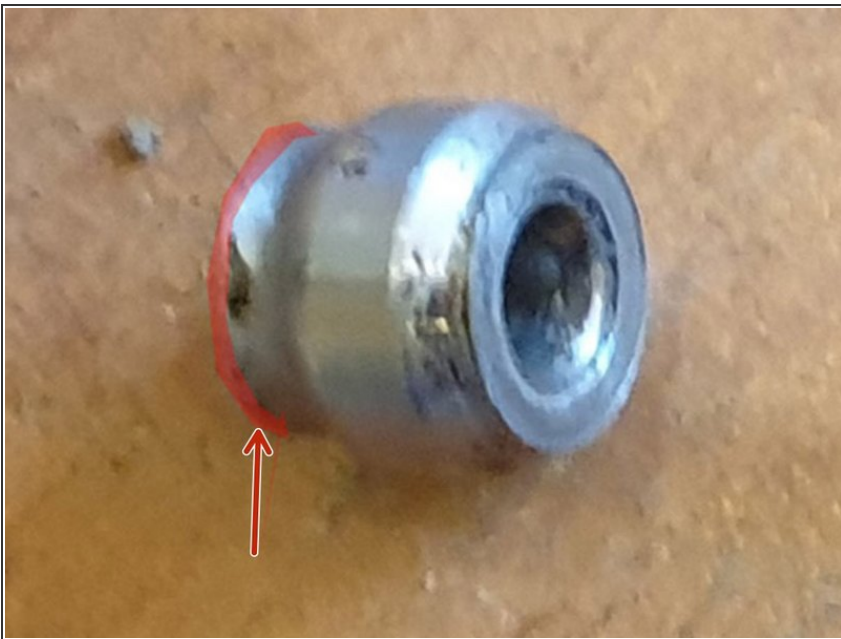
Step 4 — Remove 1mm off the top off the head

- Next remove 1mm of metal (either through filing or angle grinding) from the top of the head (area to be removed highlighted in red).
- ⓘ This will allow the shaft to stick through when reassembled, so you can peen it over to lock everything together.

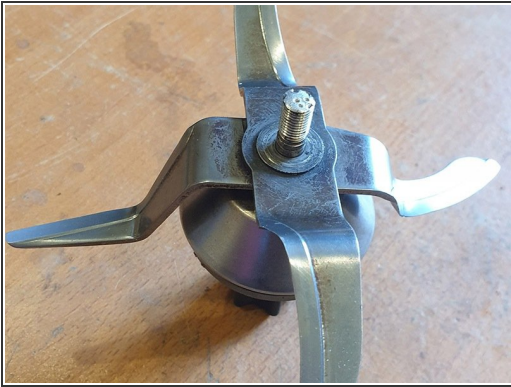
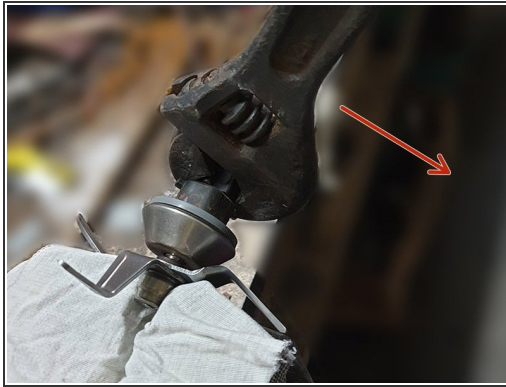
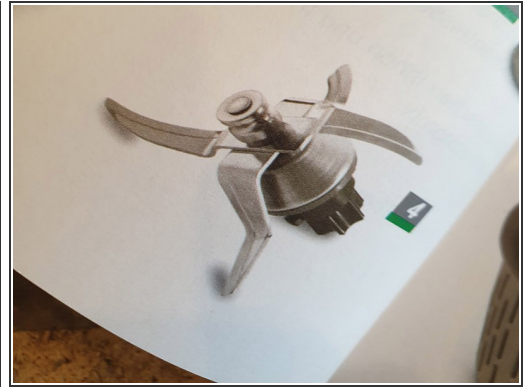
Step 5

- Reassemble blade shaft together in same order, taking note that the blades are in correct orientation (it is possible to put them upside down by mistake).
- Clamp the head portion in a vice (with cloth) and tighten with adjustable spanner in an anticlockwise direction (left-handed thread) until tight. Do not overtighten as you risk stripping the base. The assembly should self tighten once back in the thermomix anyway.

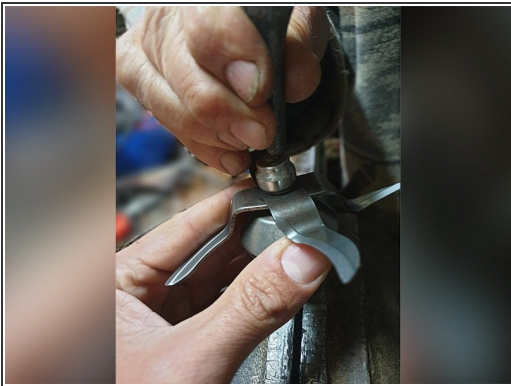
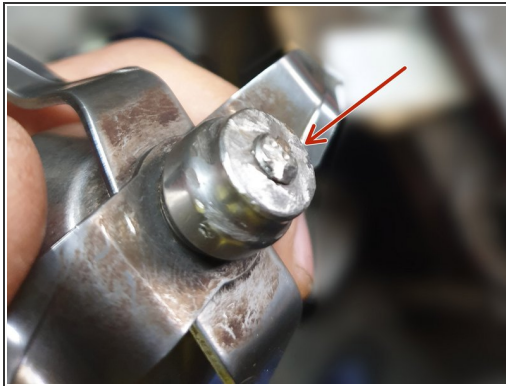
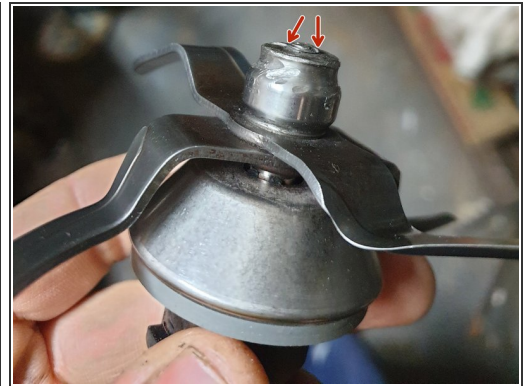
Step 6 — Peen over shaft end so that it holds down assembly

- ⓘ This step may require two people - one to hold the assembly and the other to peen the threaded shaft end over.
- Make sure to rest the assembly down against a surface that is in contact with the metal shaft underneath (we used a 3mm rod clamped in a vice).
- Next peen over the 1mm exposed end of the threaded shaft so that it holds the head down (and rest of assembly).

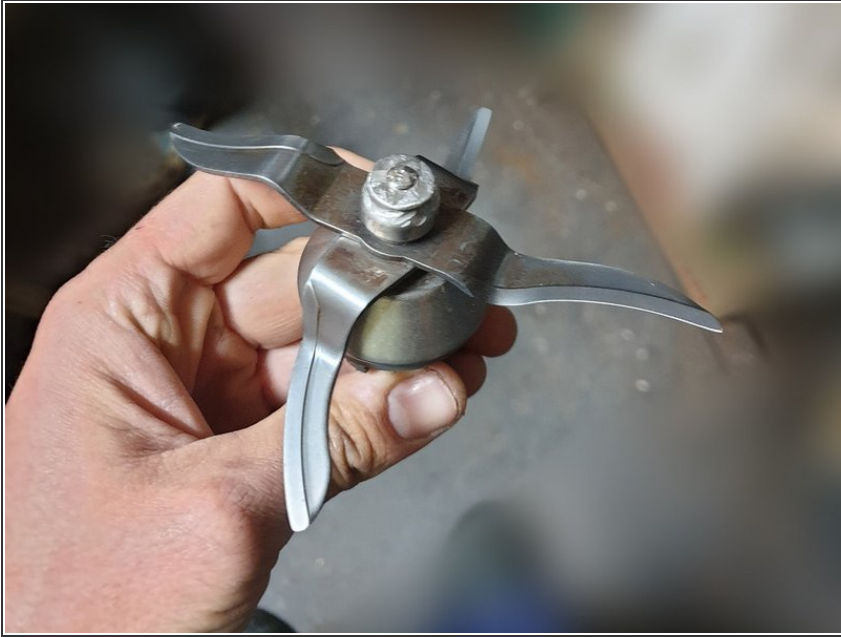
Step 7 — Wash final assembly and you're done!

- Wash the assembly with detergent and water to remove any dust, grease or grime. The repair is now complete!
