Lenovo 500e Chromebook 2nd Gen Wi-Fi Card Replacement

This guide will show you how to replace the...

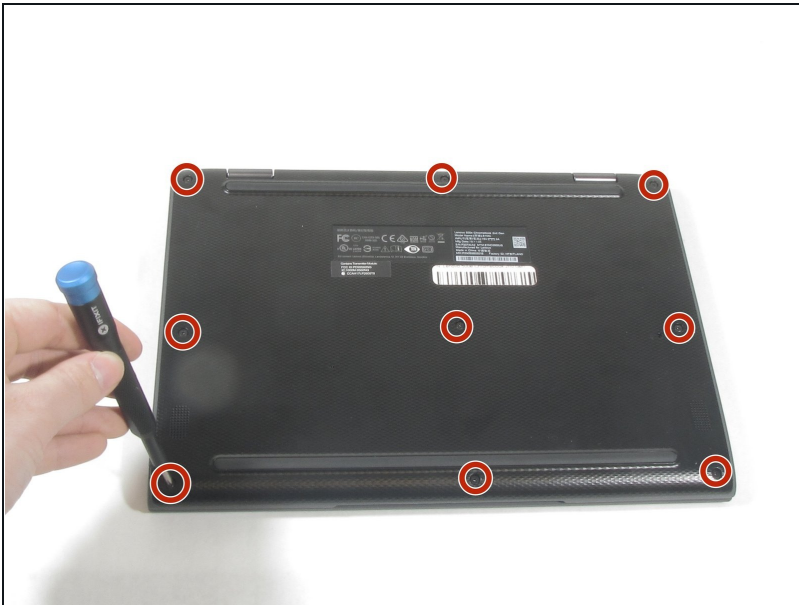
Step 1 — Back Panel

- Remove nine 6 mm screws from the bottom cover of the laptop using a Phillips #0 screwdriver.

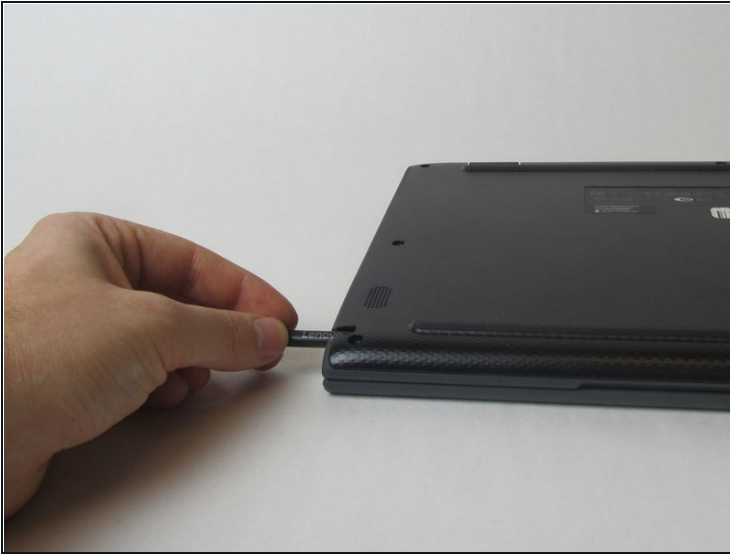
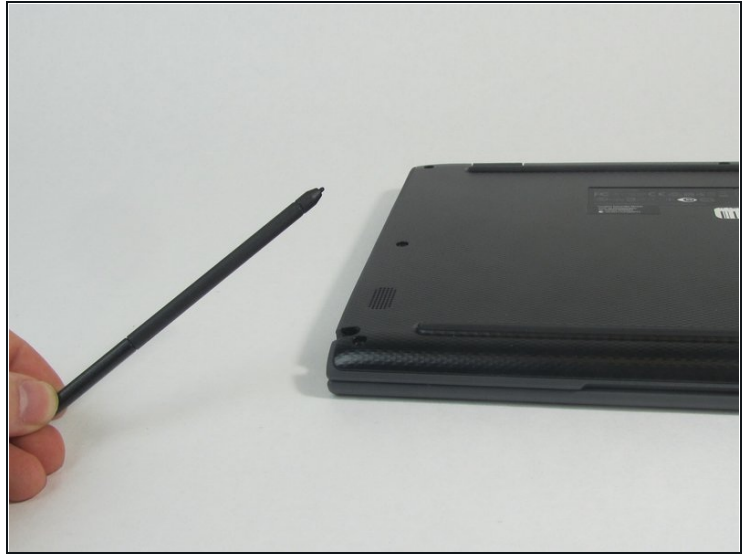
Step 2

- Remove stylus from the lower left corner of the back panel.

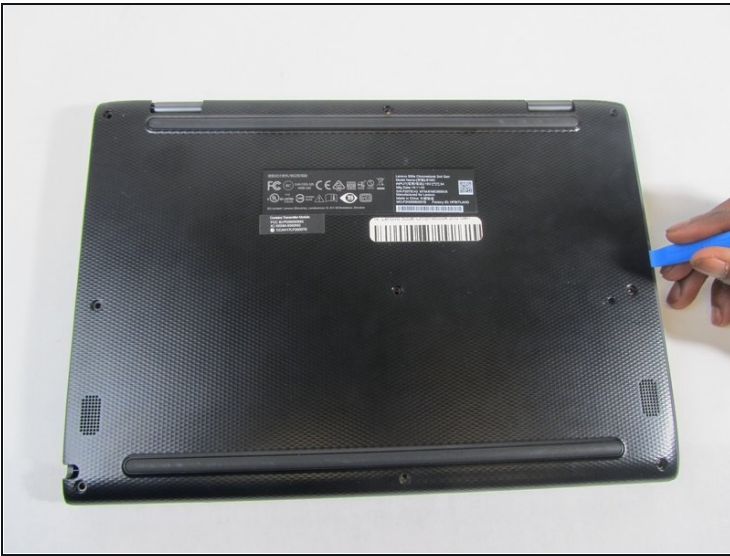
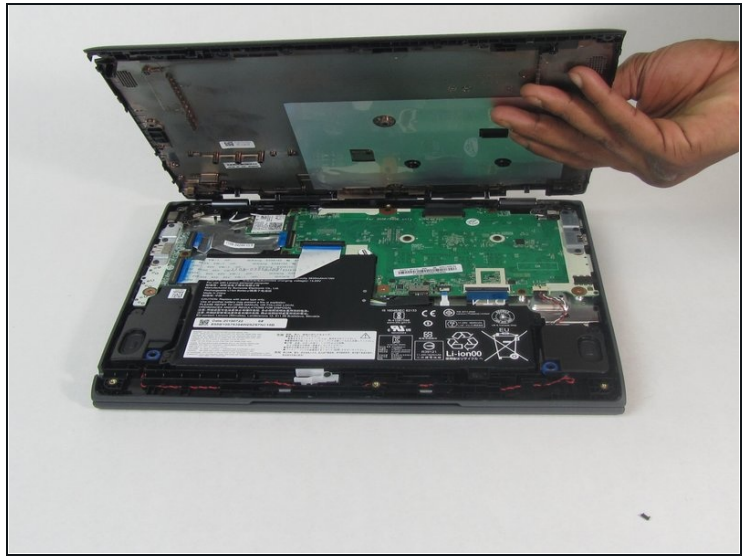
Step 3

- Go along the edge of the back panel with an iFixit opening tool until it pops loose.
- Remove the back panel from the laptop.

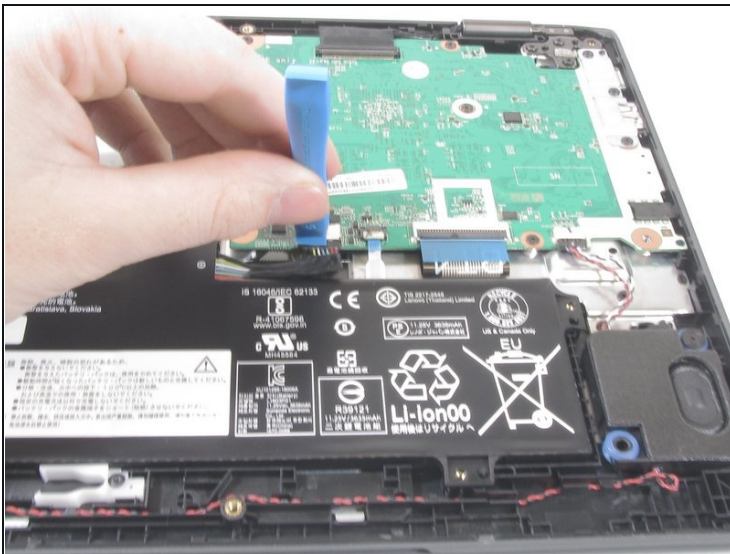
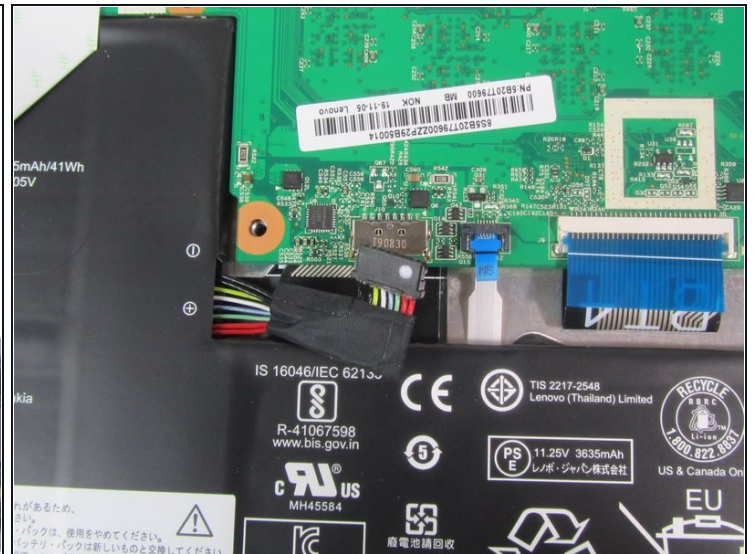
Step 5

- Use the iFixit opening tool to unplug the battery from the motherboard.

⚠ Potential for device damage: Make sure to be gentle while removing the wire.

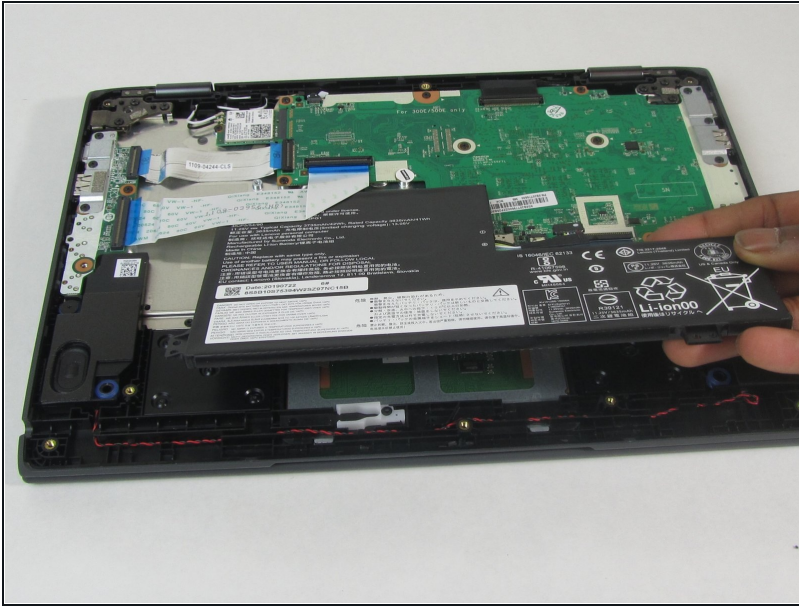
Step 6

- Remove the battery from the laptop.

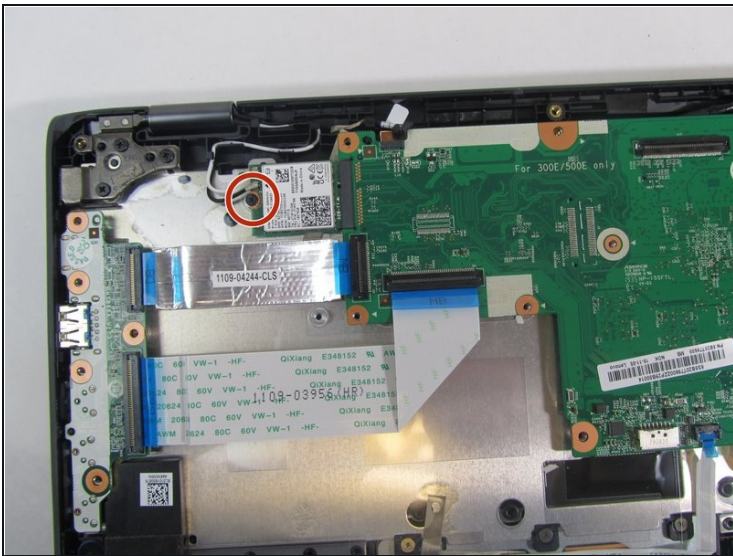
Step 7 — Wi-Fi Card

- Remove the single 2 mm screw from the Wi-Fi card using a Phillips #00 screwdriver.

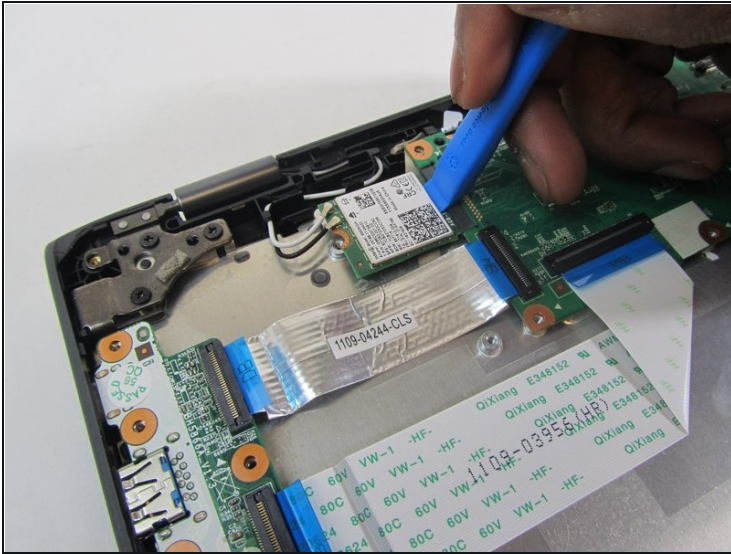
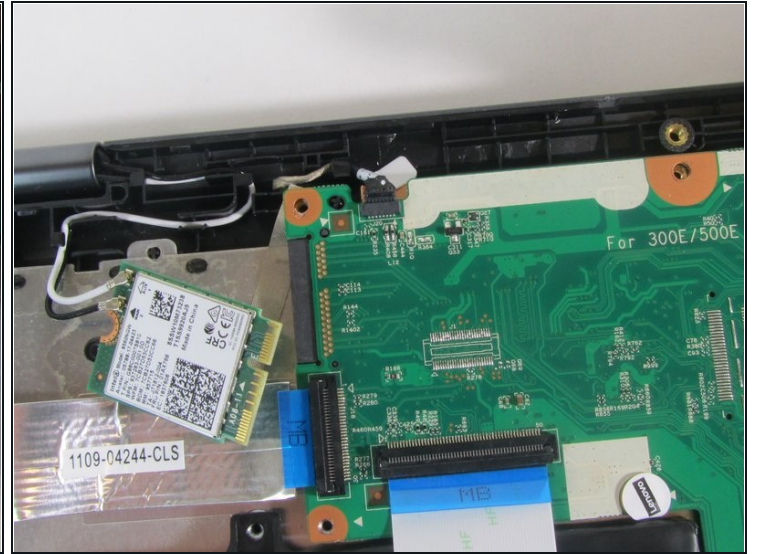
Step 8

- Detach the Wi-Fi card from the motherboard using an iFixit opening tool.
