## Lenovo 500e Chromebook 2nd Gen Back Panel Replacement

How to replace the back panel on a Lenovo 500e Chromebook 2nd Gen laptop.

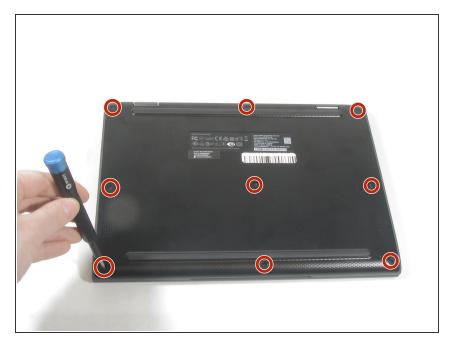
## Step 1 — Back Panel

Remove nine 6 mm screws from the bottom cover of the laptop using a Phillips #0 screwdriver.

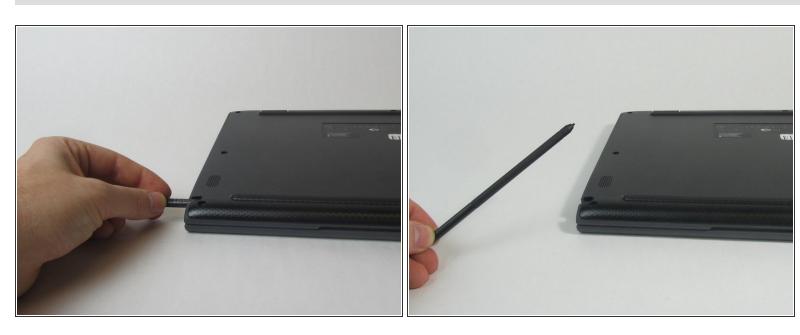
## Step 2

Remove stylus from the lower left corner of the back panel.

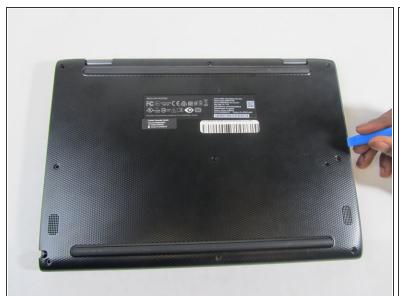
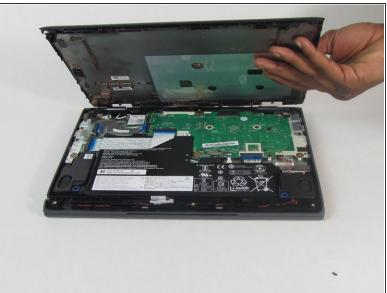
## Step 3

- Go along the edge of the back panel with an iFixit opening tool until it pops loose.
- Remove the back panel from the laptop.
