# Philips 22PFL3504D Power Transformer Replacement

This set was given to me due to excessive humming noises, frequent shut-off, as well as difficulty to turn it on. The most common issue for that is a failing transformer.

The most common issue with humming, and intermittent failure to come on, is a failed transformer. The part number for the transformer is LTT2PC0XB044. The least expensive one I found was \$11. This set opens up without any difficulties, the layout of the PCB's is clean and neat. Philips was kind enough, to mark the screws that need to be removed, with an arrow on the circuit board.

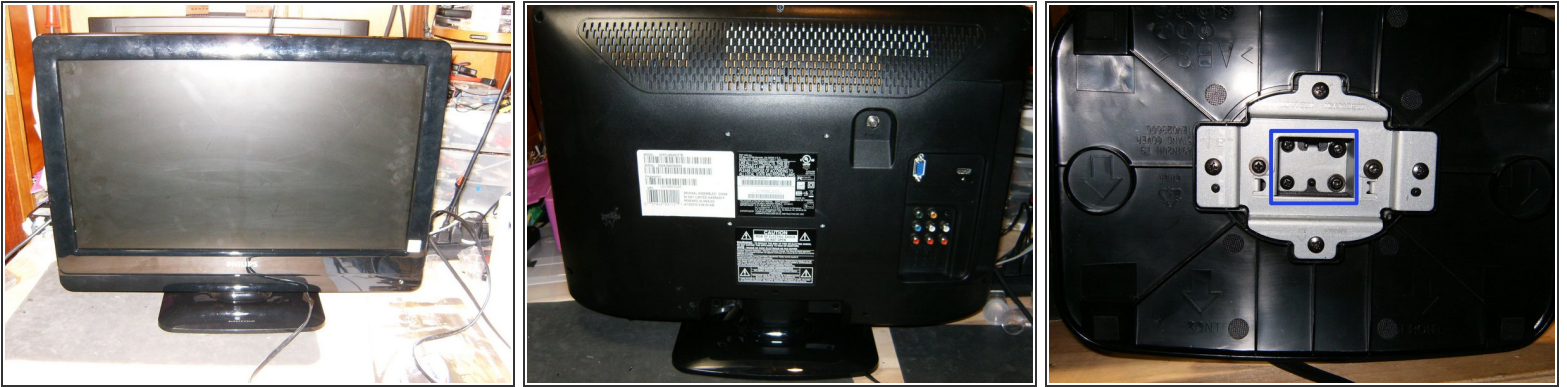
## Step 1 — Power Transformer

- Here is the Philips 22PFL3504D. Fingerprints are definitely visible on the glossy front bezel and the LCD. those are really just smudges.
- Turn the TV over and lay it down,
- this will show the four Philips head screws that hold the base on to the TV

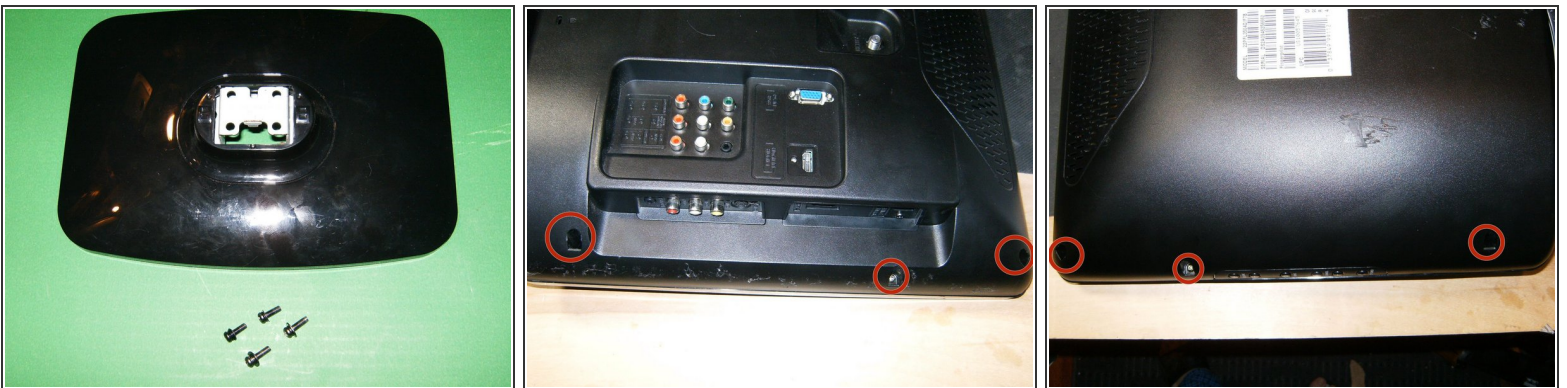
## Step 2

- With the four M3X15 mm screws removed, the base can be taken off.
- Remove the three Philips head screws on the right side
- Remove the three Philips head screws on the left side.

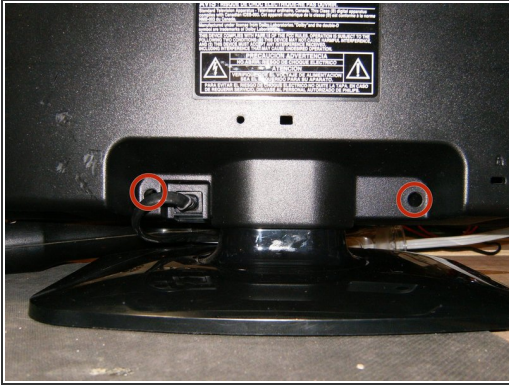
## Step 3

- Remove the two Philips head screws on the bottom
- The back cover can now be removed by simply lifting it up.
- Here is a view of the layout of this TV. Clean and tidy with only a few ribbon cables.

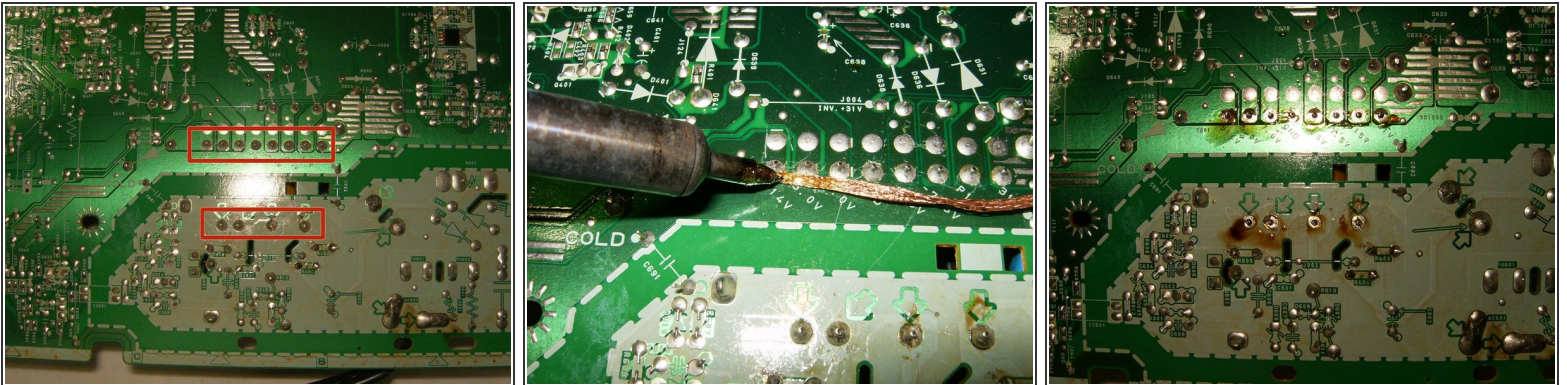
## Step 6

- Turn the board over so that the solder points are up. Identify the connections for the transformer
- Use some flux on the desolder wick and desolder the contacts.
- The wick leaves the contacts without any solder, which will help to easily remove the transformer.

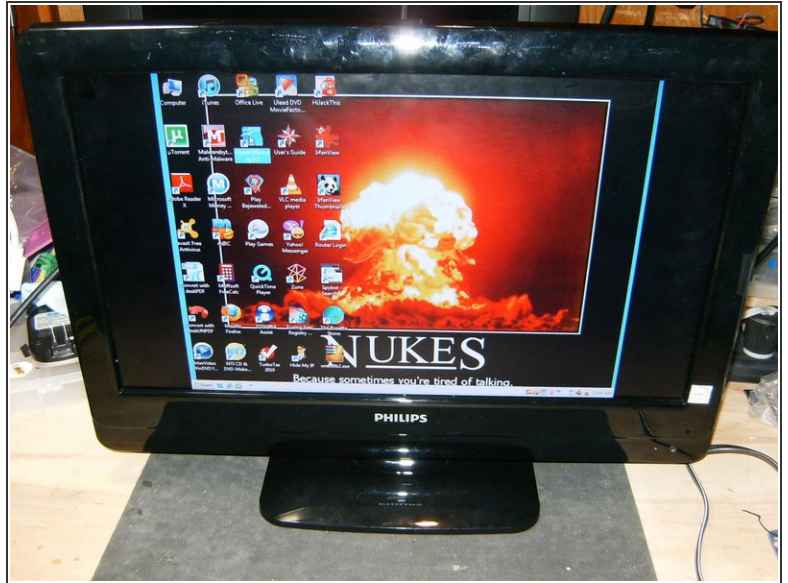
## Step 9

- Ensure the all connections have been soldered and no accidental solder bridge was created. If it all looks satisfactory, reassemble the TV
- After the repair and reassembly. hopefully this is what you will see. A perfect picture and no disturbing humming
