Repairing Dolce Gusto Melody Water Seal

Showing how to repair the leaking water from the bottom of the machine caused by a dirty water seal near the bottom of the water tank.

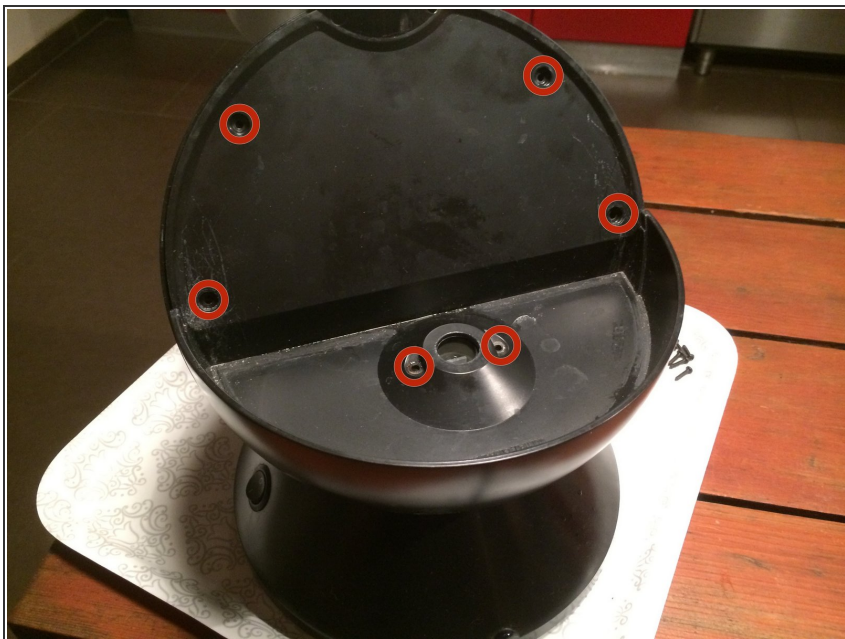
Step 1 — Repairing Dolce Gusto Melody Water Seal

- ❗ Be sure to unplug the device before you begin the procedure.
- Remove the 6 screws from the back.

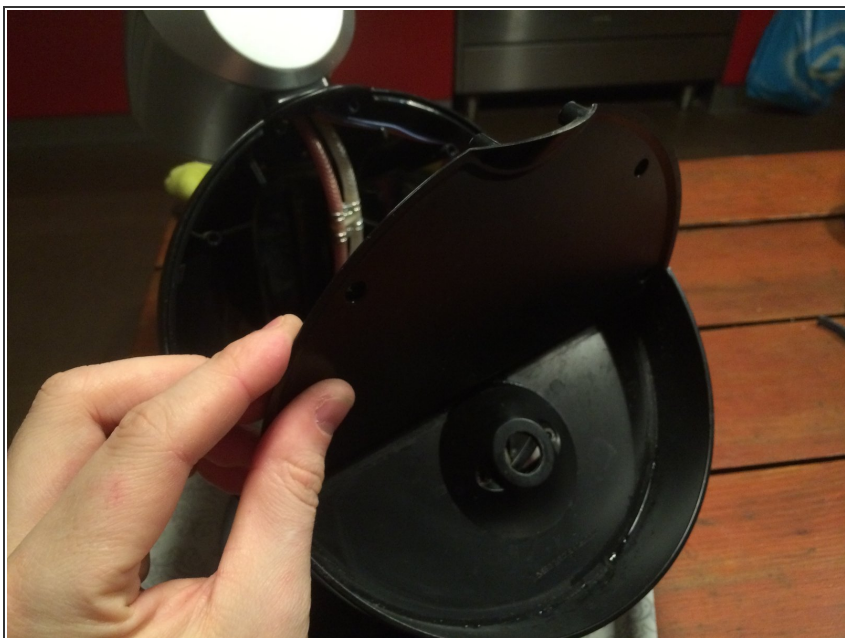
Step 2

- Gently pull at the top of the rear cover.

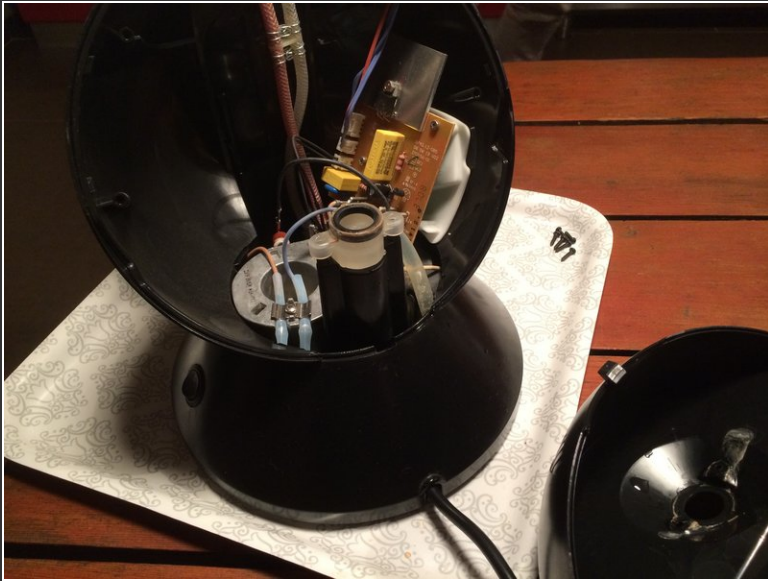
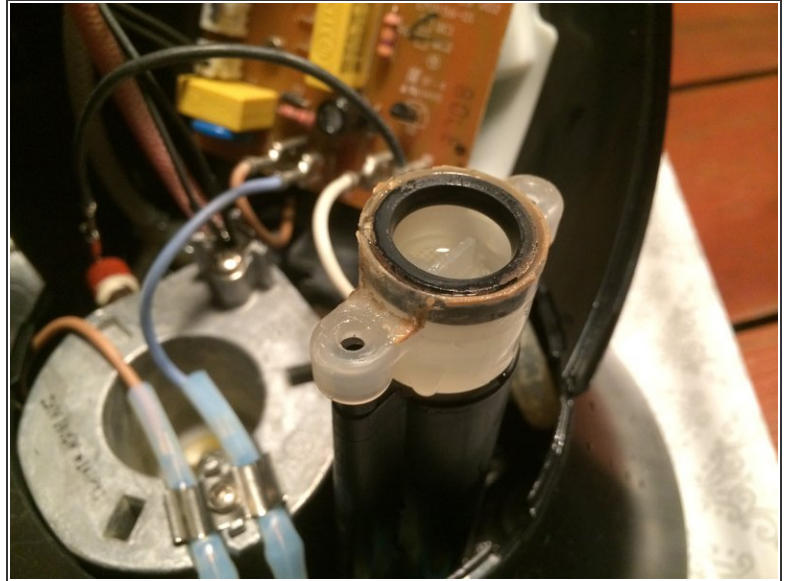
Step 3

- Locate the dirty seal inside

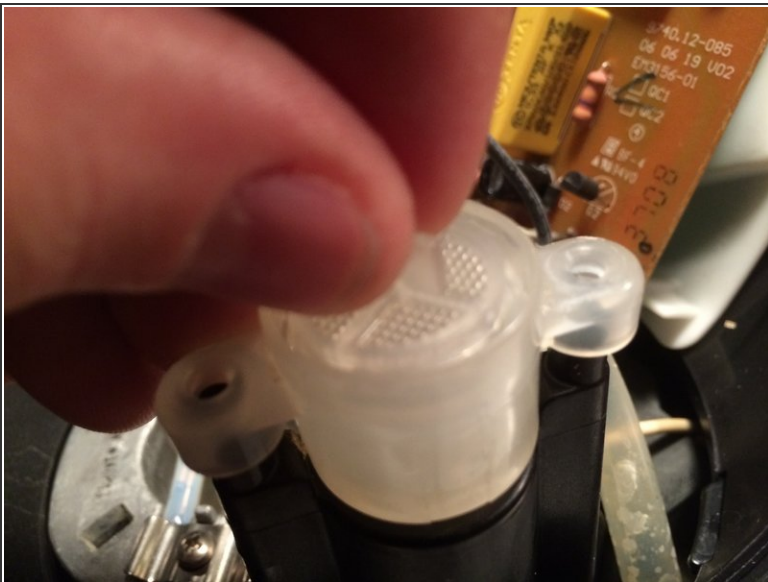
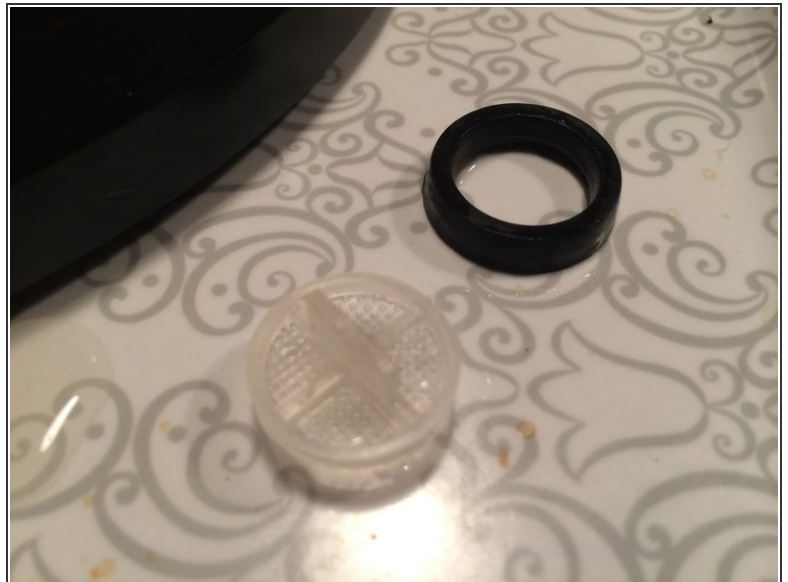
Step 4

- Pull out the rubber seal and the filter.

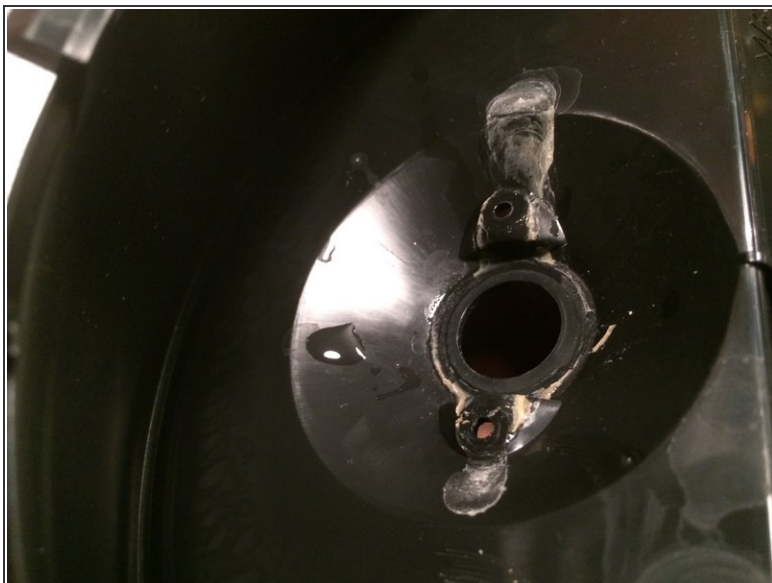
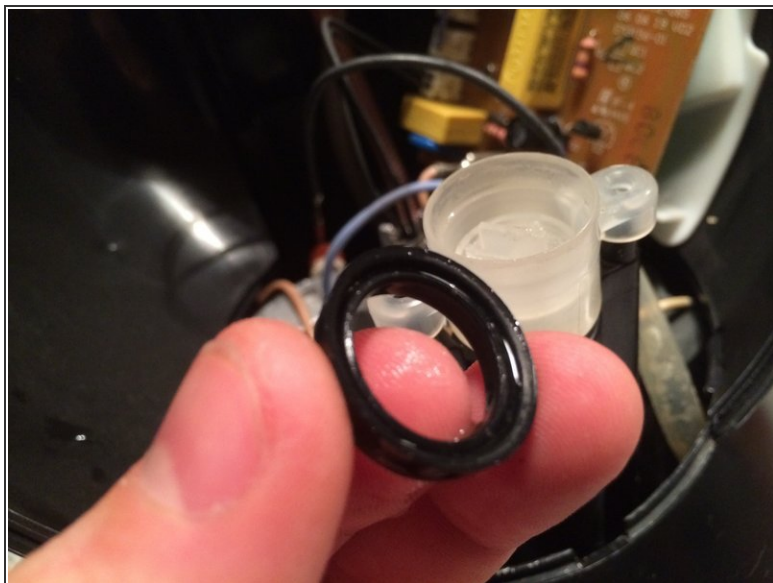
Step 5

- Clean the inside of the cover, the rubber ring, the filter and the holder of the rubber and filter.

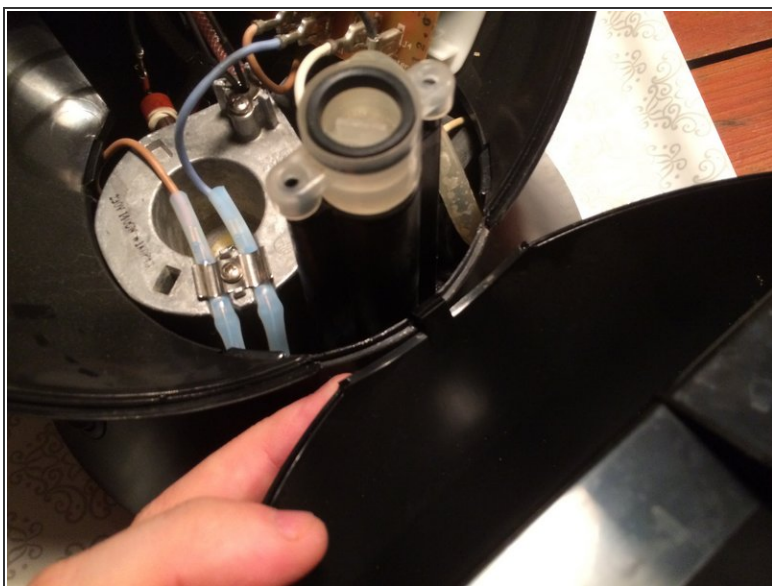
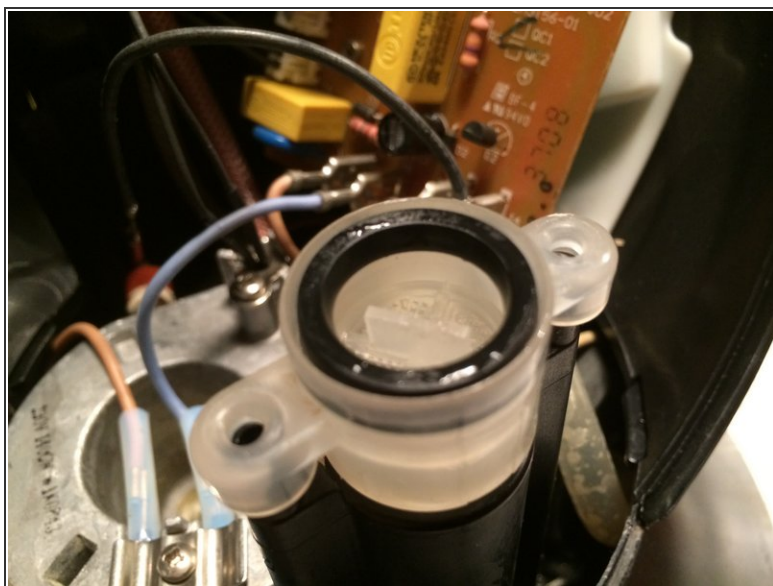
Step 6

- Put it all back together... First the filter, then the rubber ring... You need the smooth side of the ring facing up.

In case you notice the water seal rubber is broken or has tiny cuts in it. You can re-order part: MS-0907124 - Krups Seal

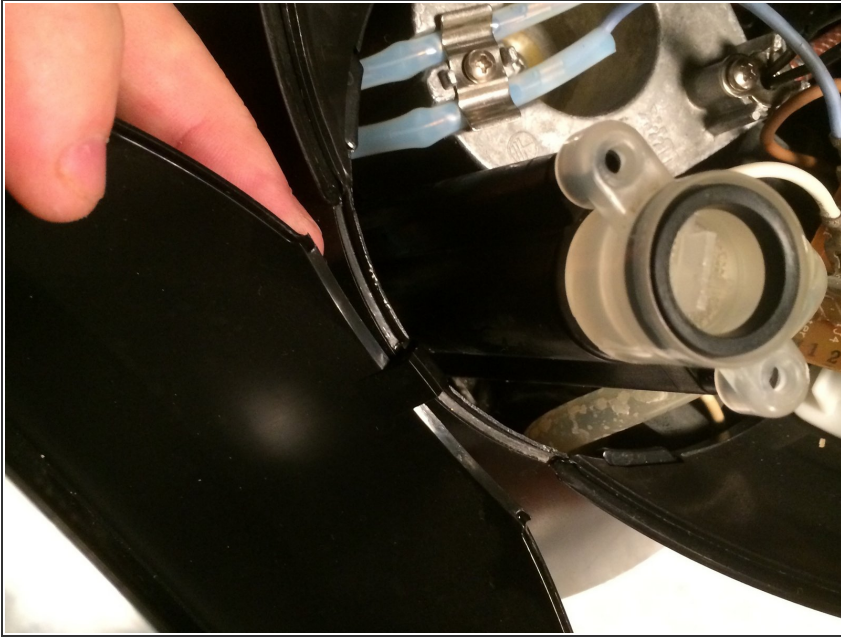
Step 7

- Hook back in the back cover, be careful not to break the clip at the bottom

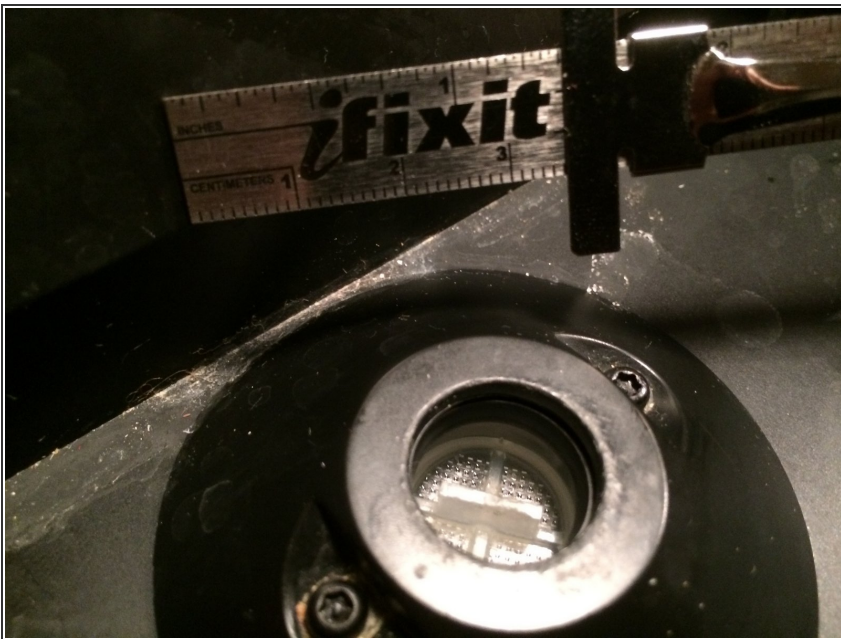
Step 8

- Back together... And you are ready to make some coffee...
