Canon PIXMA MP190 Scan Bed Removal

A dirty scan bed will cause poor scan or copy quality. Cleaning of the scan bed will remedy this issue.

The following guide will demonstrate how to remove the scan bed from the printer as well as how to correctly clean the scan bed.

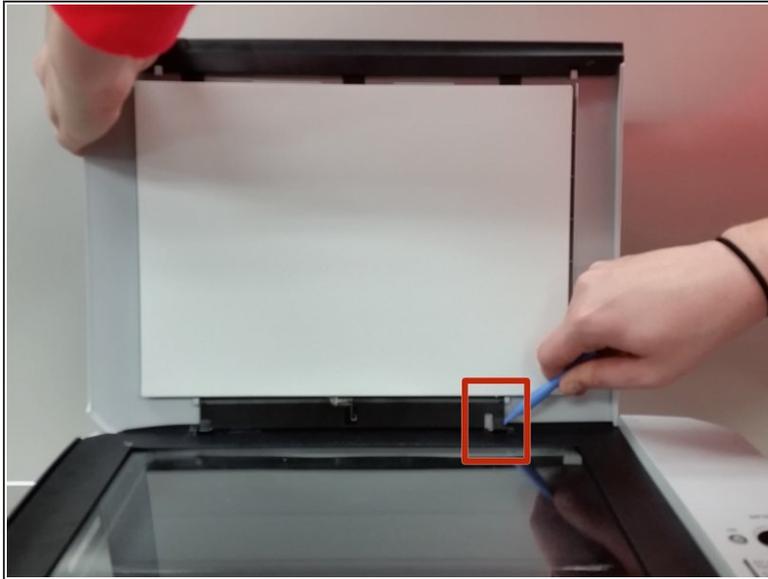
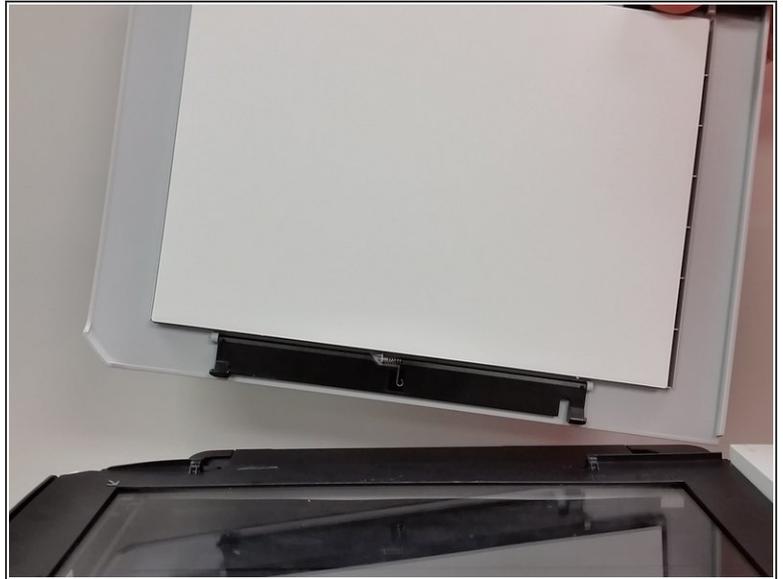
Step 1 — Remove Scanning Bed Cover

- Lift scanning bed cover with one hand, and pry the right hinge inward using a plastic opening tool.
- The cover will lift up and away from the printer.

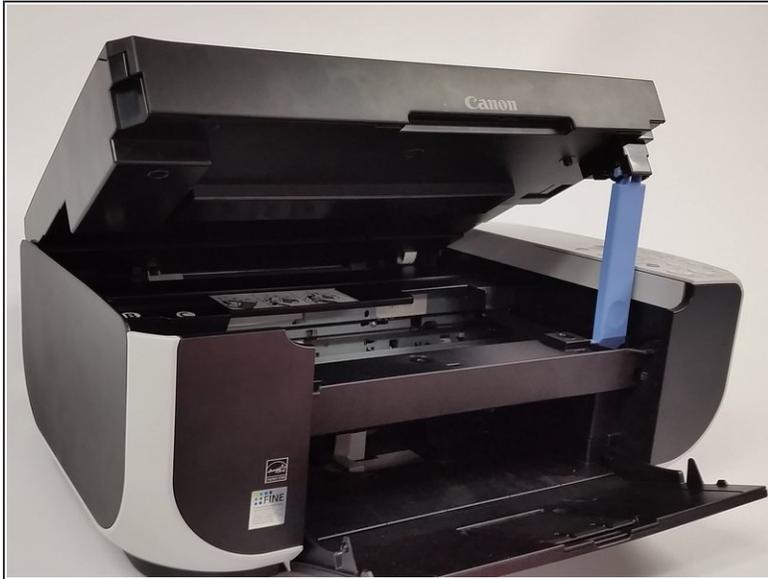
Step 2 — Accessing Scan Bed

- Lift the scan bed into the upright position.
 - Ensure the scanning unit support seats into the scanning unit support slot.
- The four arrow markers located on the bottom edge of the scan bed mark the four tabs that must be released.

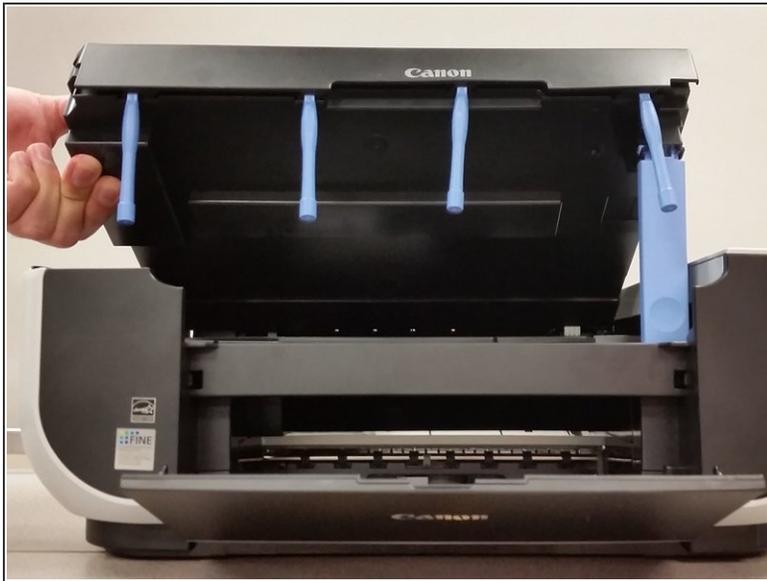
Step 3 — Accessing Scan Bed

- Place a plastic opening tool at each of the four marking arrows.
- The scan bed will detach from the scan bed unit. Lift scan bed glass upward to access the bottom surface of the glass.

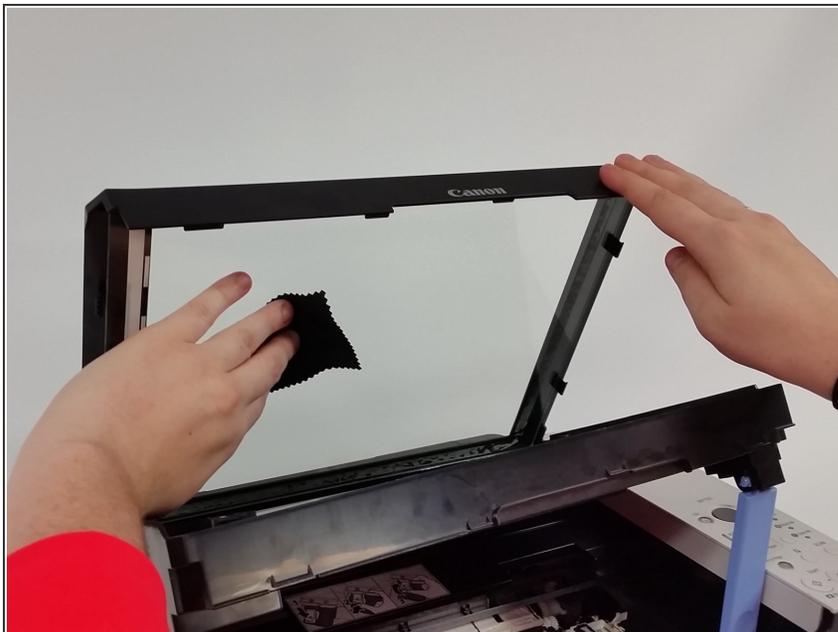
Step 4 — Cleaning the Scan Bed Glass

- Using the screen and device cleaner and cloth remove any dirt or debris from the bottom surface of the scan glass.

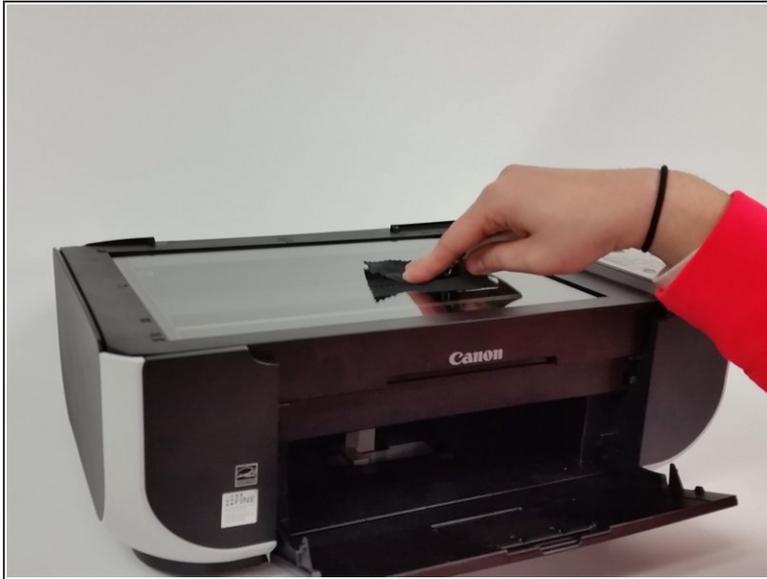
Step 5 — Reassemble Scan Bed Unit

- Lower the scan bed glass down on to the scanning unit until the clips reengage.
- Clean the top surface of the scan bed glass using the screen and device cleaner and cloth.
- Put the scan bed cover back on by placing the left hinge in first.
 - Then snap the right hinge into place.
- The printer is now ready to scan or copy.
