Repairing NEC VT700 Lamp Cover

How to repair a "Lamp cover error or lamp housing error" due to a missing part of the lamp cover.

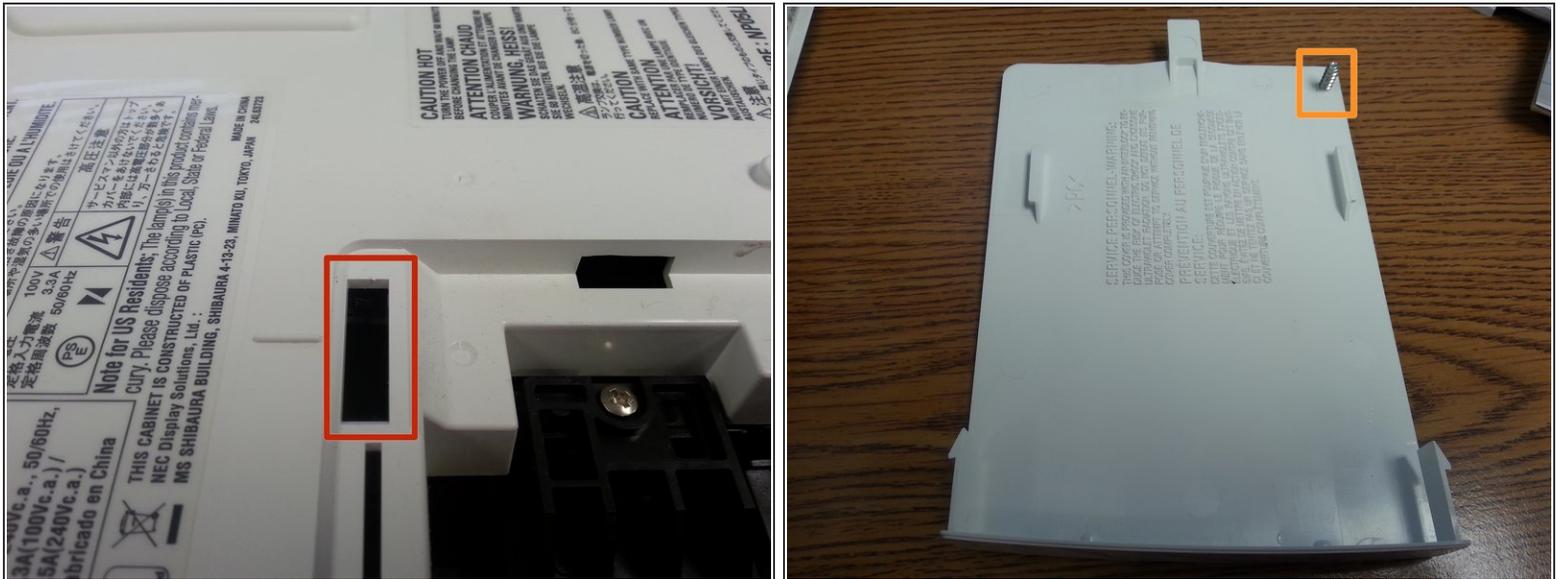
Step 1 — The Root of the Problem

- This is the bottom of the projector with the lamp cover removed. The long rectangle shaped slot in the center of the photo has a micro switch located at the far end that would indicate the cover being in place.
- This is the inside of the lamp cover. At the marked location (sorry the repair is already in place) there should be a plastic "L" shaped extension from the cover. This would extend into the slot in the first photo and actuate the switch indicating the cover is in place. This was broken off of the cover.
