HP Pavilion 11 x360 Fan Replacement

Fix overheating issues by replacing your fan.

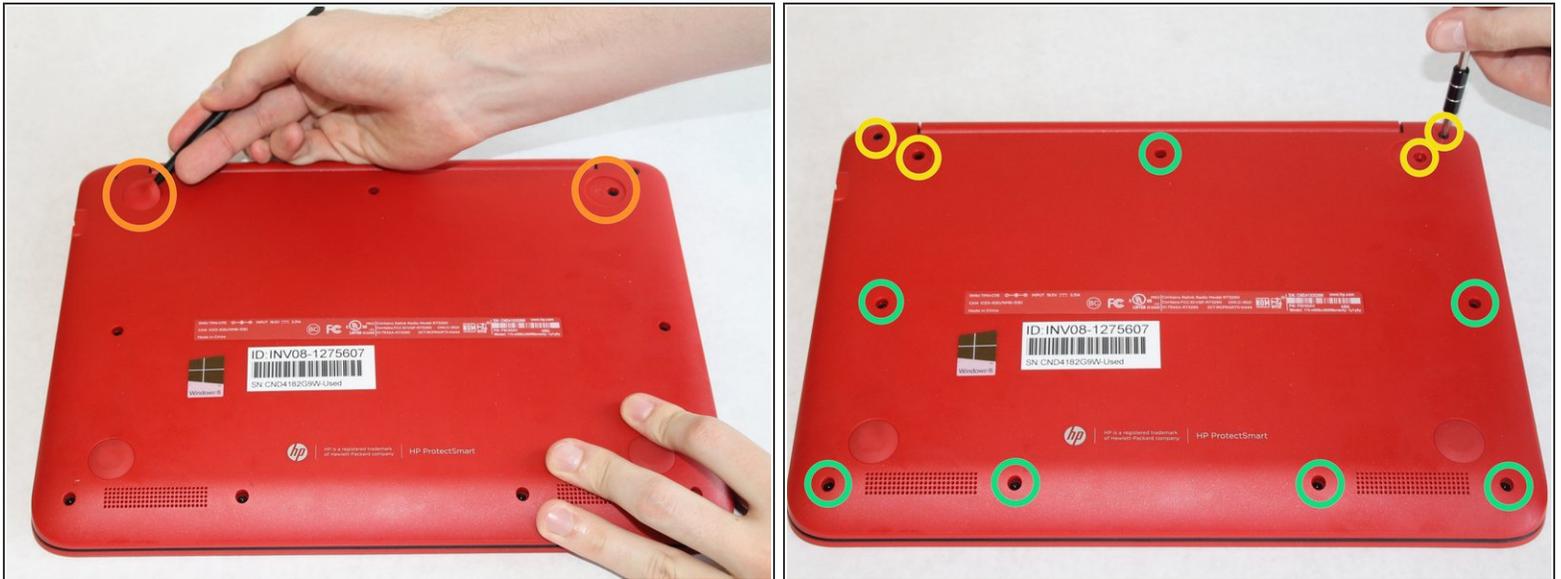
Step 1 — Remove Screws

- Use the spudger to pry off the two rubber feet near the hinge of the laptop. This will reveal two hidden 9mm screws.
- You must remove eleven screws.
 - Four 9mm screws with the PH0 screwdriver.
 - Seven 6mm screws with the PH0 screwdriver.

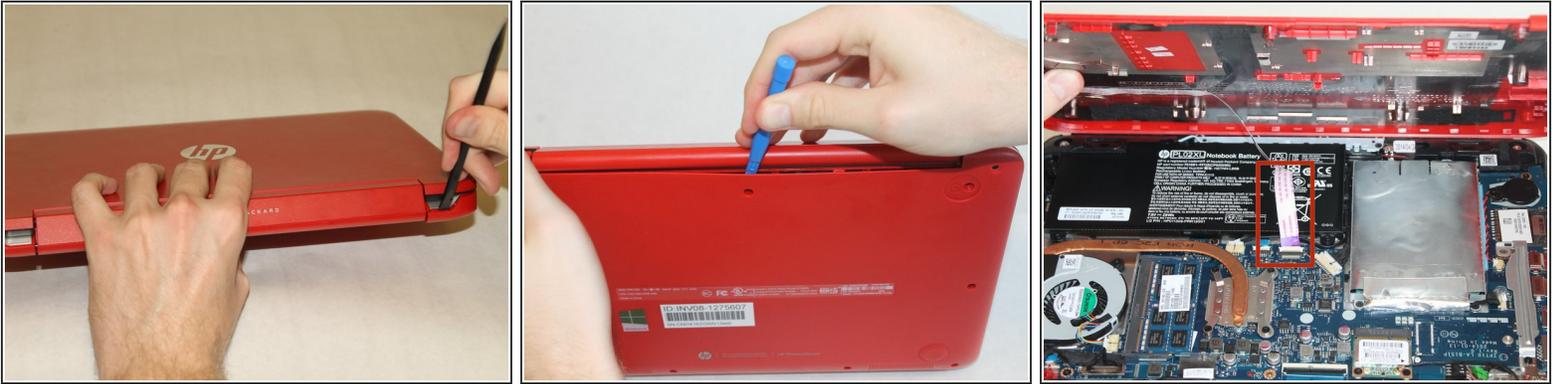
Step 2 — Remove Backing

- Use the spudger to pry the corners of the laptop near the display hinges.
 - Pry around the seam of the laptop with the plastic opening tool until the backing begins to pull apart.
- ⚠ When you lift the bottom cover, there is a cable connected between the motherboard and the bottom cover. Be careful not to pull the cable loose!

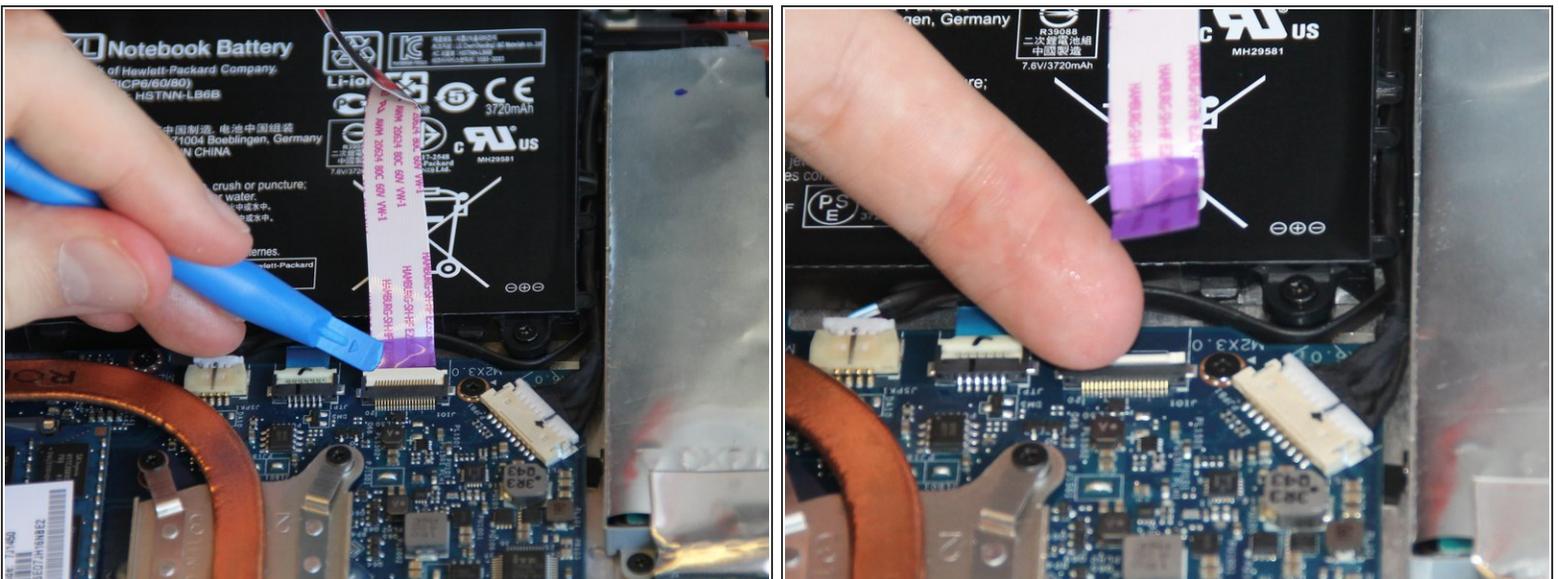
Step 3 — Detach Cable

- Use the plastic opening tool to lift the white tab up at the connection.
- Pull the cable outwards.

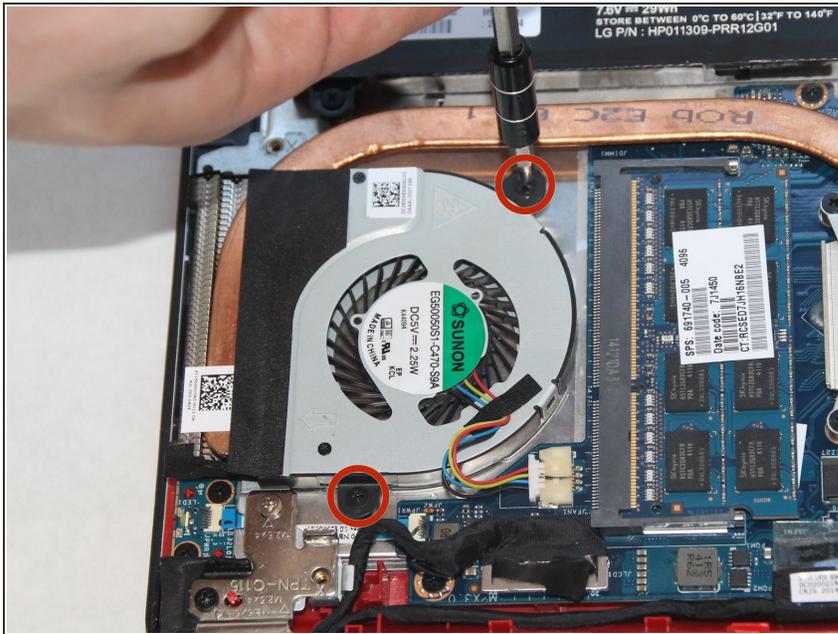
Step 4 — Remove Screws

- Remove the two 3mm screws with the PH0 screwdriver.

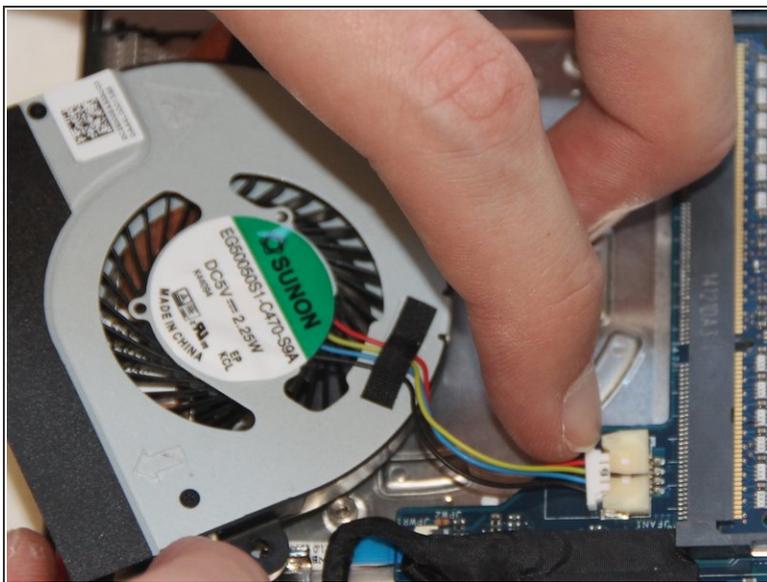
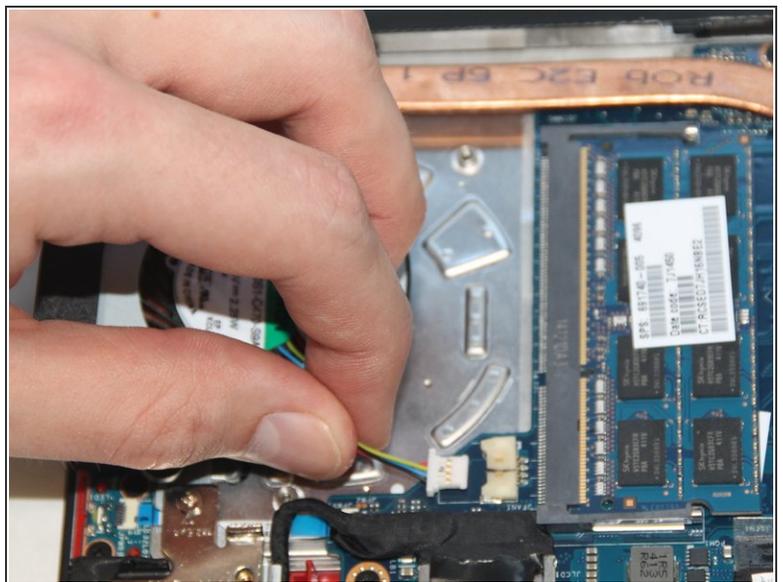
Step 5 — Disconnect Cable

- Use your fingernails to slowly loosen the fan connection cable.
- After the cable is slightly pulled from the connection, grab the cable and pull it outwards.
