Garmin Nuvi 2589LMT Microphone Replacement

If your GPS device is not responding to voice...

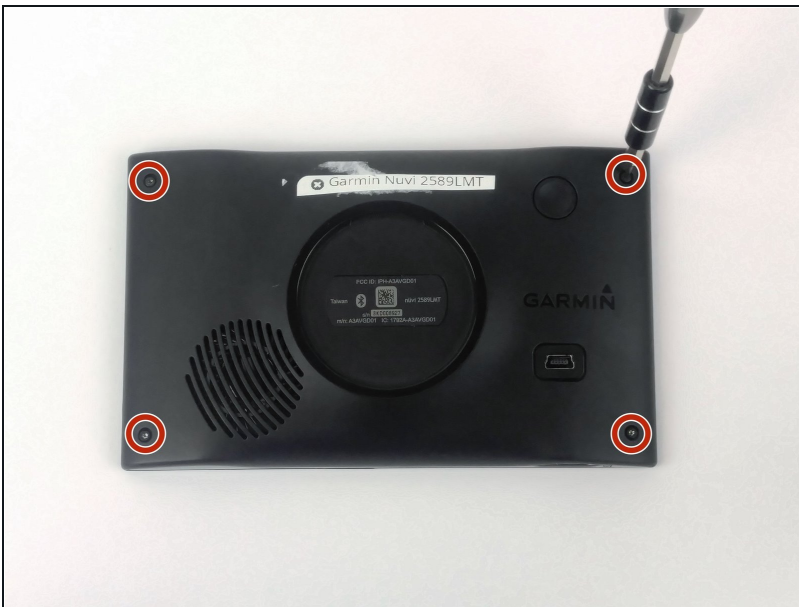
Step 1 — Back Panel Assembly

- Using the T5 Torx Screwdriver, remove all 4 of the 5.7mm screws from the back of the device.

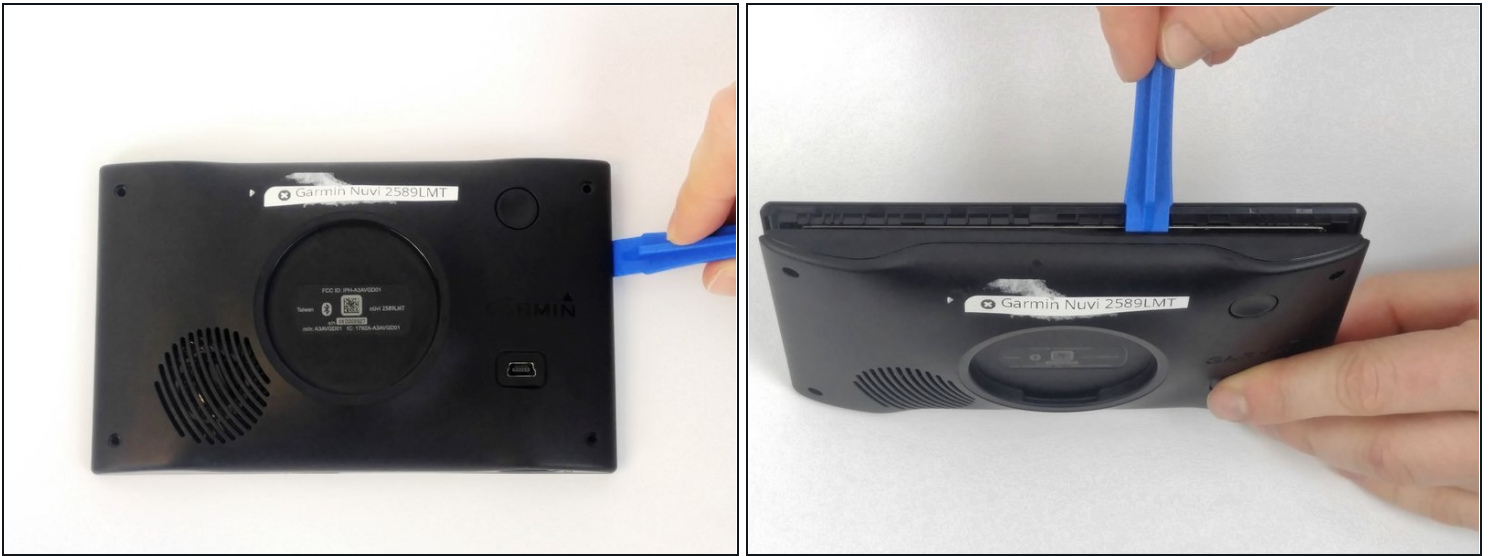
Step 2

- Using the plastic opening tools, pry the shorter sides of the device apart.
- Once a gap has formed at the top of the device, insert the opening tool into the gap and slide it along the top of the device. Repeat for the bottom edge of the device to separate the LCD screen from the back.

⚠ Do not disconnect or tear the ribbon wiring, located at the bottom of the motherboard, when removing the back of the device.

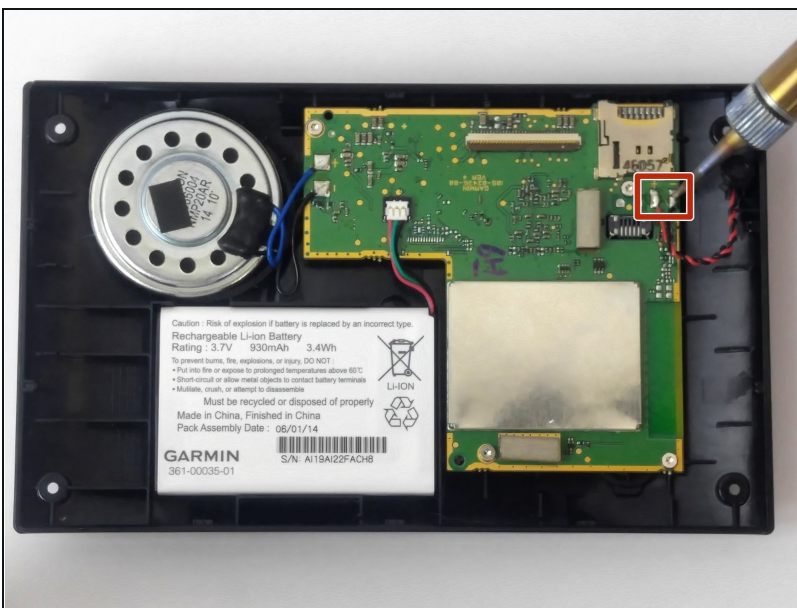
Step 3 — Microphone

- Using a soldering iron, desolder the wire connection at the two soldering points between the microphone and the motherboard to remove.

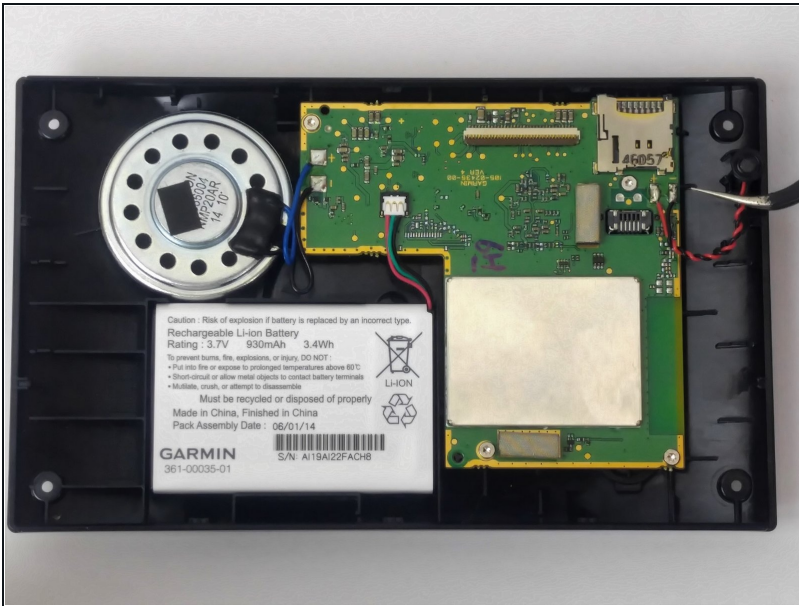
Step 4

- Using the angled [tweezers](#), grab the microphone wires and gently pull to remove the microphone from the device.

To reassemble your device, follow these instructions in reverse order.
