RYDIS H68 Pro Side Brush Motor Replacement

The side brushes are a problem many people encounter when dealing with the RYDIS H68 Pro. This guide will show you how to fix a side brush issue.

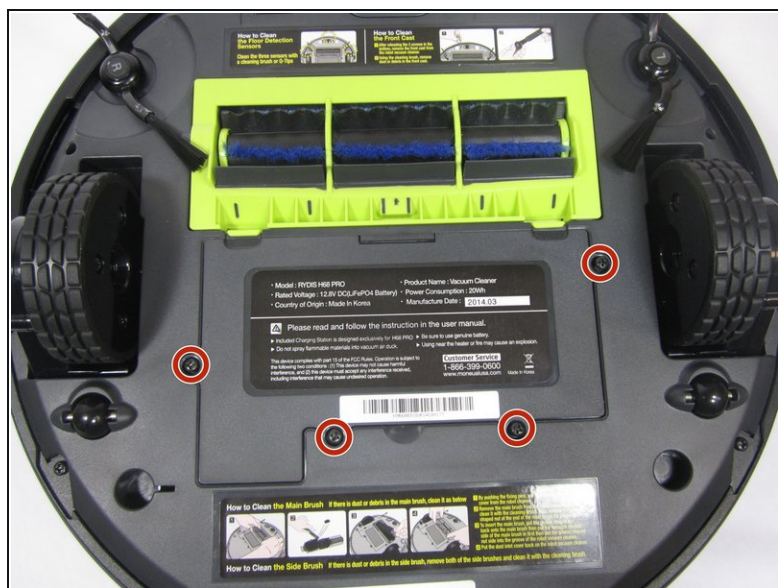
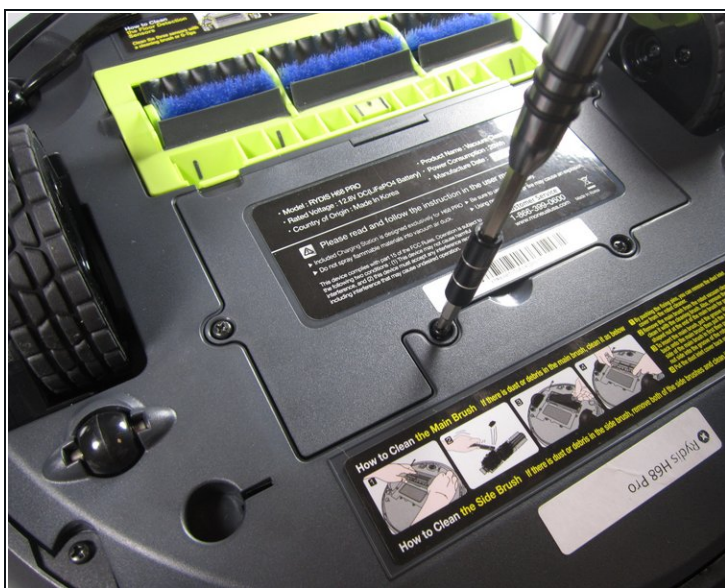
Step 1 — Battery

- Flip the vacuum over so that the wheels are facing you.
- Use a Phillips #1 screwdriver to remove the four 10 mm screws that surround the battery cover.

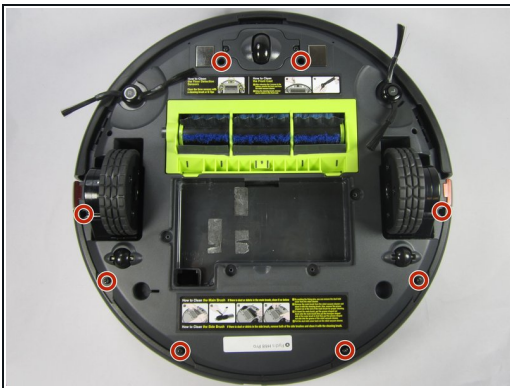
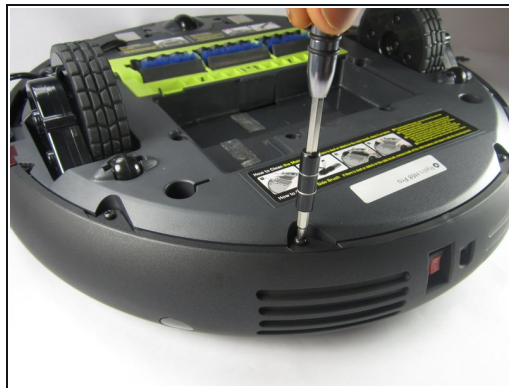
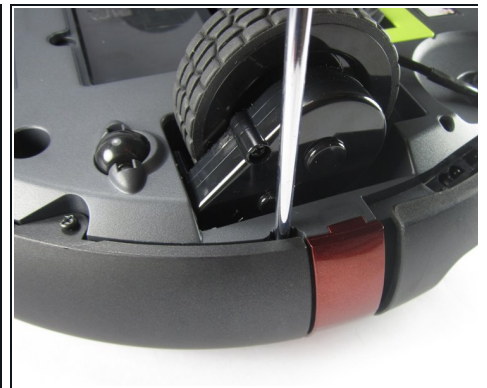
Step 3 — Bumper

- Remove the eight 10 mm Phillips #1 screws.

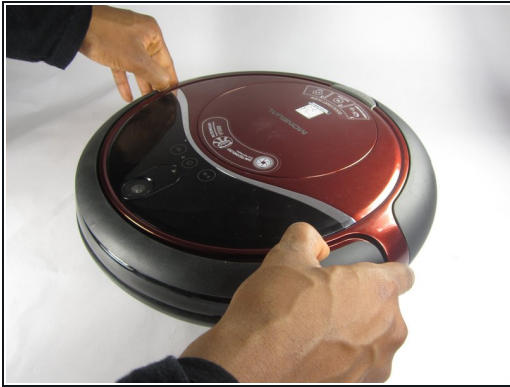
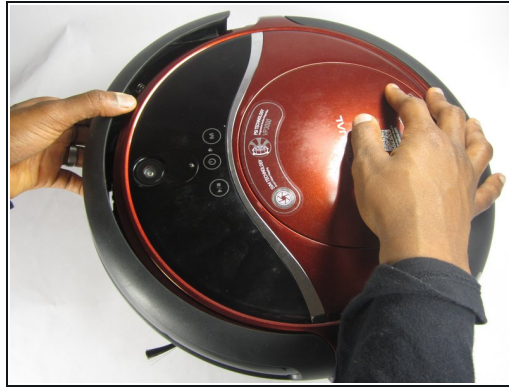
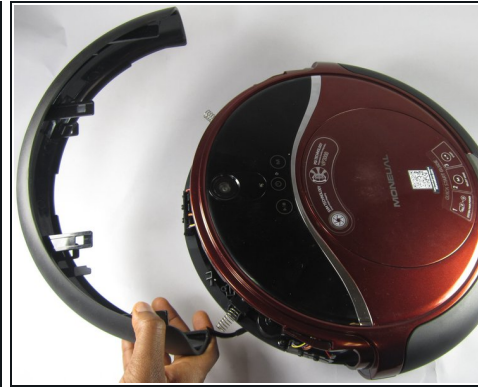
Step 4

- Hold the front bumper and pull it off.
- ⓘ It requires a lot of force to pull the bumper off.

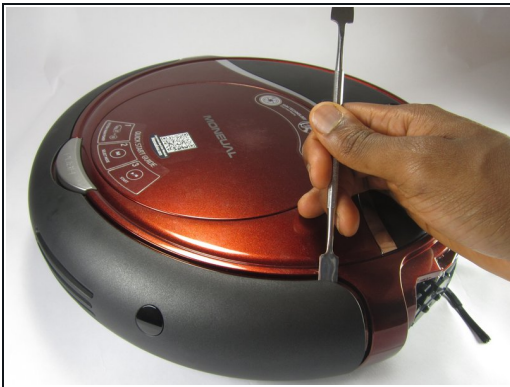
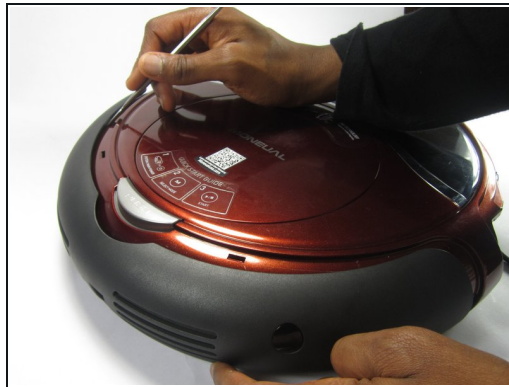
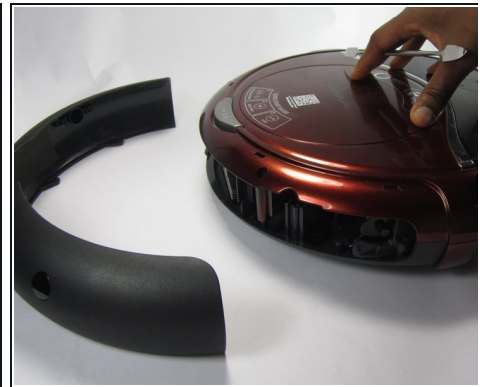
Step 5

- Pry off the back bumper by going around the entire top of the bumper with the metal spudger.
