Repair For MacBook Pro A1989 That Won't Turn On

Fix a MacBook Pro that won't turn on by restoring T2 chip data!

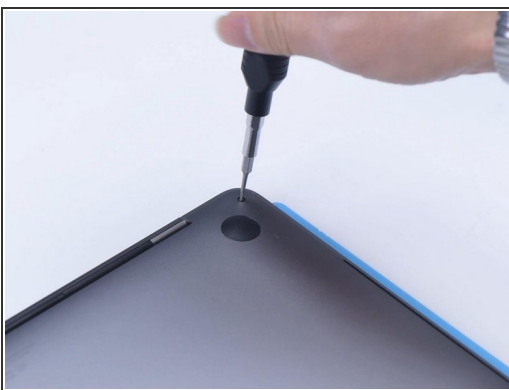
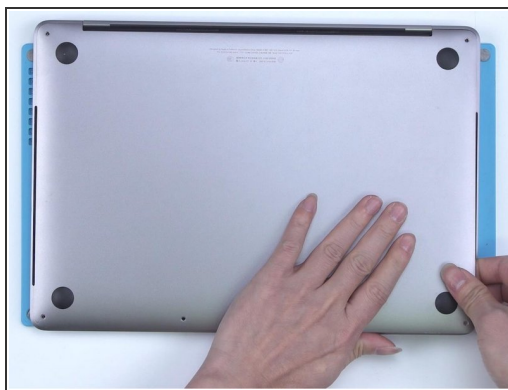
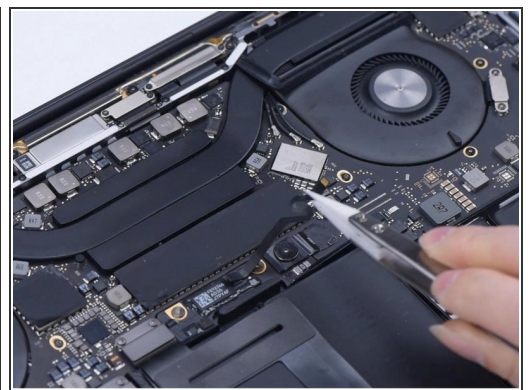
Step 2

- Unplug the power cable. Next, we need to disassemble the MacBook and test.
- ❗ The MacBook model is A1989.
- Remove the screws and disconnect the battery connector flex cable.

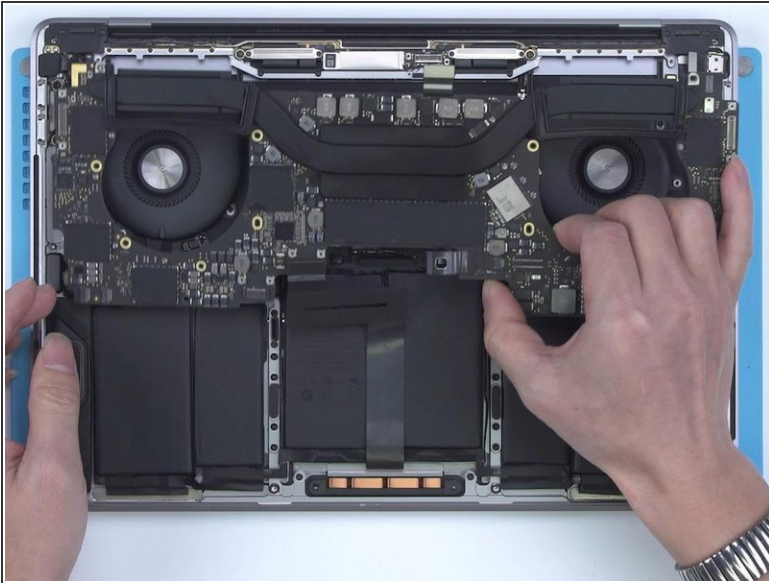
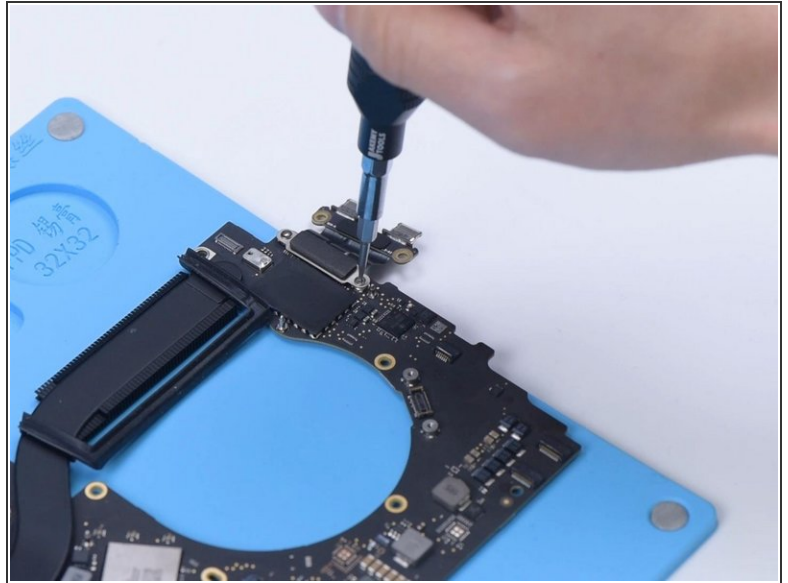
Step 4

- Then we remove the motherboard and install the power connector flex cable.

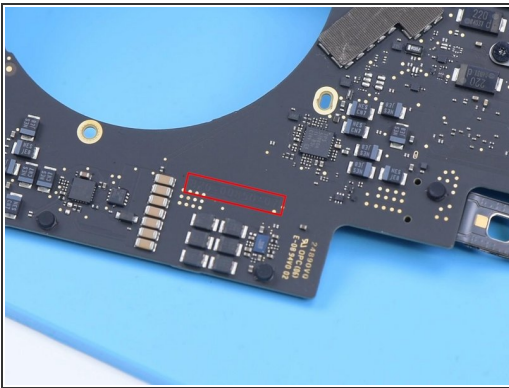
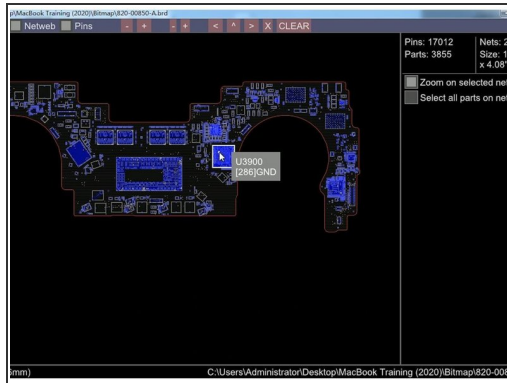
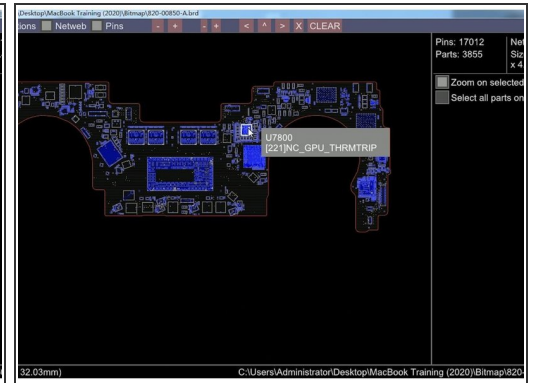
Step 5

- The motherboard number is 820-00850-07.
- Open the schematic diagram and bitmap.
- U3900 is the T2 chip. U7800 is the power chip.

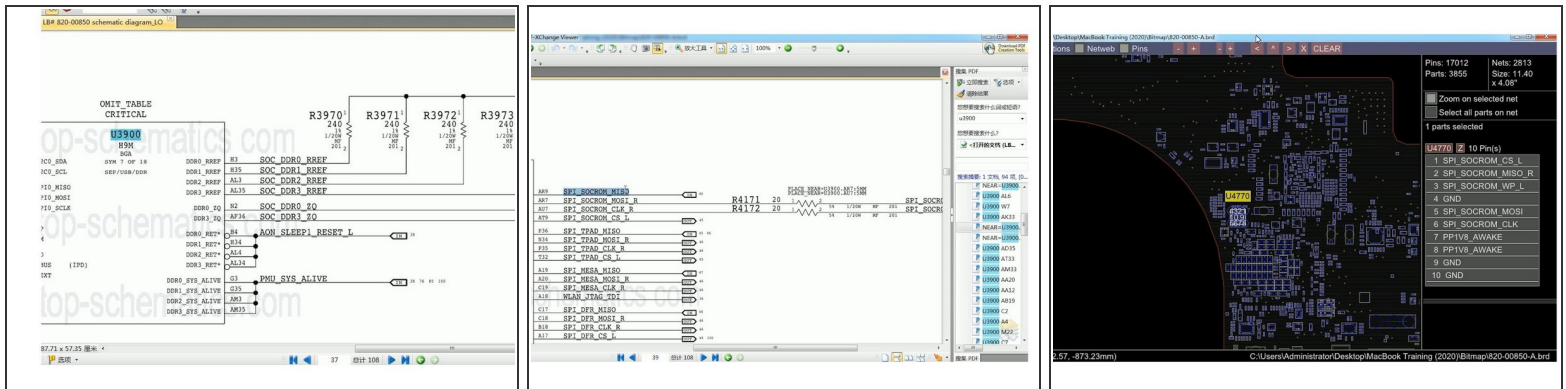
Step 9

- Find T2 chip on the bitmap and the location name is U3900. Search U3900 on the diagram and find the ROM chip for T2.
- Copy signal SPI_SOCROM_MISO. Find SoC ROM and the location name is U4770. Find U4770 on bitmap.

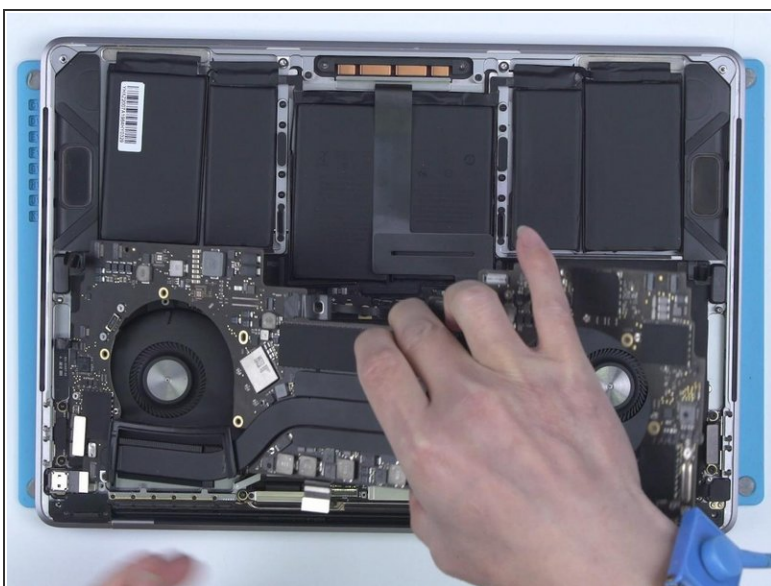
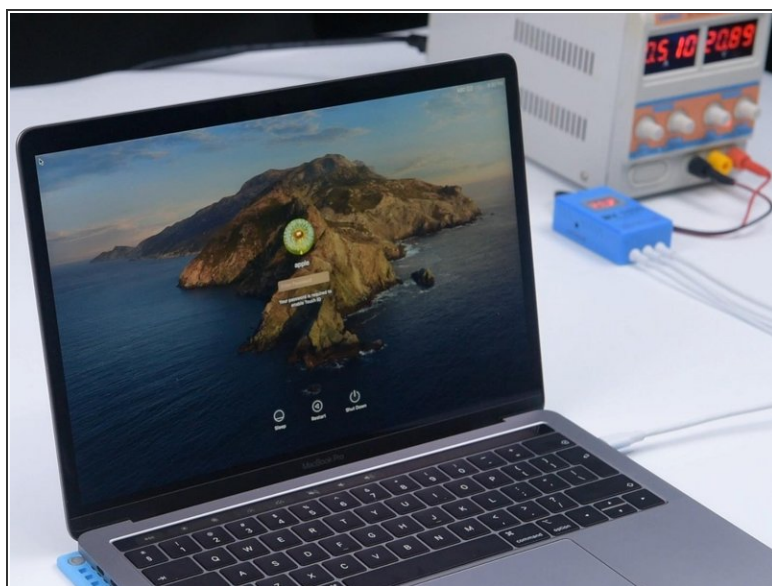
Step 16

- Disconnect the power cable and install the motherboard. Plug in the power cable.
- The MacBook is turned on and can enter the system.
