Dell Chromebook 11-3120 Bottom Base Cover Replacement

Replace the bottom base cover of a Dell Chromebook 3120

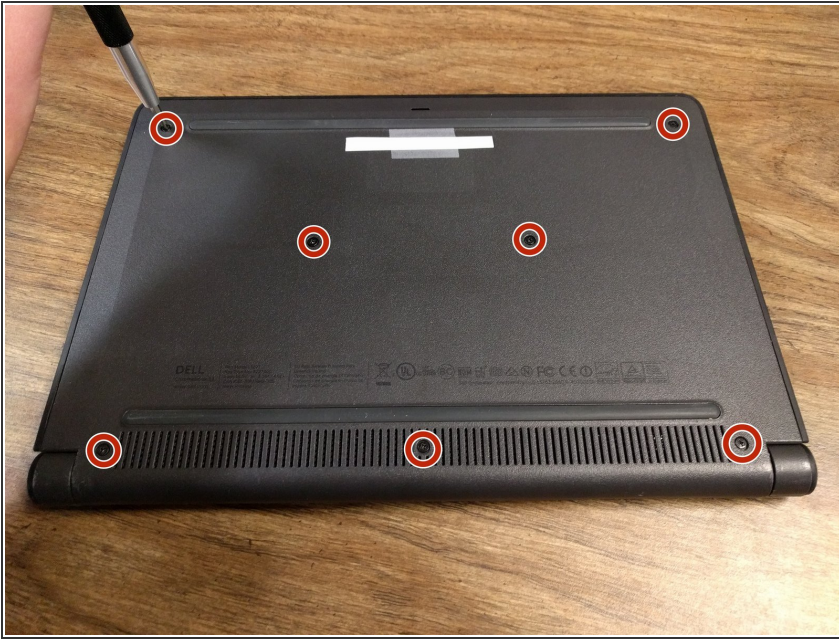
Step 1 — Remove screws

- Flip the device over so the bottom is facing up
- Remove the 7 visible Philips screws from the device's bottom cover

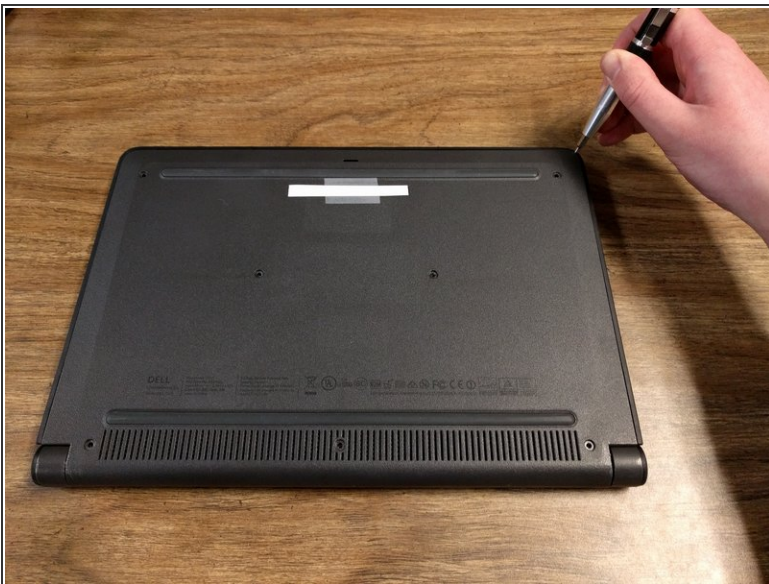
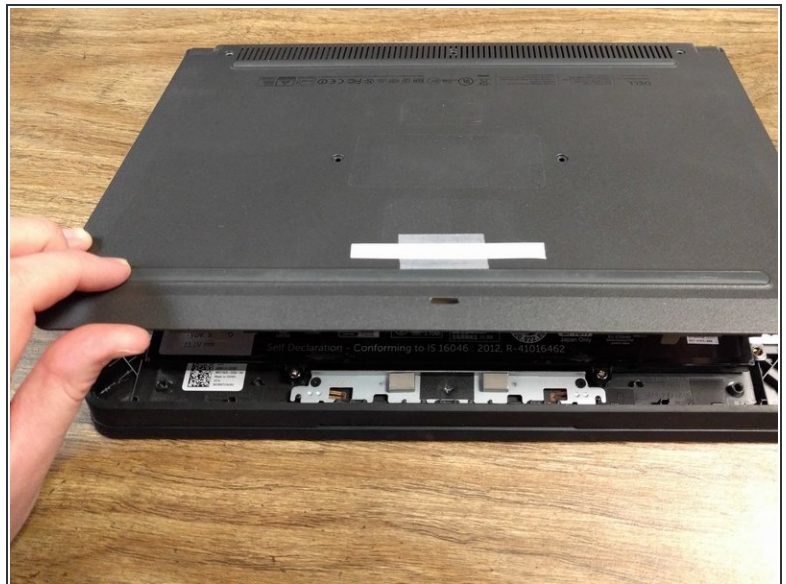
Step 2

- Insert a thin prying tool into the front (facing the user) corner between the rubber bumper and the plastic case to pop several latches.
- Starting from the partially-opened corner, pull the case away from the device in a hinging motion. I rotated the computer so that the opened corner faced me in the image.
