Insignia NS-VCS14SL7 Stick Vacuum Power Button Replacement

Use this guide to troubleshoot and replace the Insignia NS-VCS14SL7 stick vacuum power button.

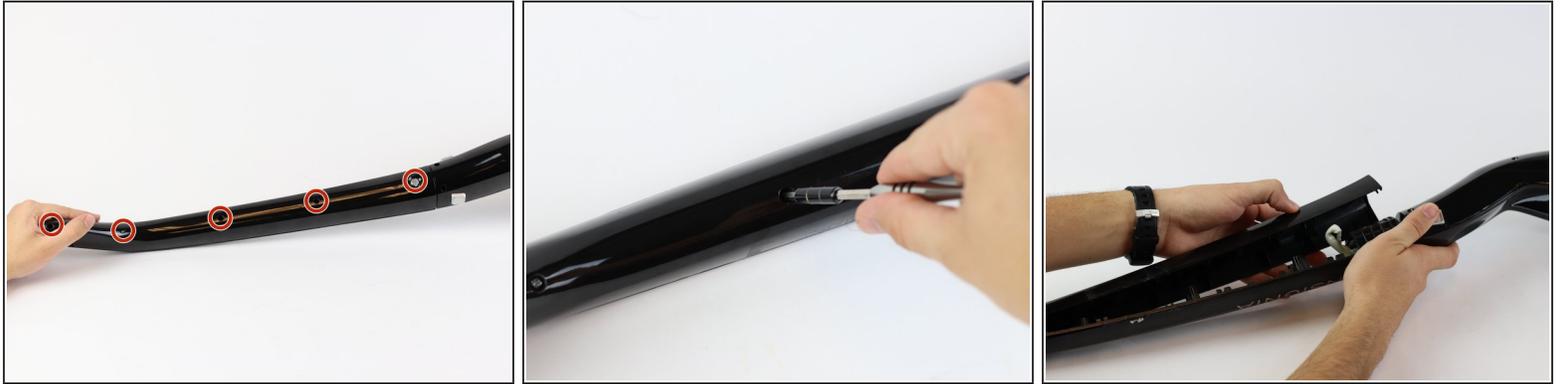
Step 1 — Stick Vacuum Power Button

- Remove the four 12mm Phillips screws , and the one large 32mm Phillips head bolt from the vacuum handle.
- Pull up on the back cover of the vacuum handle and remove it.

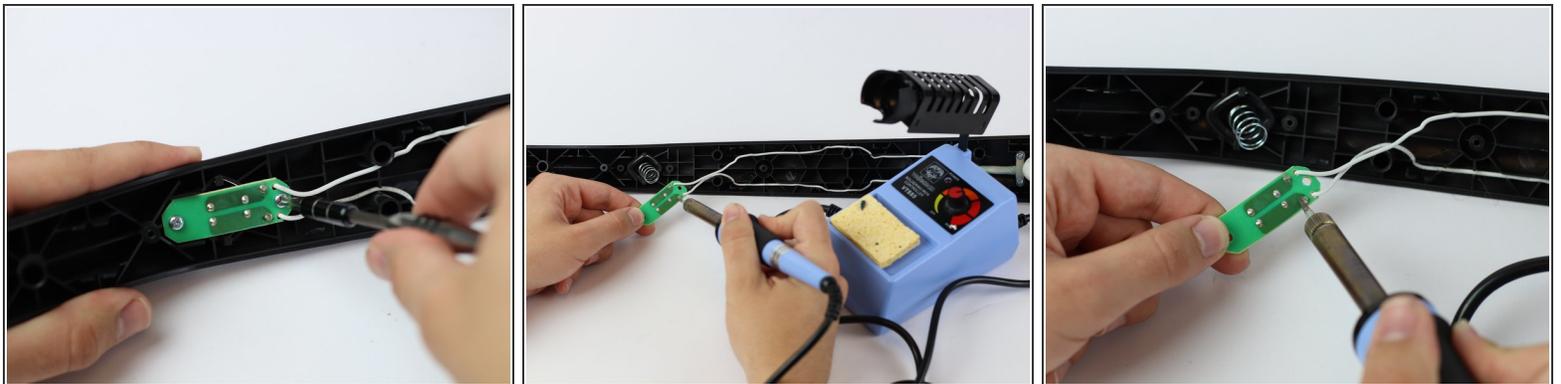
Step 2

- Remove the two 10mm Phillips #2 screws on the back of the green printed circuit board.
- ⓘ If the circuit board needs to be replaced, locate where the two white wires are soldered to the board, and de-solder the connection.

To reassemble your device, follow these instructions in reverse order.
