# LG Tribute HD Rear Camera Replacement

A guide for replacing the rear camera of a LG Tribute HD LS676 due to damaged rear camera causing blurry photos, error messages or not able to take photos

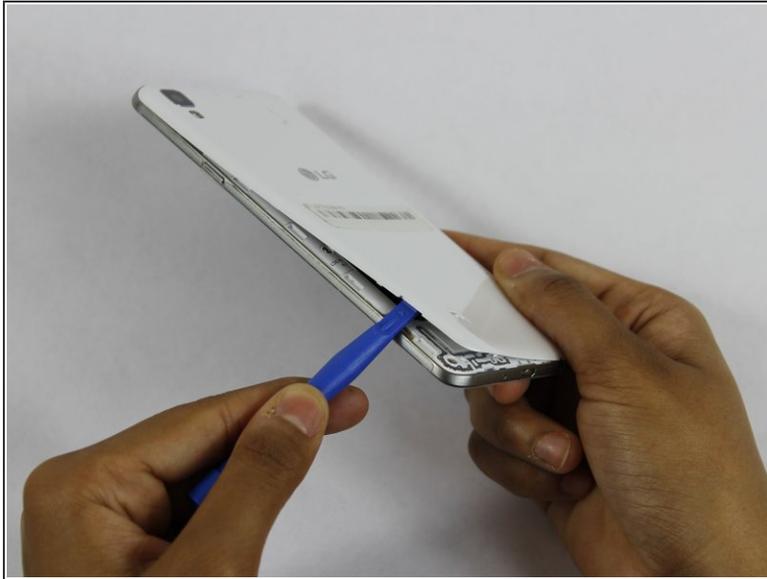
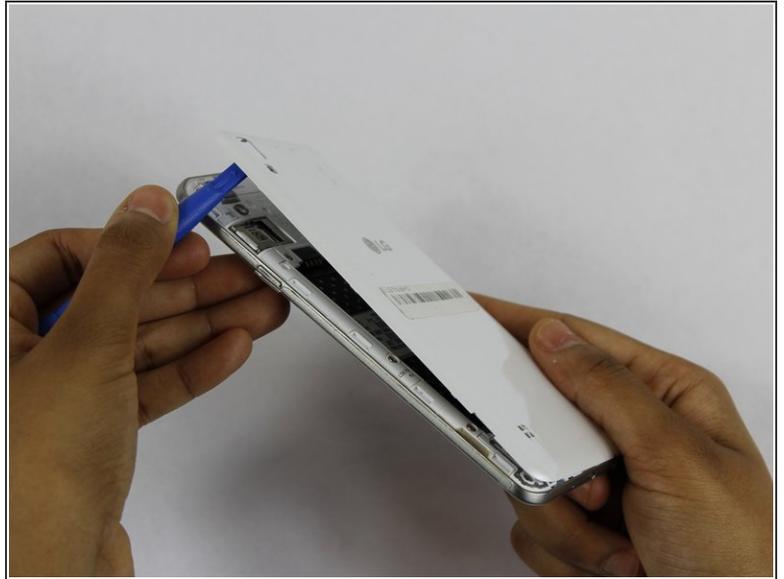
## Step 1 — Battery and SD Card

- Insert a fingernail, or plastic opening tool, into the cutout on the back cover and pry outward to remove.

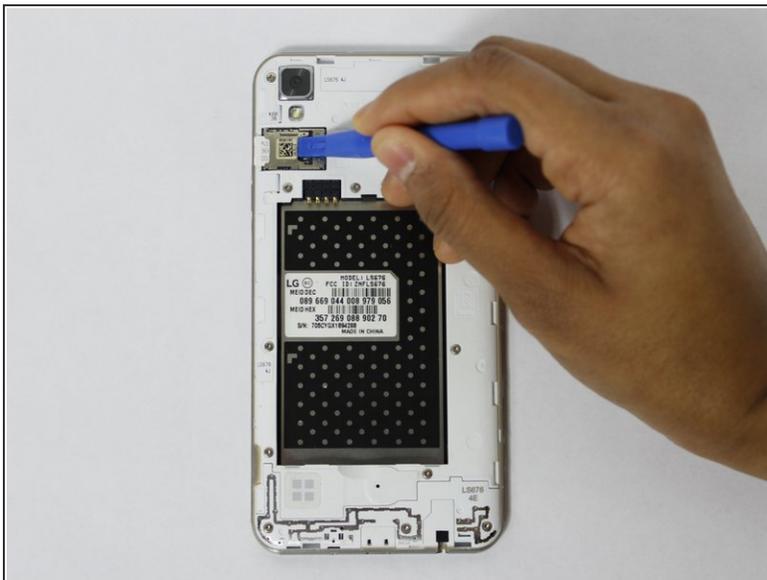
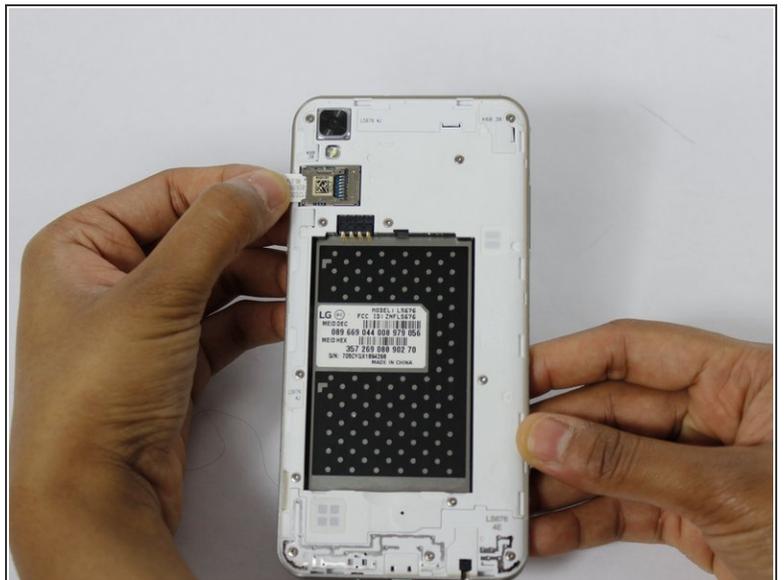
## Step 2

- Pull the battery out of the phone.
- Remove the SD Card by sliding the card out as shown.

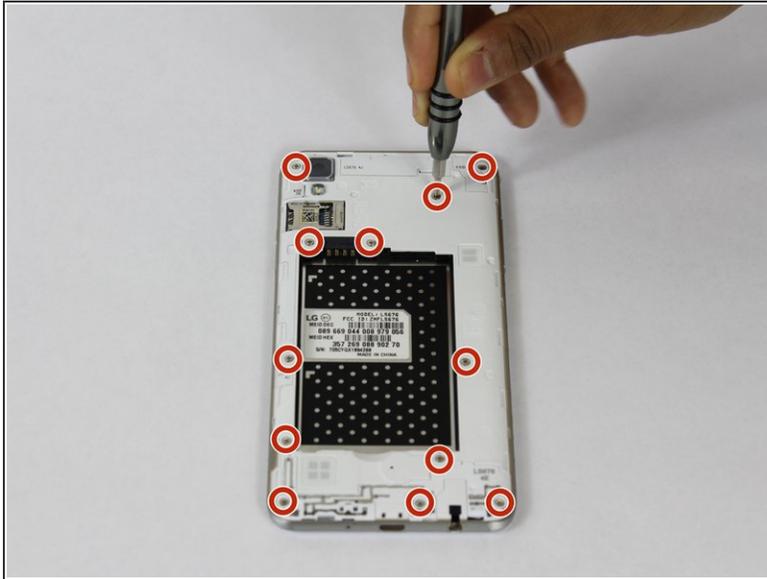
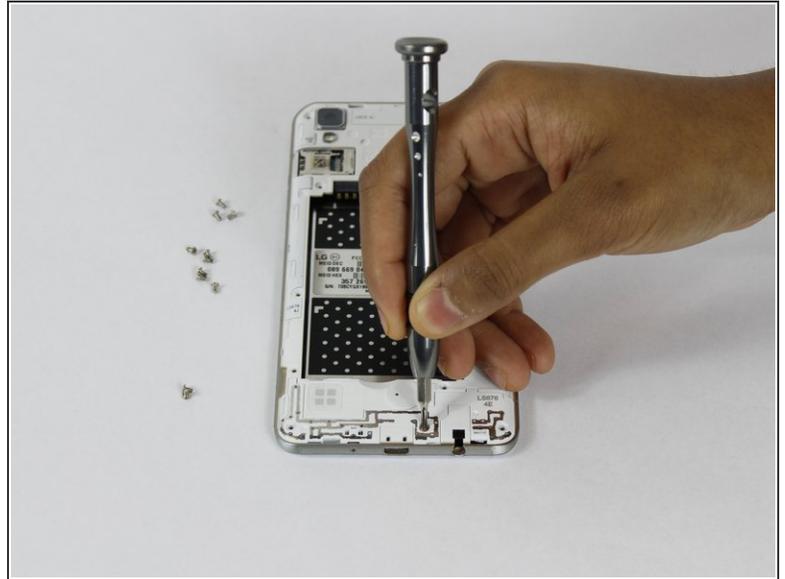
### Step 3 — Rear Camera

- Remove the twelve 2mm JIS #00 screws from the mid-frame.

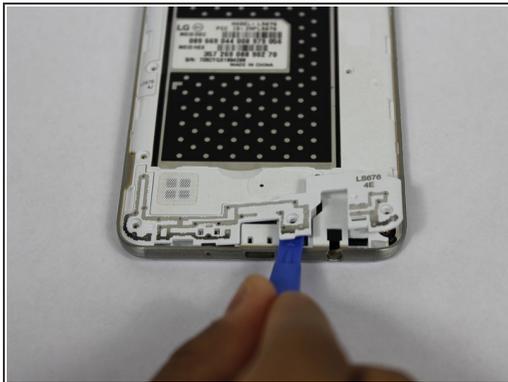
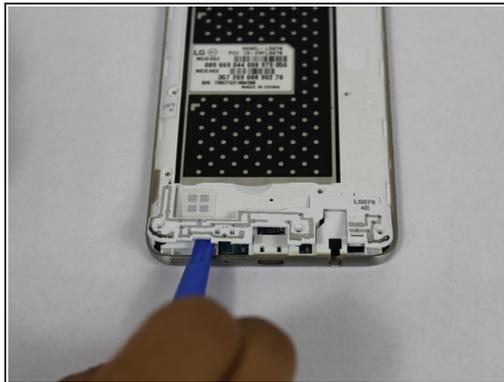
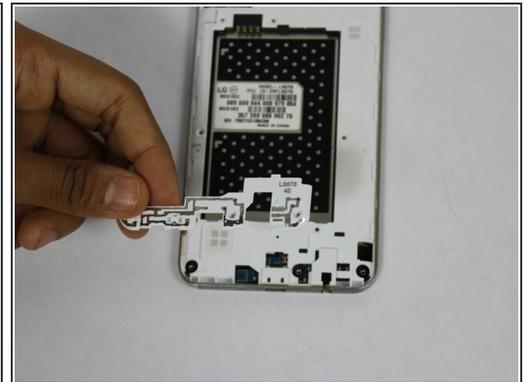
### Step 4

- Using a plastic opening tool, remove the antenna extender from the mid-frame.

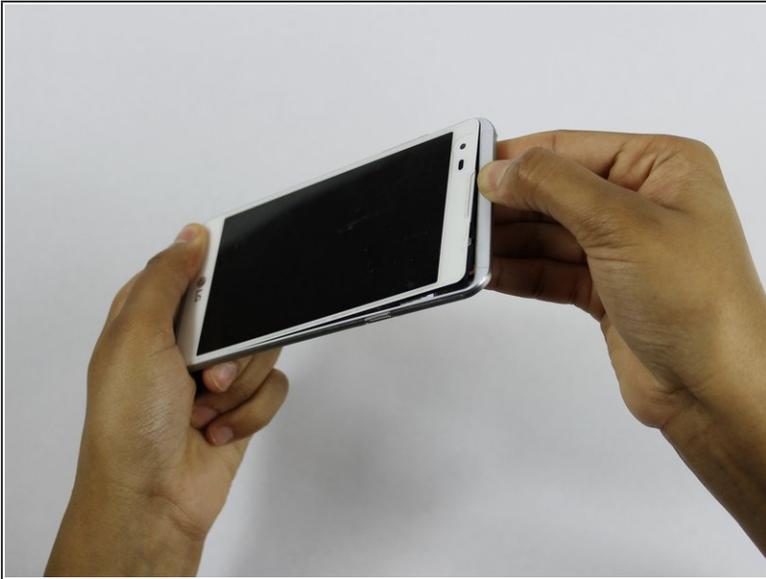
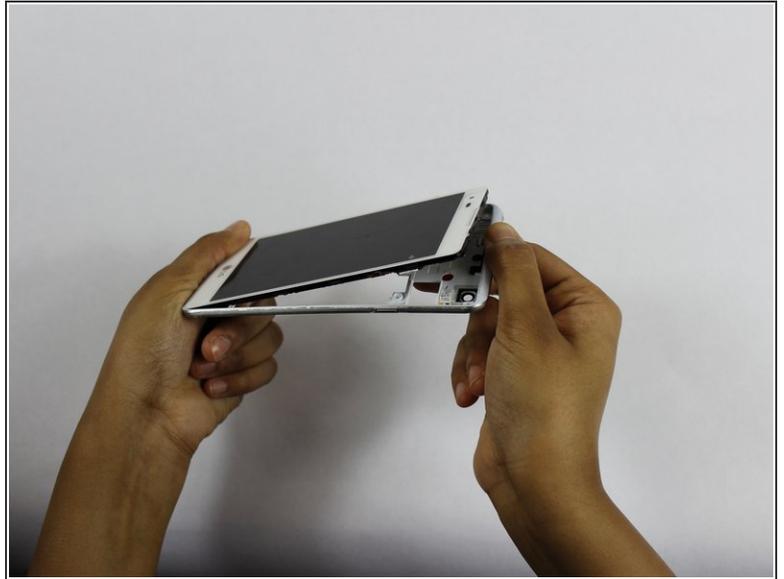
## Step 5

- Using your fingers, remove the mid-frame.

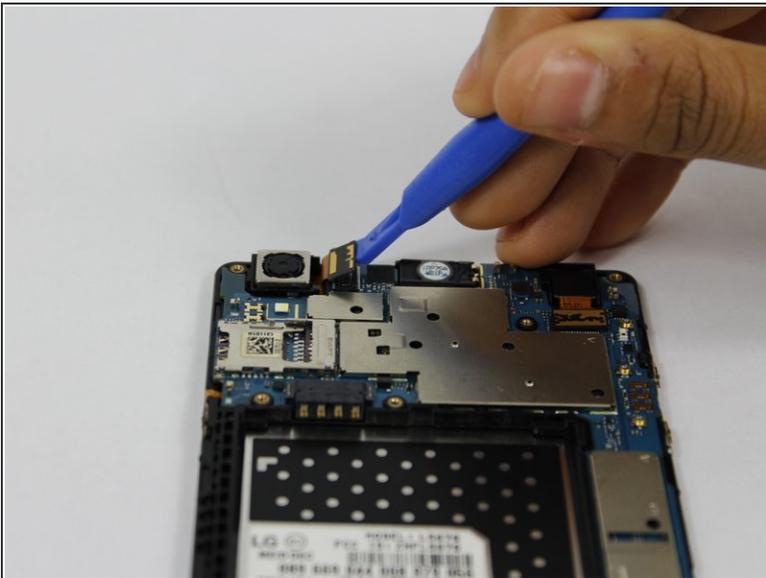
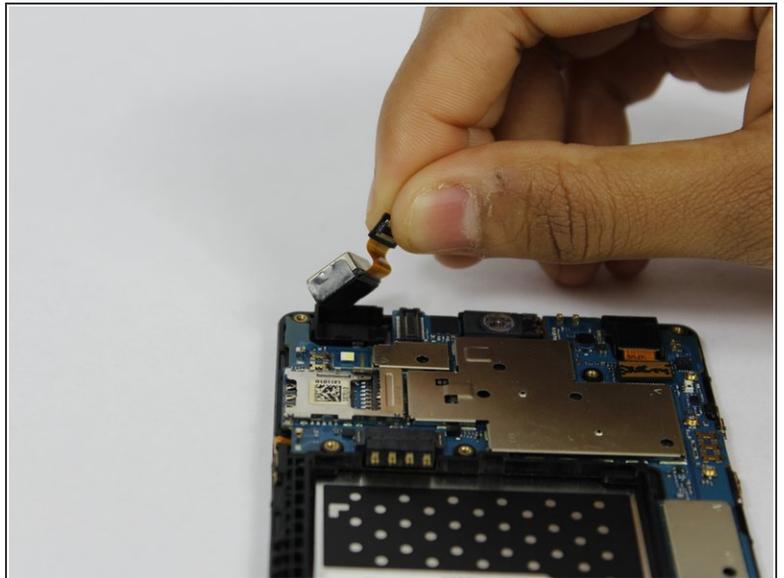
## Step 6

- Use a plastic opening tool to disconnect the rear camera and pull from the phone.

To reassemble your device, follow these instructions in reverse order.
