Handheld Toilet Bidet Sprayer Replacement

This guide will offer step by step instructions with visuals to help you replace your handheld toilet bidet sprayer and stop any water leak.

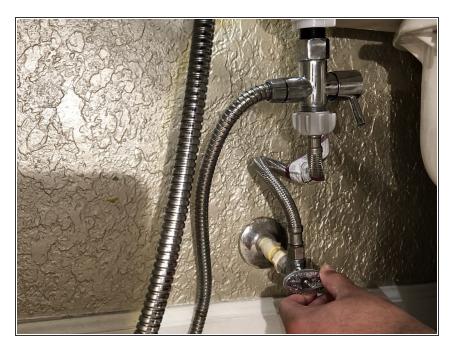
Step 1 — Handheld Toilet Bidet Sprayer

Turn off the toilet water valve by turning the knob clockwise.

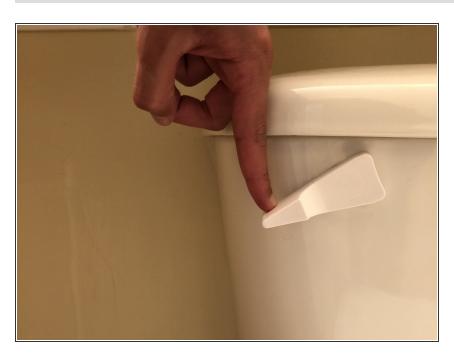
Step 2

Flush the toilet until no water is left in the tank.

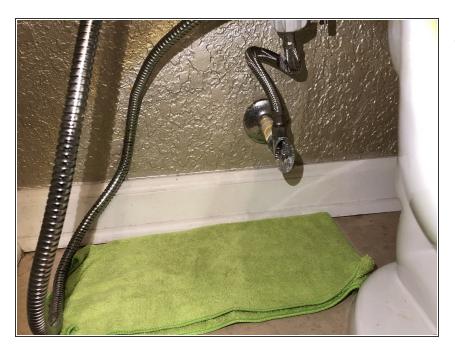
Place a towel under the tank incase of any water drops.

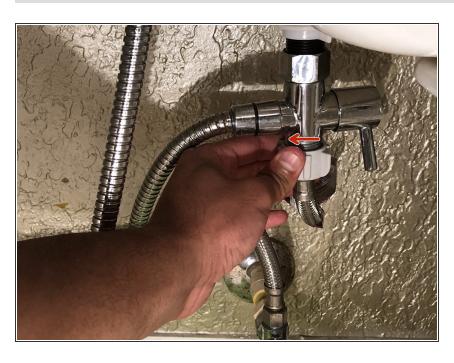
Step 4

Unscrew the water supply line from the T-connector by turning the knob counterclockwise.

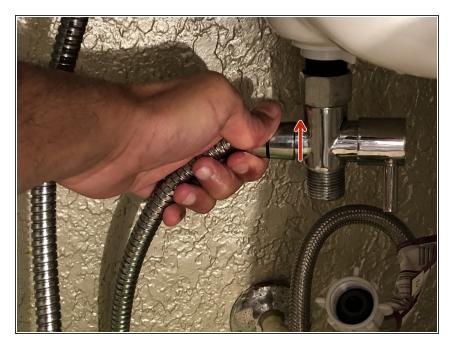
Unscrew the hose from the Tconnector by turning the knob counterclockwise.

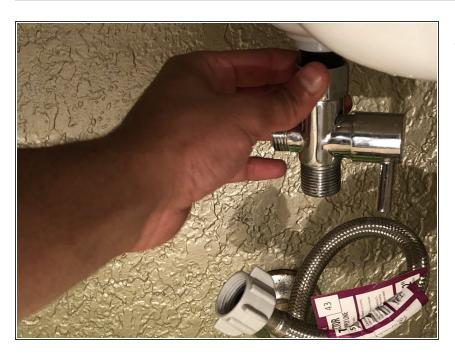
Step 6

Unscrew the T-connector from the toilet by turning the knob counterclockwise.

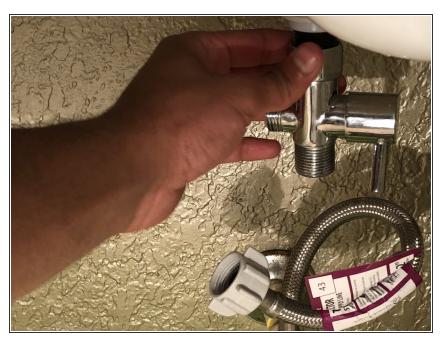
Step 8

- Screw the T-connector back on the toilet by turning the knob clockwise.
- A Be careful not to cross the threads.

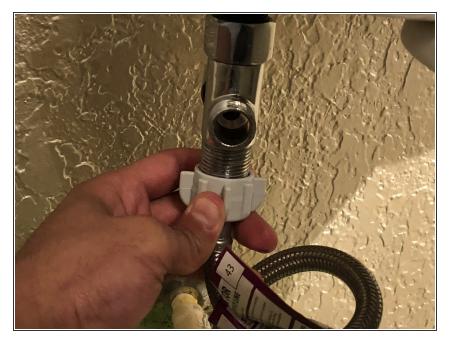
Screw the water supply nut onto the bottom of the T-connector by turning the knob clockwise. Make sure it is firmly hand tight.

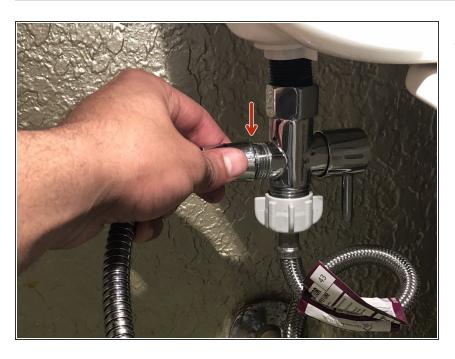
Step 10

Screw the water supply hose back on the T-connector by turning the knob clockwise. Be sure not to over tighten the nut.

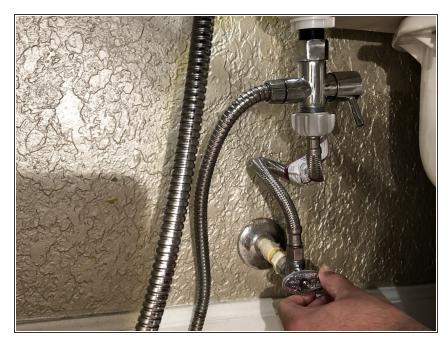
Turn on the toilet water valve by turning the knob counterclockwise. now, you can test your water and spray it through the hose. Make sure there is no water leaking.
