Brentwood TS-292B Toasting Lever Replacement

A replacement guide for the toasting lever on the Brentwood TS-292B Broken Toasting Lever.

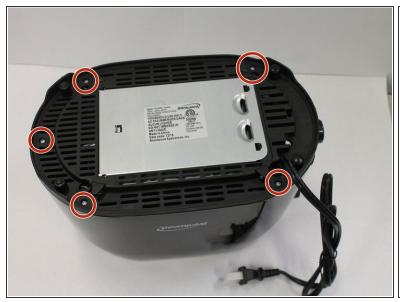
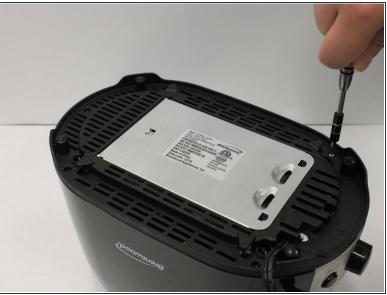
Step 1 — Toasting Lever

Use a Phillips #2 screwdriver to remove all of the 6mm screws from the bottom of the toaster.
