# HP Pavilion dv7-6178us CD Drive Replacement

This guide will show you how to remove and replace the CD Drive for an HP Pavilion dv7-6178us.

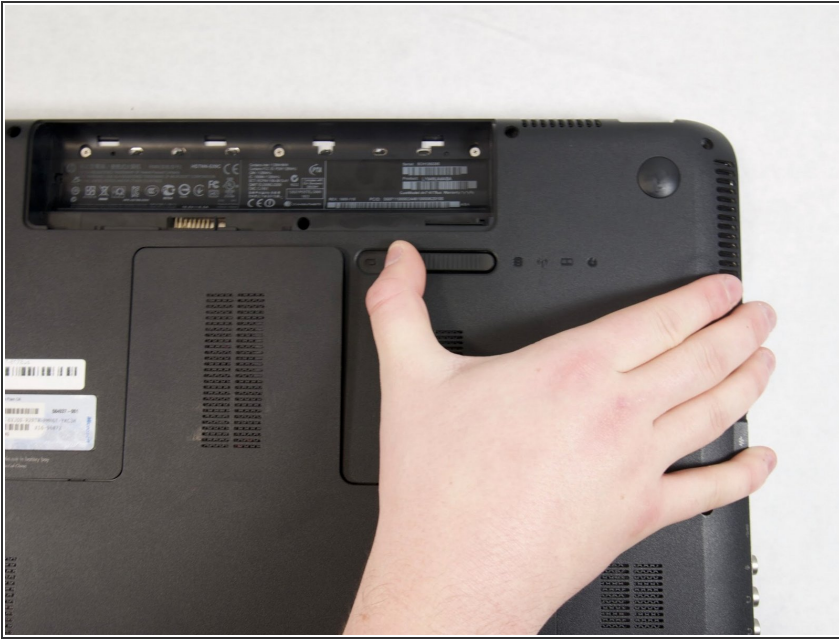
## Step 1 — CD Drive

- ⚠ Make sure the device is turned off.
- Remove the panel on the bottom of the laptop by sliding the switch to the right.

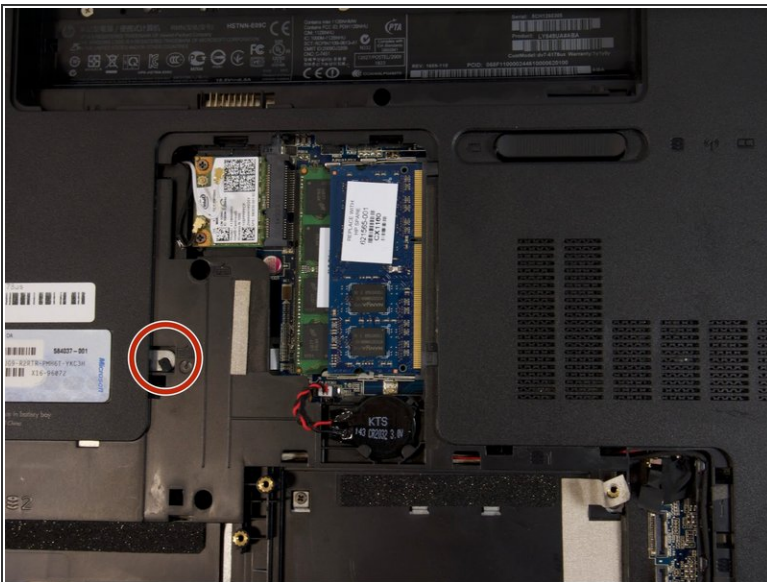
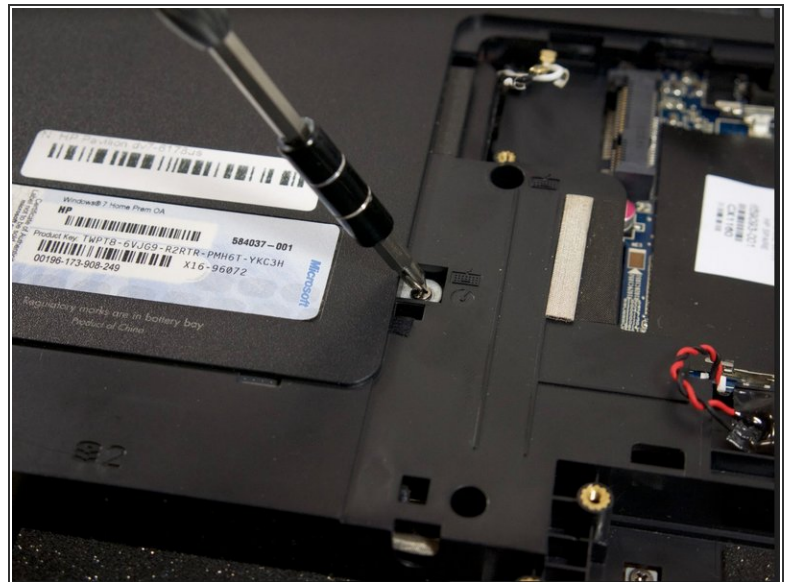
## Step 2

- Locate the screw that keeps the CD drive attached, and remove it with a Phillips head screwdriver.

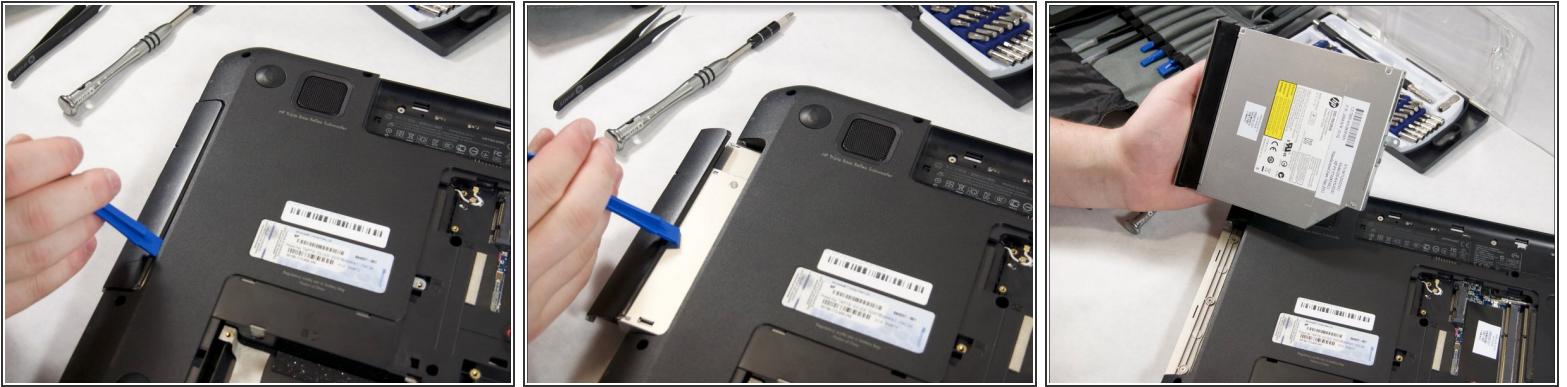
## Step 3

- After the screw is removed, pry the CD drive out of the laptop until you can grip and remove it.

To reassemble your device, follow these instructions in reverse order.
