DigiLand DL8006 Internal Ribbon Replacement

Written By: Landon Choi

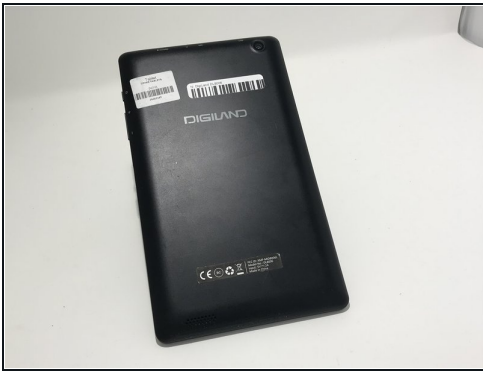
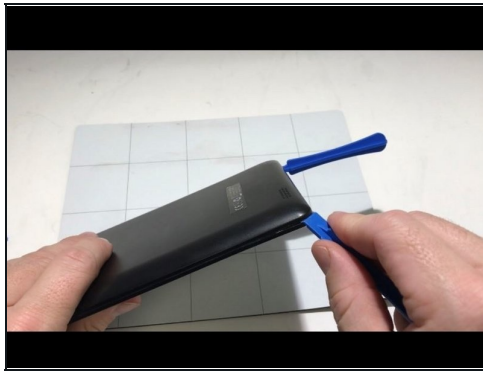
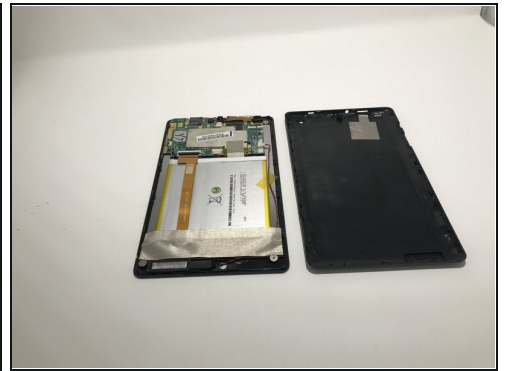
Step 1 — Internal Ribbon

- Flip the tablet to where its back is facing upward.
- Remove the back cover by prying the sides with a plastic opening tool.
- Lay the opened device with the circuit board exposed.

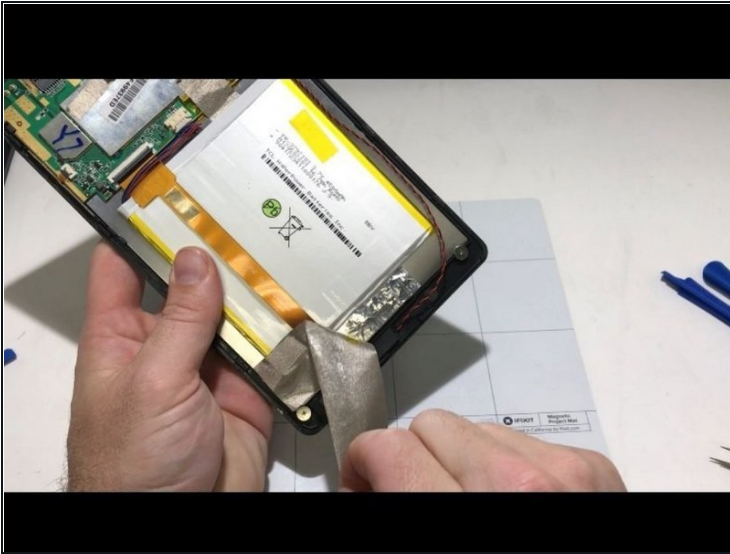
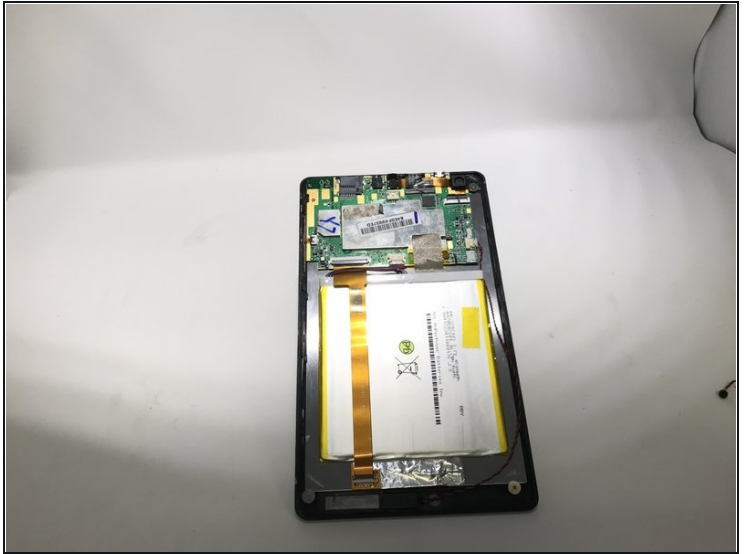
Step 2

- Remove the silver/metallic tape covering the blue and red wires overlapping the upper and lower end of the ribbon cable.

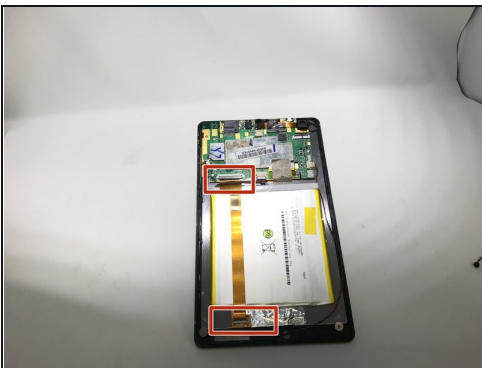
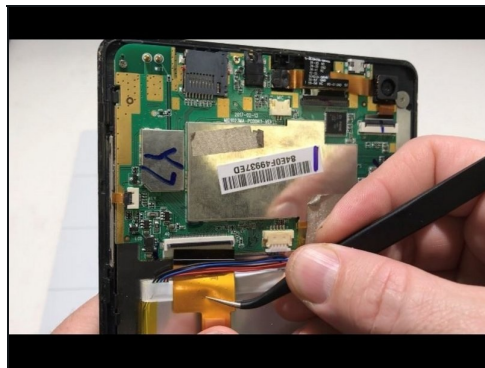
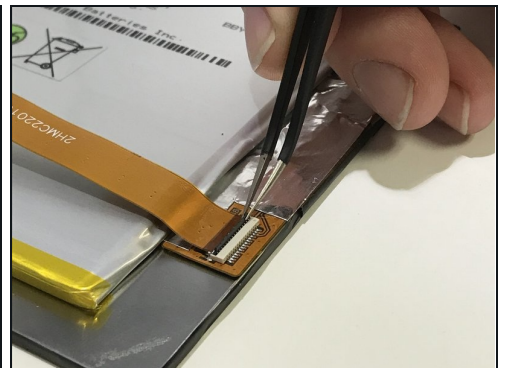
Step 3

- Remove the ribbon cable by pulling the locking tab of the ZIF connector up and pulling the ribbon cable out with [tweezers](#).

To reassemble your device, follow these instructions in reverse order.
