# Replace MSI GT72 2QE Dominator Pro Wireless Card

Replace a failed wireless card on MSI GT72 laptop.

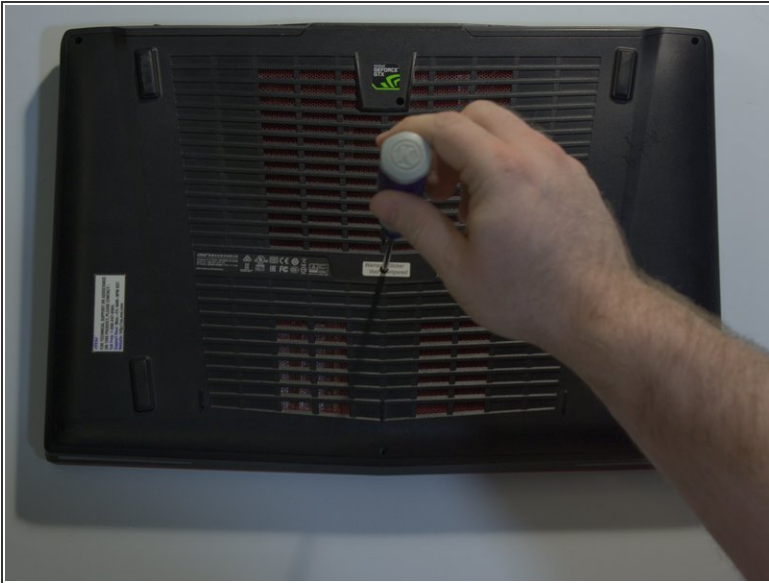
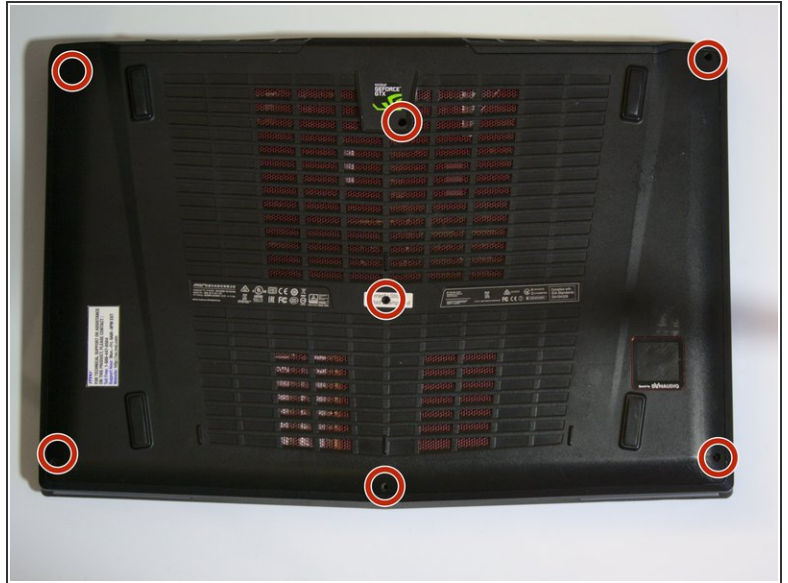
## Step 1 — Wireless Card

- Remove the seven 6 mm Philips #0 screws on the bottom of the case.

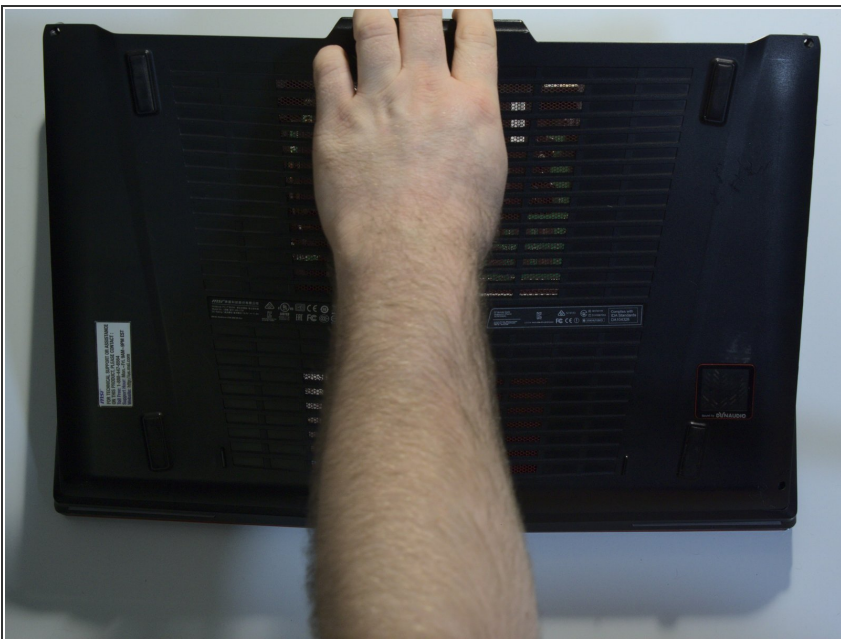
## Step 2

- Gently pull from the rear of the case upwards to remove the bottom of the laptop.
