BMW 2003-2010 5 Series Tail Light Bulb Replacement

This guide will help you replace a burnt-out tail light bulb on the 2003-2010 BMW 5-series.

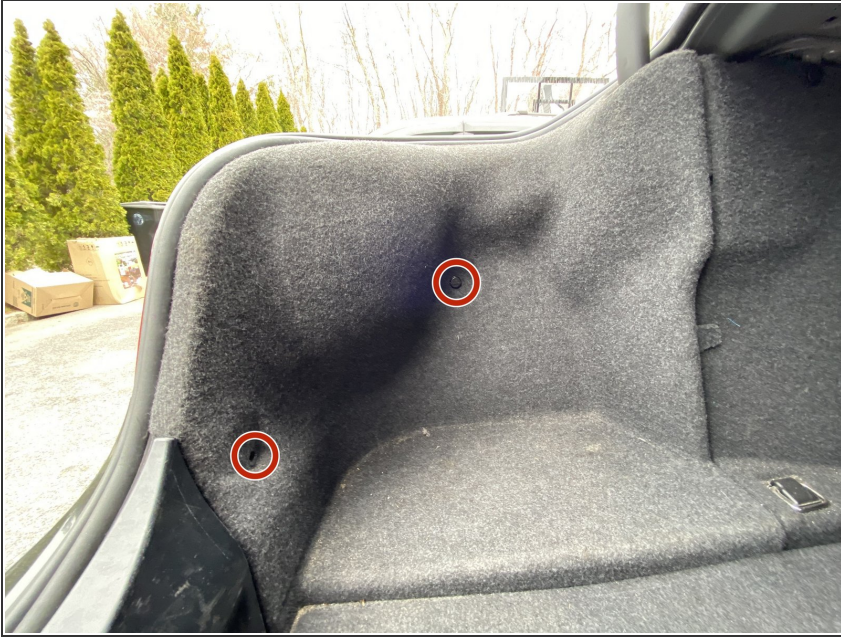
Step 1 — Tail light Bulb

- Open the trunk of the car to access the tail lights.
- Remove the two 5 mm screws holding the panel cover in place.

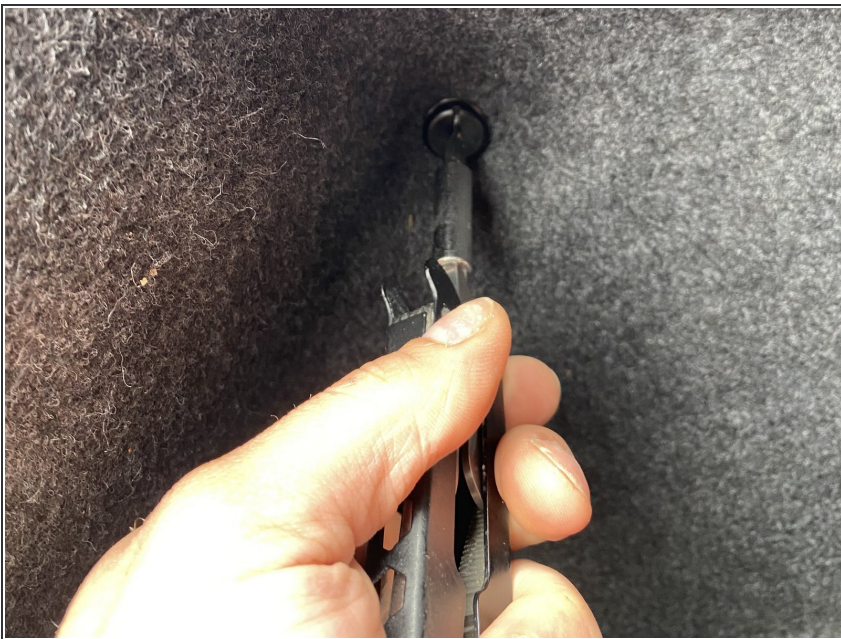
Step 2

- With a flathead screwdriver, turn the screws half a turn counterclockwise.

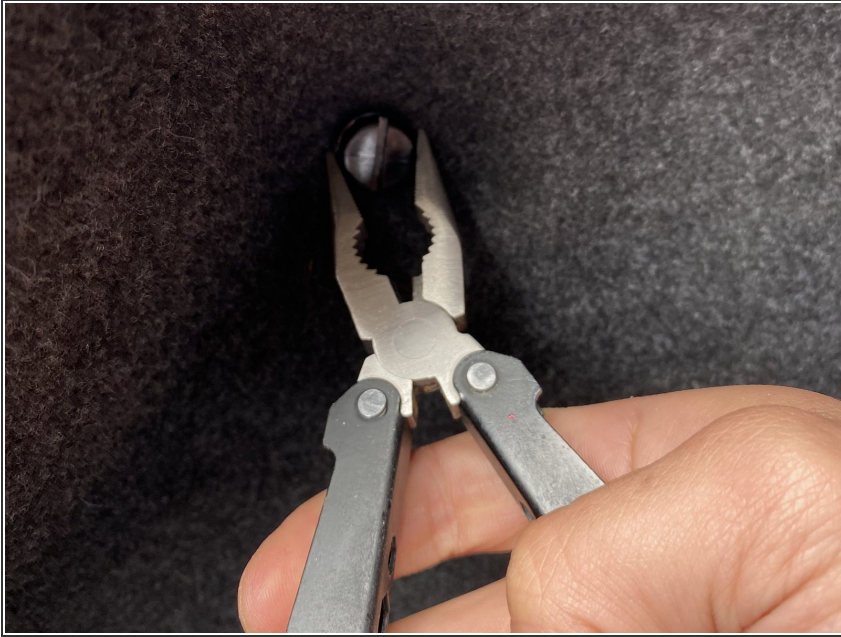
Step 3

- With plyers, remove the screws.

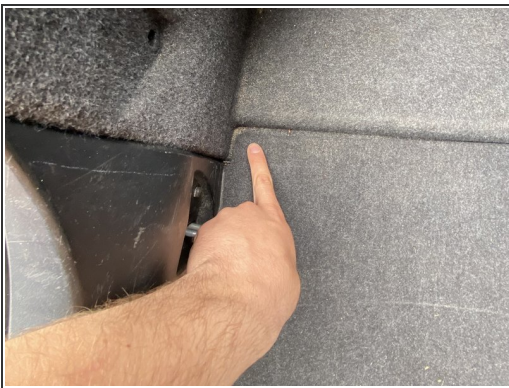
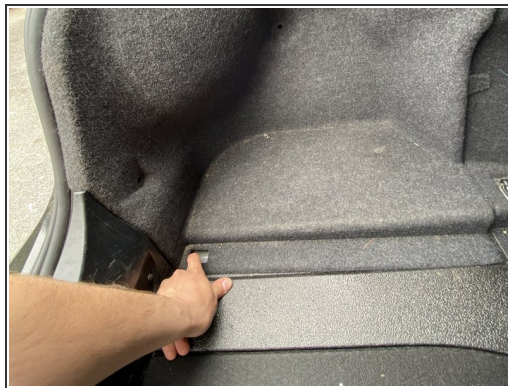
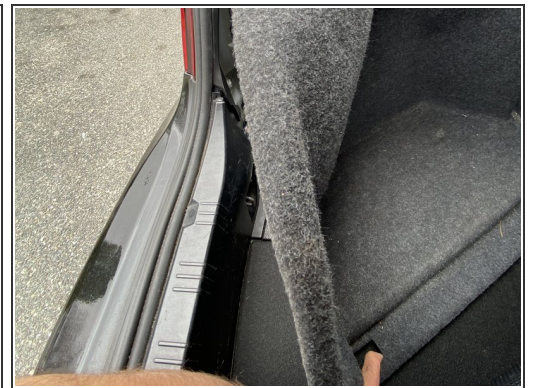
Step 4

- Pull up the trunk matt and remove it from the corner.
- Pull up the panel by the tab.
- ⓘ The panel should lift right out.

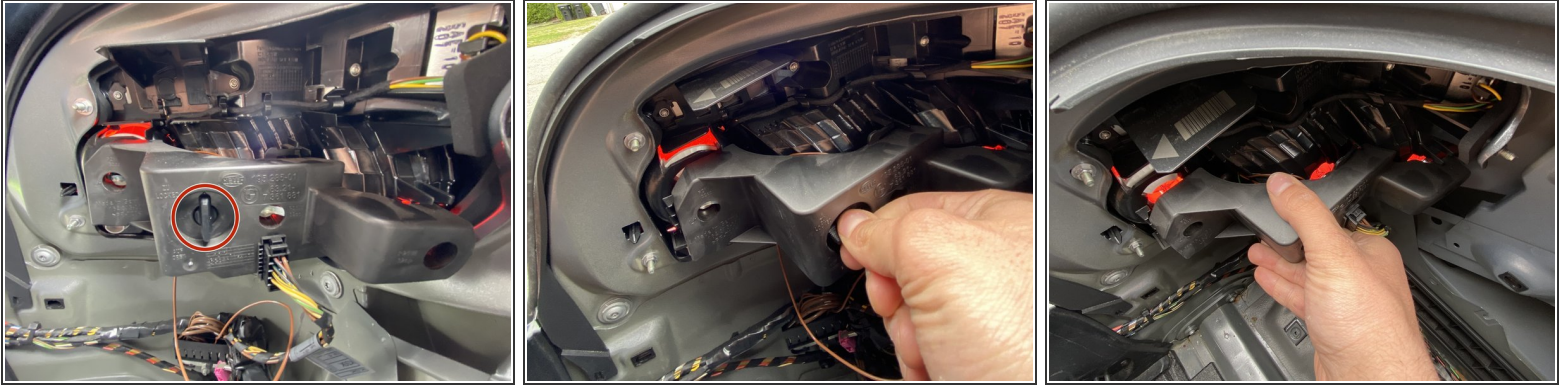
Step 5

i You will see the light bulb holster.

- Turn the dial in the middle of the black plastic light bulb holster.
- Pull the holster out of the trunk bay.

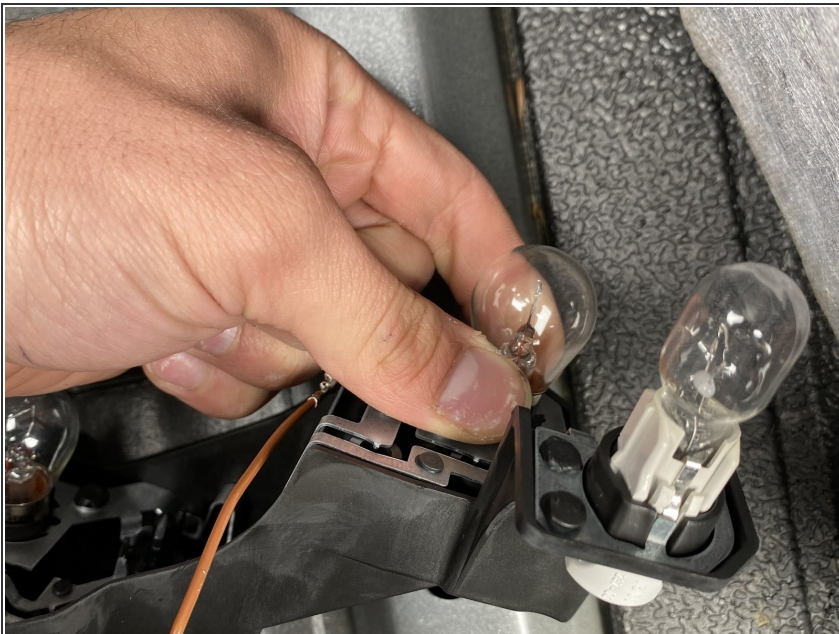
Step 6

- Grab the light bulb at the base and twist counterclockwise.

⚠ DO NOT TWIST THE BULB BY THE GLASS.

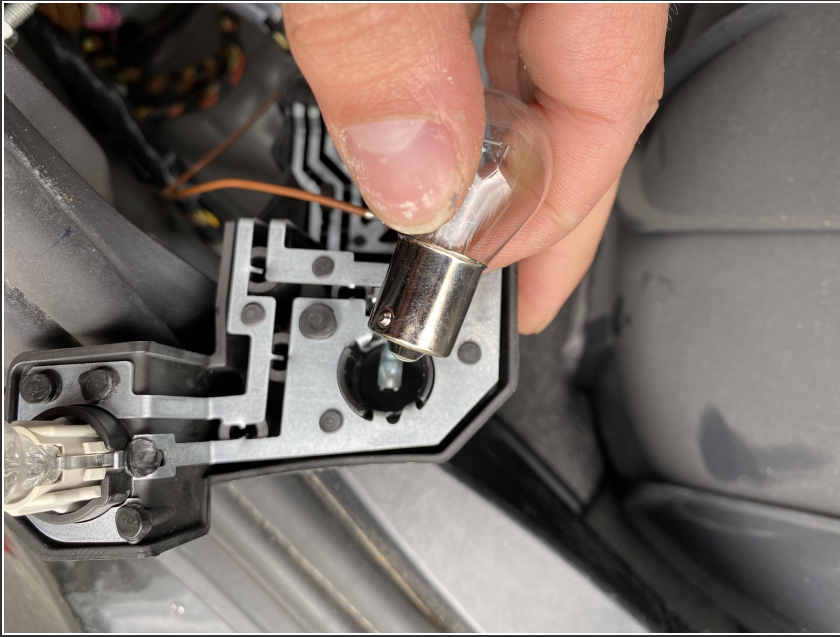
Step 7

- Pull out the bulb and repeat the process in reverse order with the new bulb to reassemble.

To reassemble, follow these instructions in reverse order.
