# HP Compaq nx7010 Business Notebook Teardown

A look inside an old Hewlett-Packard Business notebook made in 2004.

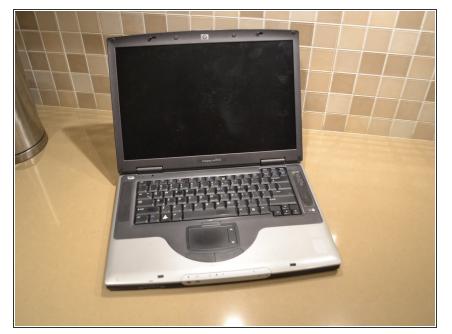
- A 9 year old Hewlett Packard nx7010 Business Notebook from 2004.
- More specifically, its model number is Cnx7010RP745Y580Wcg25P
- Back in 2004 it was a mid-range notebook priced at around A\$2,000.
- 1.8GHz Intel Celeron single core CPU.
- Windows XP Professional.
- 1680x1050 Anti-glare Screen (Which had a HORRIFIC ghosting effect).

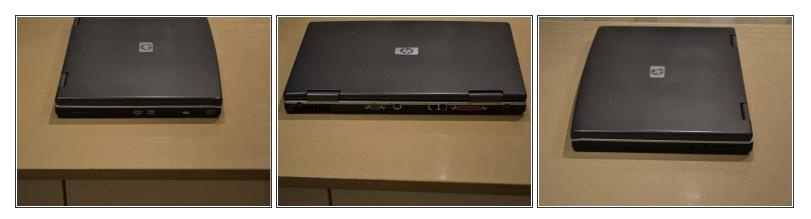
- A tour around the Notebook.
  - On the left hand side you will find a PCMCIA Card slot and the Optical drive.
  - On the right hand side you will find an Infra-Red window, Power jack, Kensington Lock and a fan vent.
  - On the back you will find VGA out, S-Video, 3x USB 2.0 ports, Phone line and Ethernet, Parallel port and FireWire (4 pin).

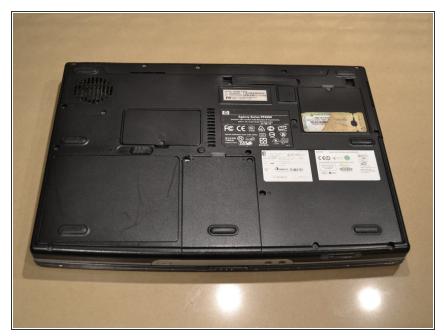
- Here is the base of the notebook.
- Product Number PQ803PA#ABG
- Doors to access the battery, hard drive, RAM, CMOS battery, docking port and Mini PCI LAN network card.
- Serial number is [CND4500VRZ].
  Decoding it reveals the notebook was made in China in December 2004.

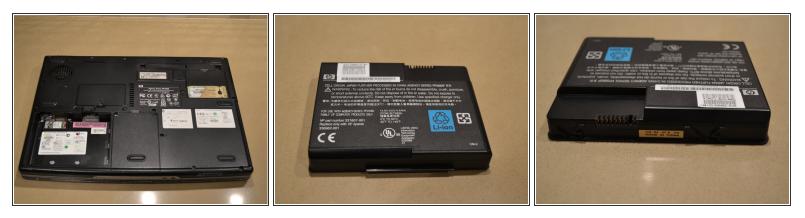
- Battery part number is [337607-001]
- 14.8 volts.
- 4.4 Amps per hour (4400 mAh).
- 8-cell.
- The battery was advertised to last for 5 hours unplugged when it was new back in 2004.
- After 9 years of cell deterioration, battery life is no more than 10 minutes.

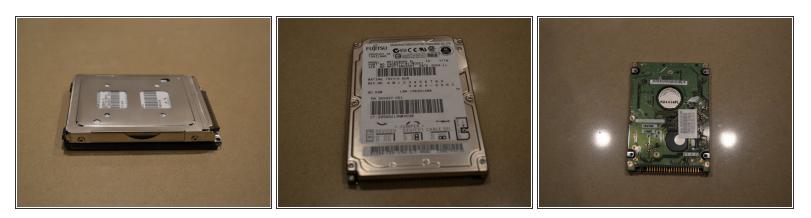
- Hard Disk Drive
  - Fujitsu MHT2080AH PL
  - 80.0GB capacity
  - 5,400 revolutions per minute
  - IDE Interface
  - Made in Thailand
- (i) The notebook was available with several hard drive options. 40GB and 60GB both with 4,200rpm or 5,400rpm speeds. Also available was an 80GB 5,200rpm HDD (as seen here)
- S.M.A.R.T data reveals that this drive has been powered on for a total of 2 years

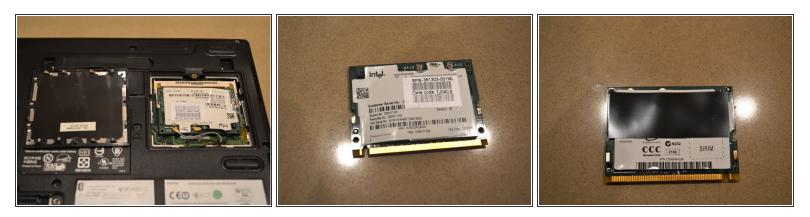
- Mini PCI LAN Network card
  - Intel
  - Model Number [WM3B2200BG]
  - Wi-Fi Antennae plugs into this card

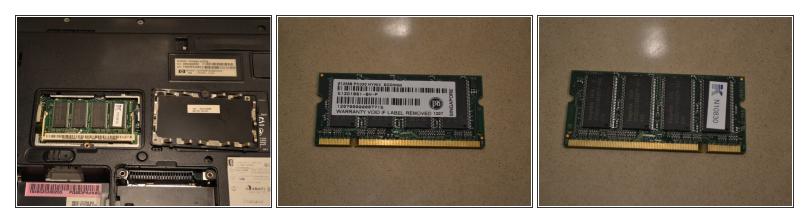
- Hynix RAM from slot 1 under the base
  - 512Mb SODIMM
  - 333MHz
  - Model Number [512D16S1-6H-P]
- (i) There are two slots in the nx7010 with slot 2 being under the keyboard. The computer maxes out at only 2Gb (1Gb per slot)

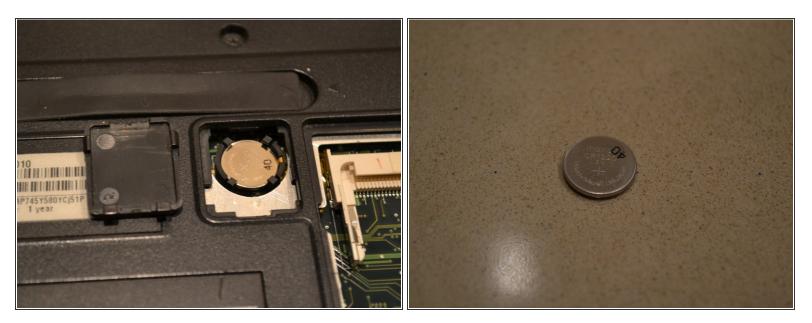
- CMOS battery
  - Maxell CR1220
  - 3 Volts
  - Not very interesting

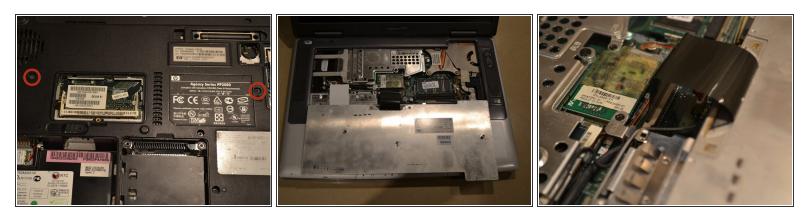
- Removing the keyboard
  - Remove the two #0 Phillips screws from the base of the laptop
  - Turn the laptop over and open the lid
  - Undo the four clips at the top of the keyboard and flip out
  - Carefully undo the clip on the ribbon cable with a flat-head screw driver or spludger

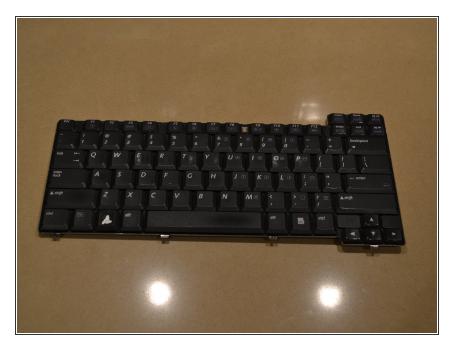
- The keyboard
- Part number [K001602E1 US]
  - Note that the dodgy Tux symbol painted on the Meta key is a customised key and is not original.

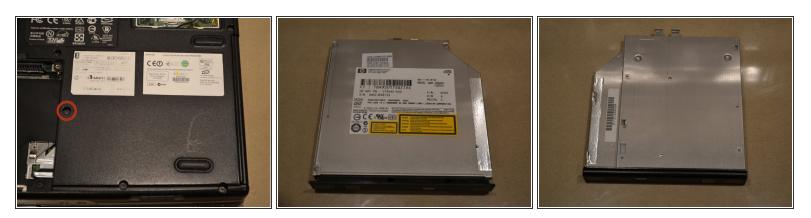
- Optical drive
  - Remove the single #0 Phillips screw
  - Slide out the optical drive
- Model Number GWA-4080N
- Manufactured with HP branding
- Made in Korea in November 2004
- DVD and CD compatable

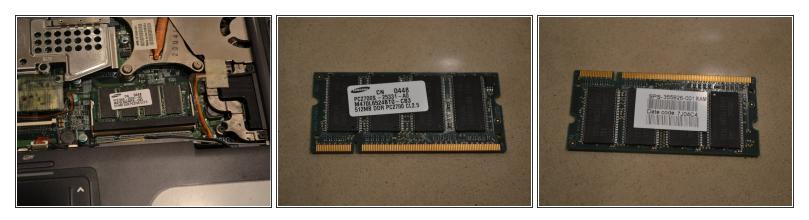
- RAM slot 2 located under the keyboard
- It's another 512Mb DDR SODIMM made by Samsung
- Product number [PC2700S-25331-A0]

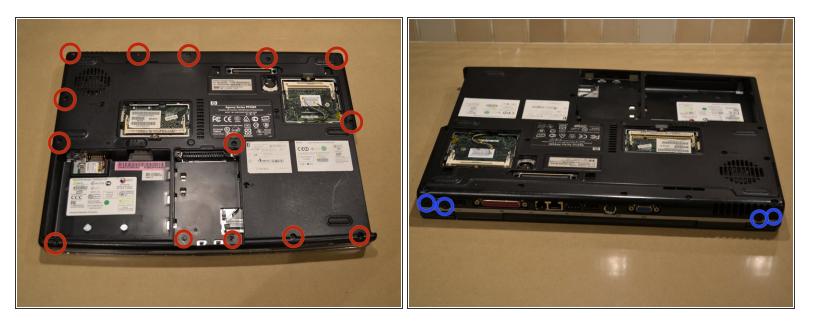
- Remove all 18 screws form the base and the rear.
  - 14 screws from the base
  - 4 screws from the rear

# (i) Keep track of all the screws because they vary in length

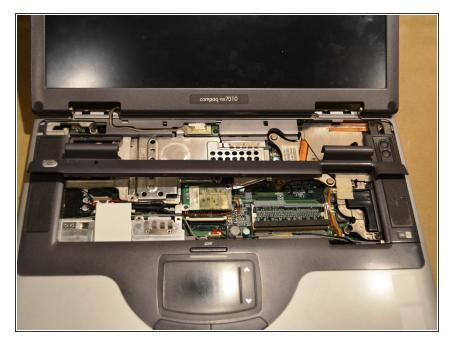
Removing the top panel between the keyboard and the screen reveals more screws to remove

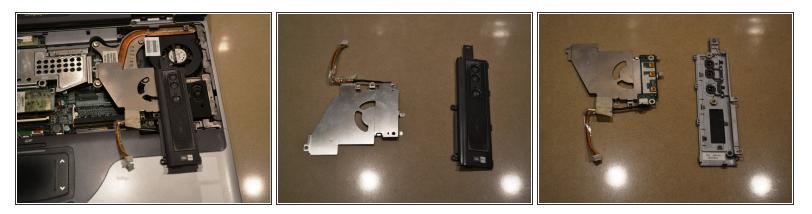
- 4 screws remove the left speaker and fan shield
- The three buttons in the speaker grille control the speakers
- From top to bottom it goes Volume up, Volume down and Mute.

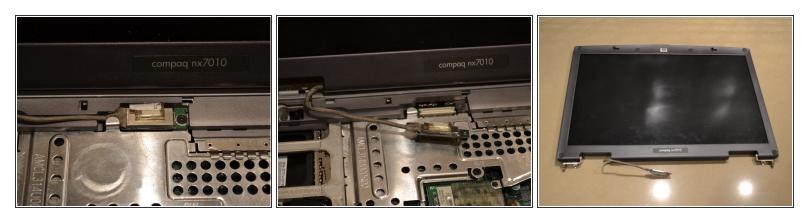
- Remove a single screw and pry the connector for the screen from the motherboard.
- After the connector is removed, the 1680x1050 15 inch (38cm) screen is free.

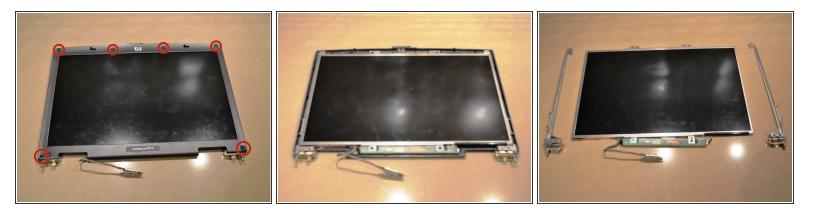
- The display enclosure
- It is actually quite easy to do a DIY screen replacement as there is no glass or adhesive to deal with but there are tabs that snap everything together
- Removing the 6 screws allows you carefully remove the bezel by carefully undoing the tabs with a flathead screwdriver.
- (i) I recomend using something made from soft plastic to undo the tabs as the plastic bezel and metal back panel damage easily.
  - The hinges simply screw on and off

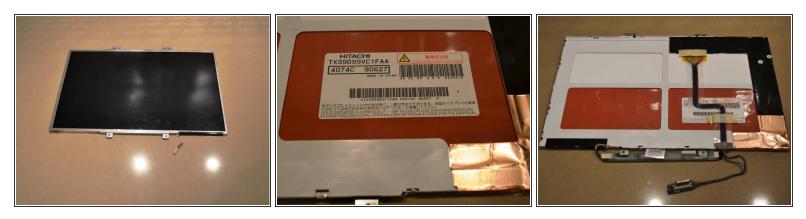
- The 1680x1050 Cold Cathode Fluorescent back-lit (CCFL) display
- Hitachi model number TX39D99VC1FAA
- Working and/or handling CCFL displays is dangerous as they contain Mercury and run at extremely high voltages.

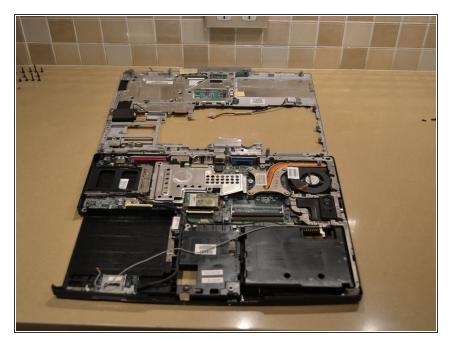
- Separating the top from the bottom
- Carefully remove both speaker, SD card, Touchpad and Bluetooth module plugs and de-route the cable that leads to the wireless module (not pictured)
- After that you can lift to top from the base.

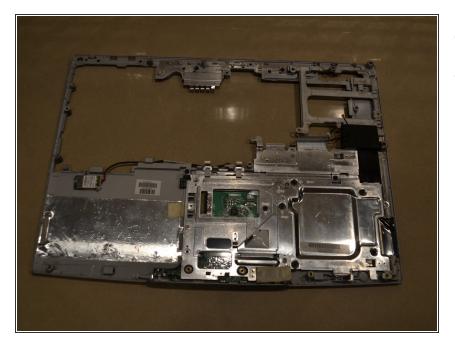
- The Interior of the top panel
- Contains the right hand speaker, Bluetooth module and Touchpad assembly

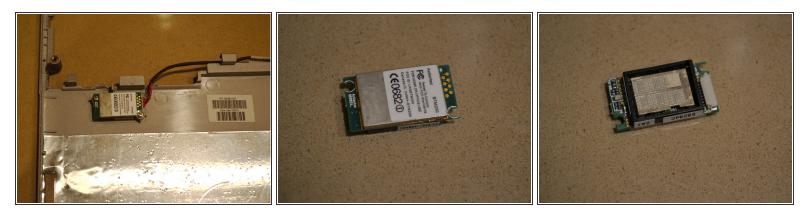
- The Bluetooth module located above the battery or under the palmrest on the top right-hand side.
- It is an Actiontec BTM200

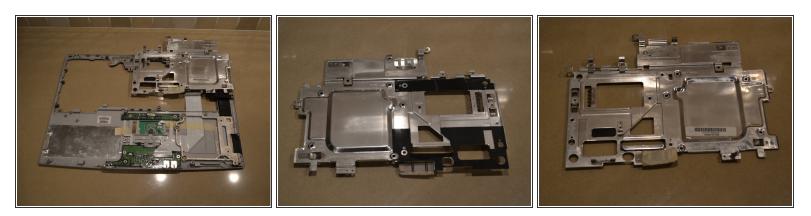
- The EMI shield for the optical drive and the touchpad
- Removing it gives access to the Touchpad and mouse button daughter boards.

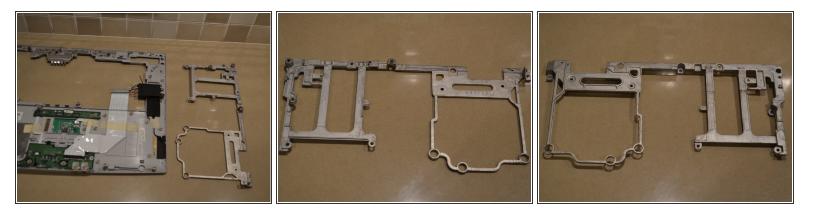
- The metal frame bracket
- It provides support for the notebook and makes it feel solid and rigid

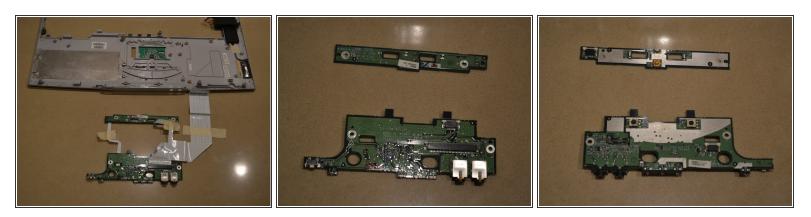
- Mouse and status LED daughter boards
- The daughter board on top controsl the on/off mouse switch. The lower daughter board has status LED's, wireless on or off switch and headphone/microphone jacks

(i) The touchpad sensor was intergreated into the palmrest and therefore was un-removable.

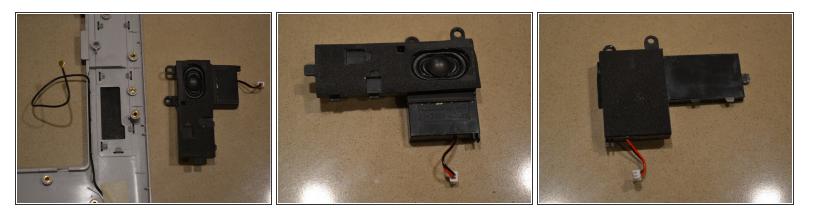
- Left hand speaker
  - Model Number: FG-CP630
  - Product Number: PK230005610
- 1.5 watts of decent quality sound output.

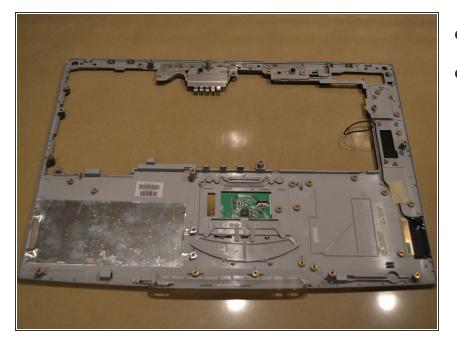
- The bare upper base.
- All that is left that is not worth removing is an EMI shield and wireless network cable as well as the touchpad which is integrated into the upper base.

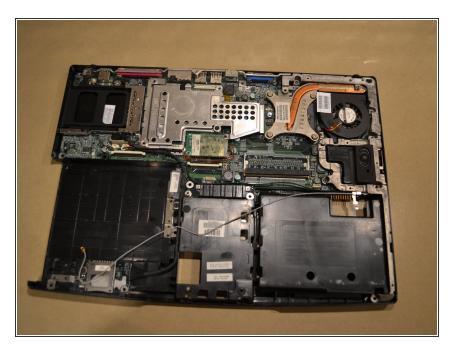
- Now the best bit. The lower base
- It contains the motherboard as well as all the other important components such as the graphics card and CPU.

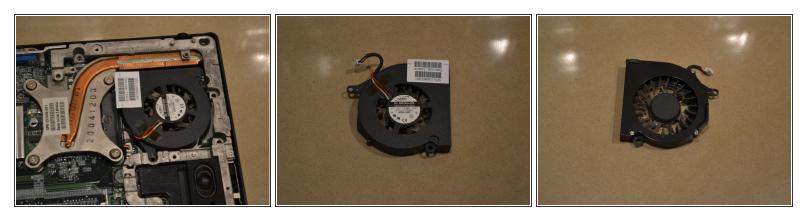
- First thing to be removed from the motherboard is the fan.
- There are (currently) no screws securing the fan in place so removal is as simple as pulling it out.
- Make sure to unplug the fan first before removing.
- (i) The wires are very delicate and are very hard to repair. Carefully pull by the plug.

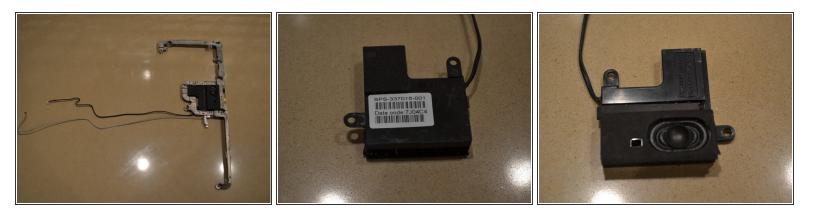
- The left hand speaker, metal frame and wireless communications.
- The wireless (gray) cable attaches to the frame so the frame can act like an antenna.
- The speaker has the model number PK230005710.
- This speaker also provides 1.5 watts of sound output.

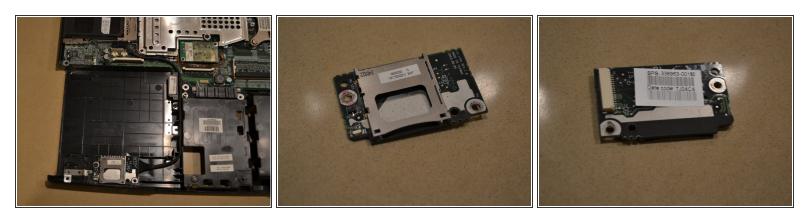
- The SD card reader is located right at the front of the computer and it's screwed into the base with a single screw.
- The model number is LS-1704.
- Manufactured on 09/05/2003 (9th of May, 2003)

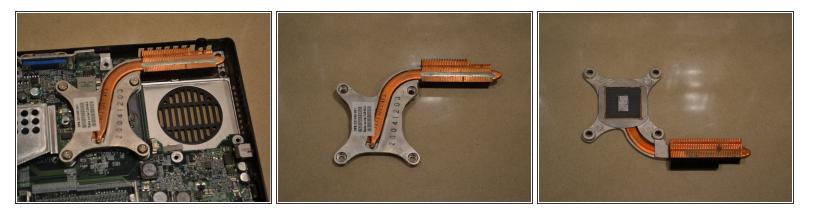
- Next out is the CPU heat-sink.
- It is held in with 4 sprung screws place around each corner of the CPU
- The thermal paste on the CPU can be a potential health hazard. Try not to come into contact with skin.
- (i) It is recommended (but not absolutely necessary) to re-apply thermal paste once the heat-sink has been removed to avoid overheating issues.

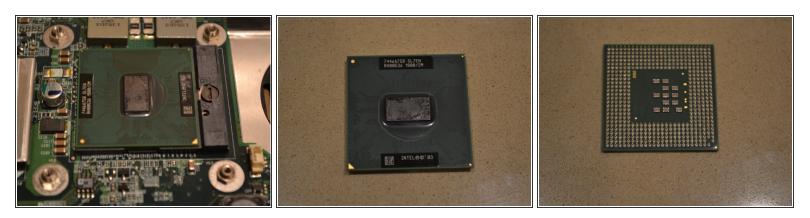
- And finally, the CPU
- It's an Intel Celeron M 1.8GHz Single Core with 256k of cache.
- 55 million Processing Die Transistors
- 400MHz Front Side Bus (FSB)
- Removal is as easy as turning the locking screw half a turn anti-clockwise to unlock and to then carefully lift up to remove.
- (i) CPU's are very delicate especially the pins and the thermal paste residue presents a potential health hazard.

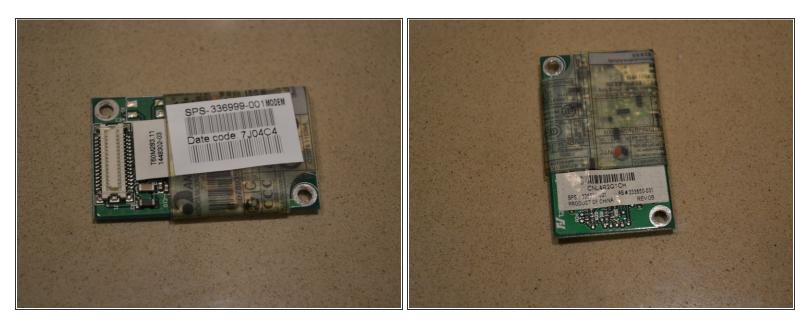
- The Modulator Demodulator (or Modem)
- It is an Ambit Microsystems T60M283.11

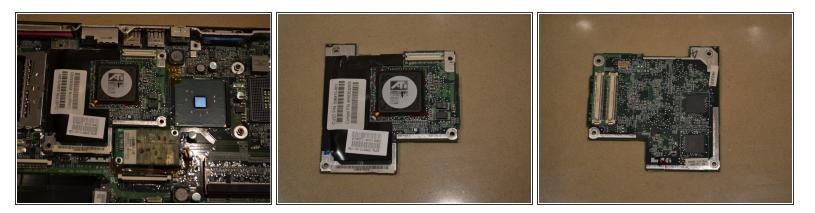
- Underneath an EMI shield (not pictured) we find the ATi Mobility Radeon 9200 graphics card.
- 64mb of dedicated graphical goodness
- It is not integrated into the motherboard so if it fails it can replaced individually rather than having a whole motherboard or CPU replacement.

(i) The notebook was available with the option of 32mb or 64mb dedicated graphics cards.

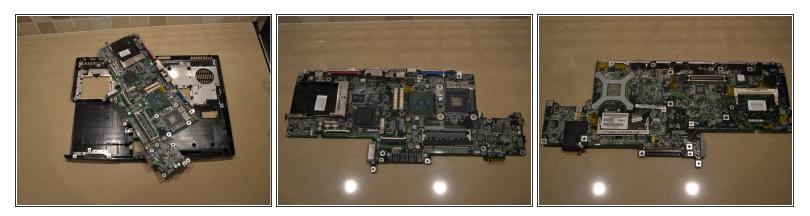
- The removal of the motherboard.
- (i) The release button for the expansion card slot must be pressed and held in, in order to remove the motherboard.
- Model Number A-1701 REV:2.0
- Manufactured on the 9th of July, 2003
