Durofix RV332 Bit Chuck Replacement

This guide will demonstrate how to properly replace a defective bit chuck on the Durofix RV332 Cordless Li-ion Screwdriver.

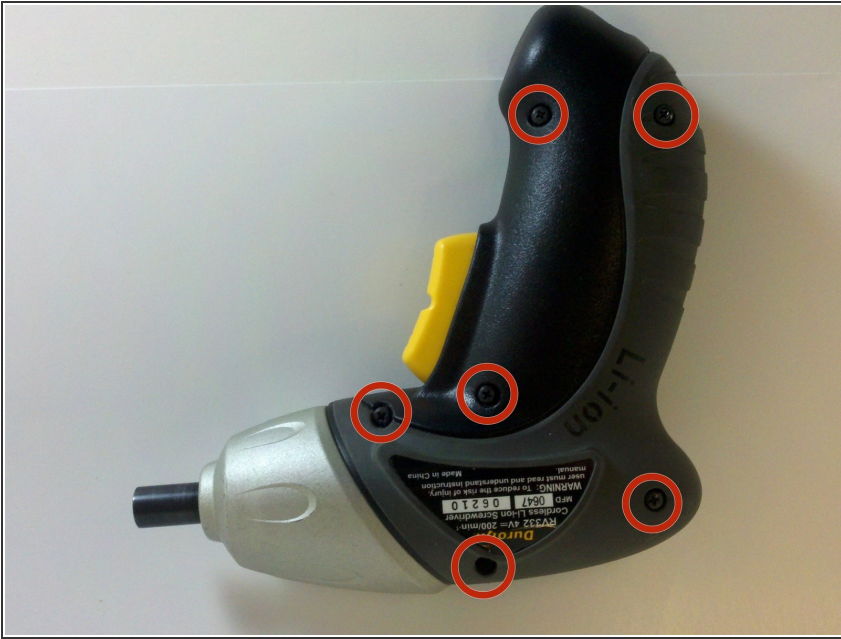
Step 1 — Bit Chuck

- Remove the six 13 mm casing screws with the #0 Phillips screwdriver.

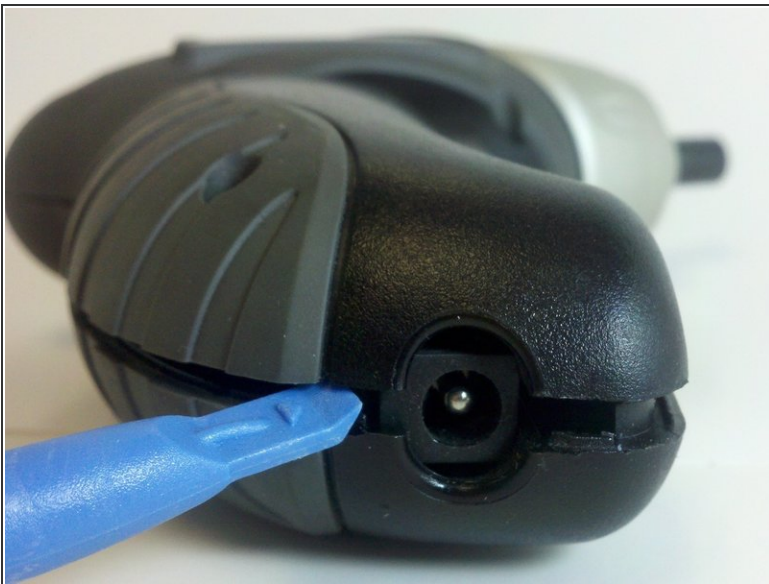
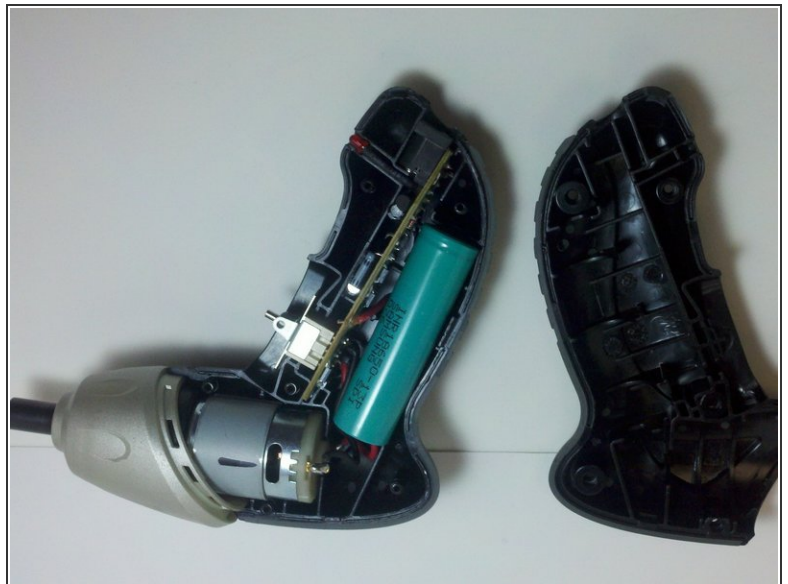
Step 2

- Separate the screwdriver casing halves with the plastic opening tool.

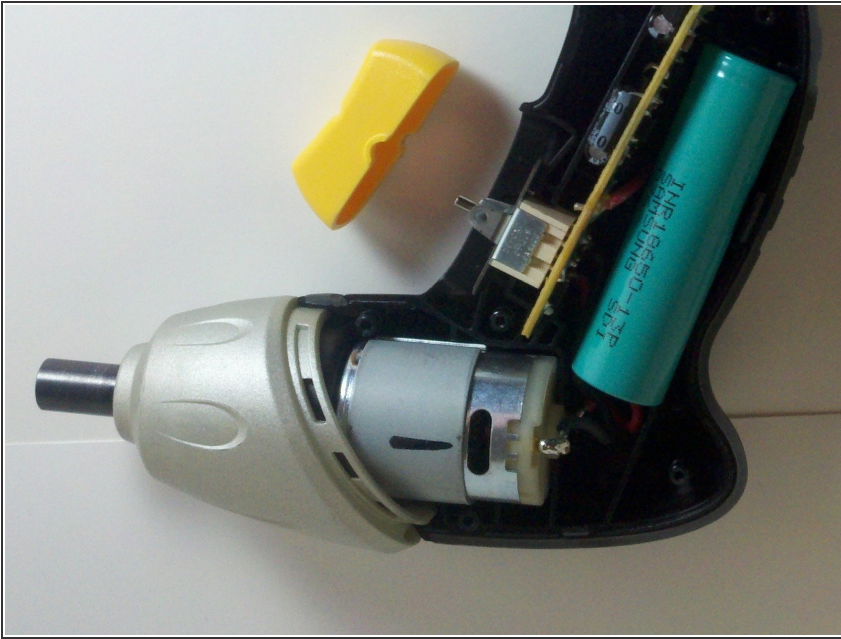
Step 5

- Insert new bit chuck assembly into the drill casing.
