TomTom One 310 LCD and Touchscreen Replacement

Older model TomTom that is well used. Replacement LCD and digitizer purchased as one assembly. Total cost \$20 for the repair.

This was given to me by a coworker for repair. It is a well used GPS that fell out of a Jeep and cracked the digitizer. The digitizer and LCD are available as separate units. I opted to replace the complete assembly since there was only a minor difference in money.

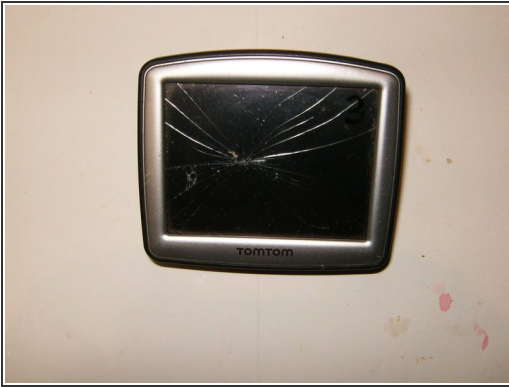
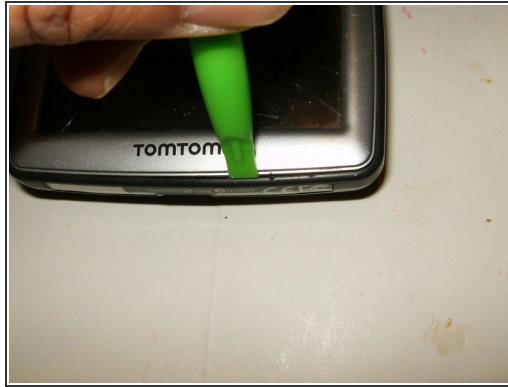
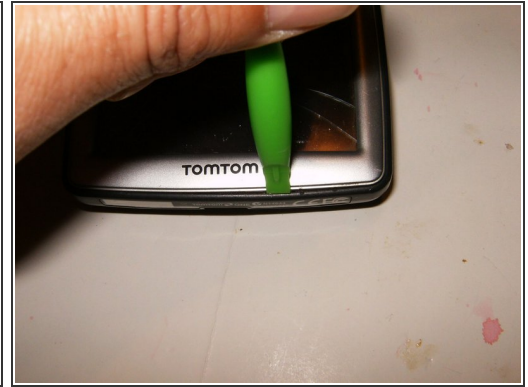
Step 1 — LCD and Touchscreen

- Here is the TomTom with a clearly visible damage. The LCD did work, but for obvious reasons the digitizer did not.
- Use a plastic opening tool and insert it between the outside of the bezel and the plastic case. It will need some effort, but the plastic of the case does have enough give to make it possible.
- Continue to work the tool around the bezel. There are multiple plastic tabs that need to be released

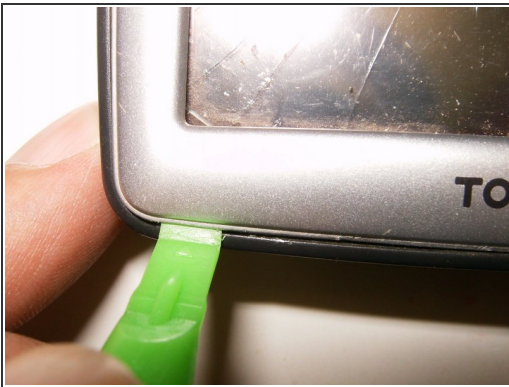
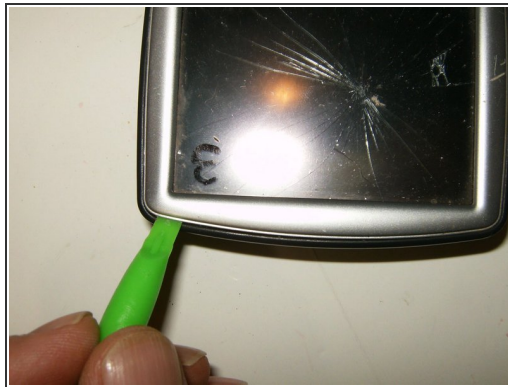
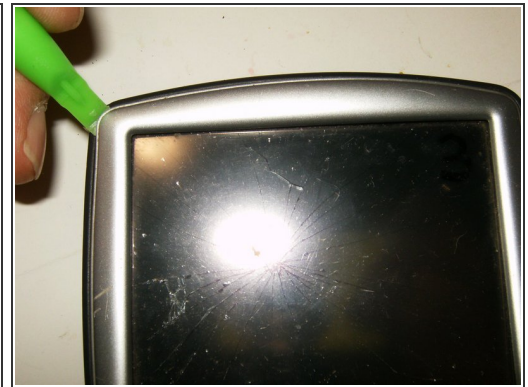
Step 2

- Continue to move the tool to the outside edges,
- then along the sides
- and finally the top.

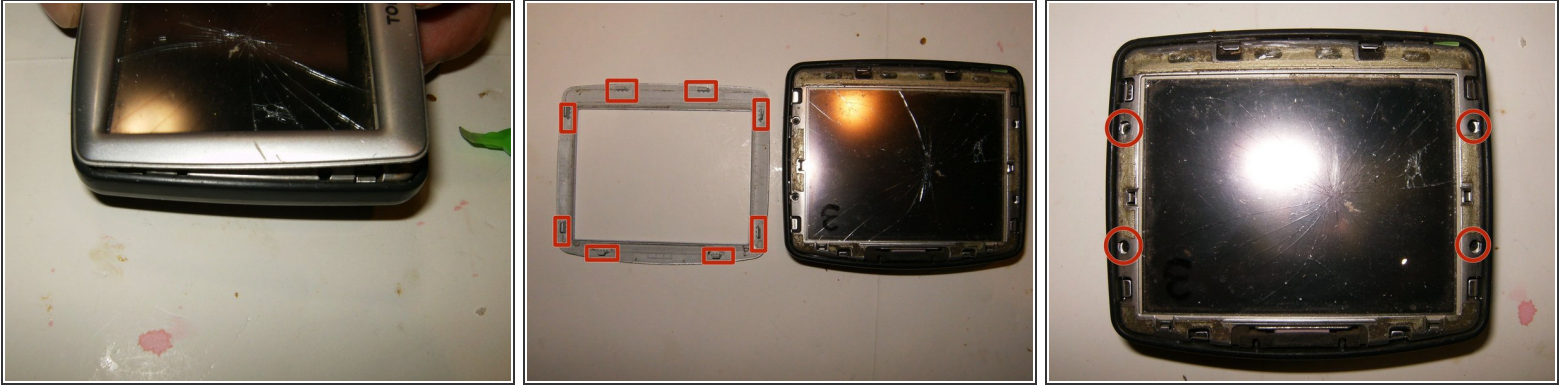
Step 3

- Once all the tabs are released, carefully lift the bezel up and remove it.
- Now the 8 holding tabs are visible
- Remove the 4 Phillips screws that connect the LCD holder

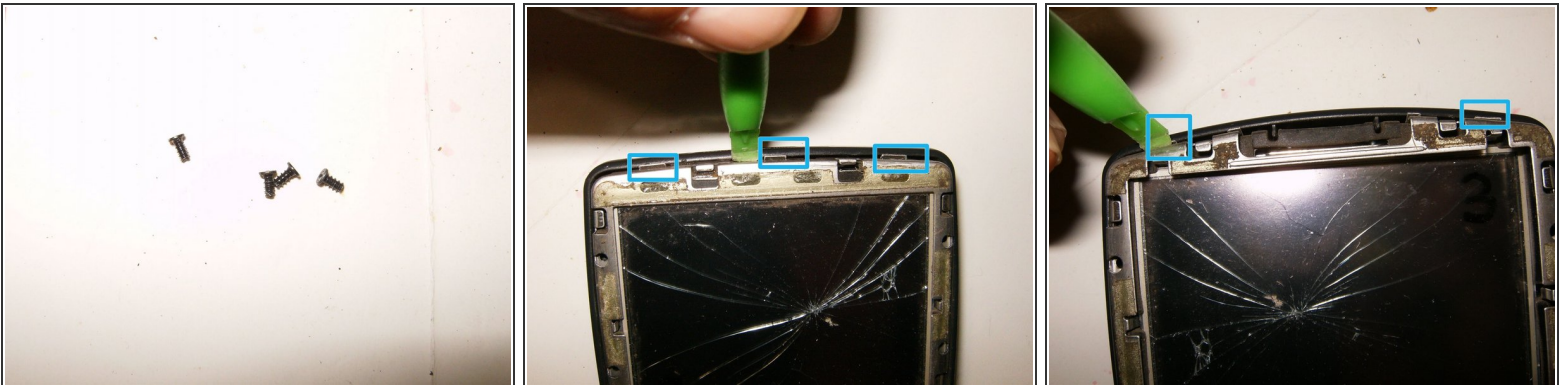
Step 4

- Here are the four coarse threaded 3mm long screws.
- The LCD holder shows three metal tabs on the bottom that hold it to the plastic case. Use the plastic opening tool to clear those tabs.
- There are two metal tabs at the top that hold it to the plastic case. Use the plastic opening tool to clear those tabs.

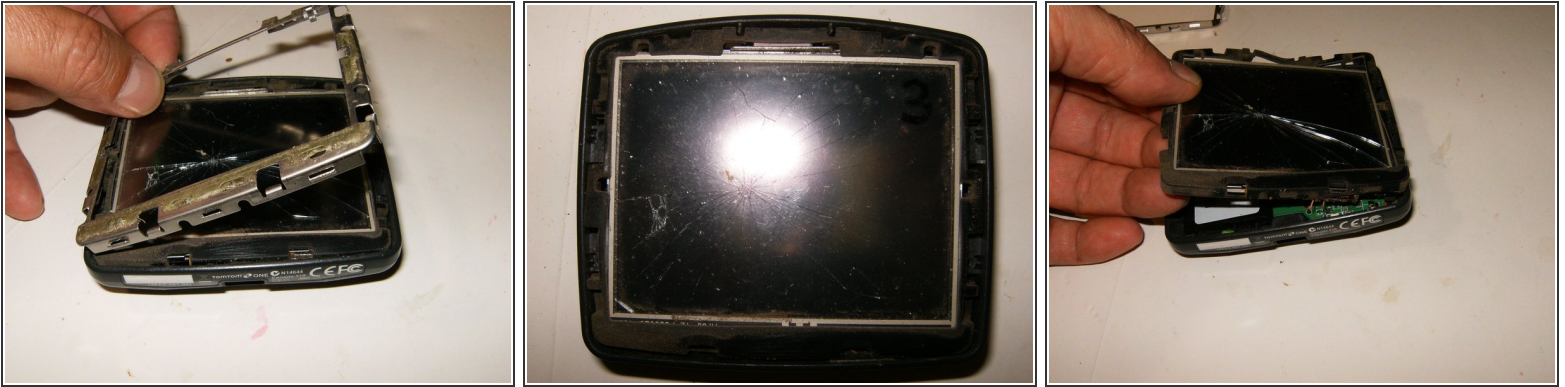
Step 5

- Remove the LCD holder
- Here is the LCD without the holder. There is a rubber gasket placed around the outside of the LCD. Note its position
- Lift the LCD gently out of the plastic case and fold it toward the bottom of the case. The display cable is still connected and may tear if this is done in either the wrong direction or too forcefully.

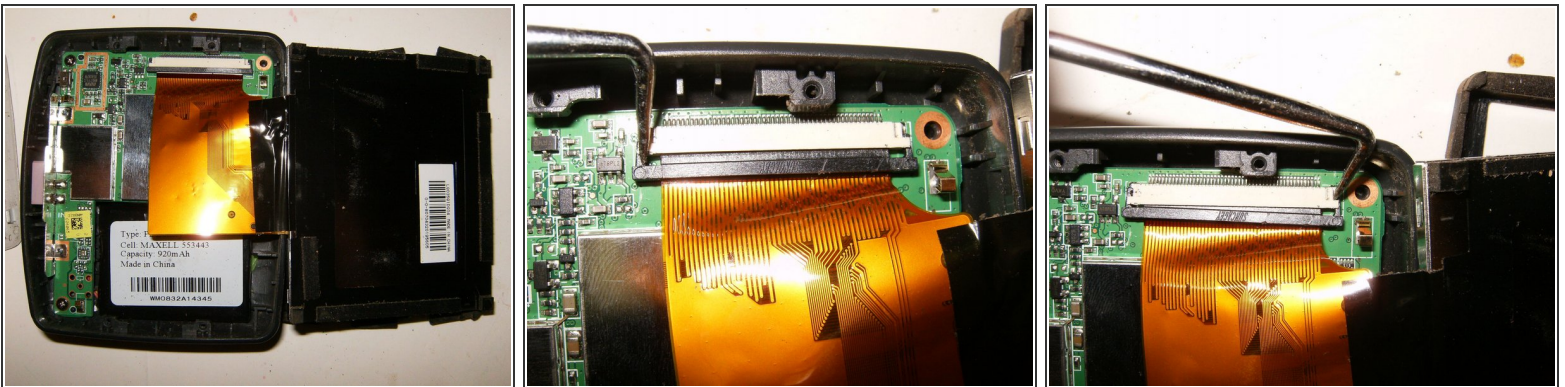
Step 6

- LCD flipped toward the bottom of the case. The display cable is still connected.
- Use a pick or similar tool to gently move the locking tab. First the bottom,
- Then the top until the locking tab is released and the display cable can be removed.

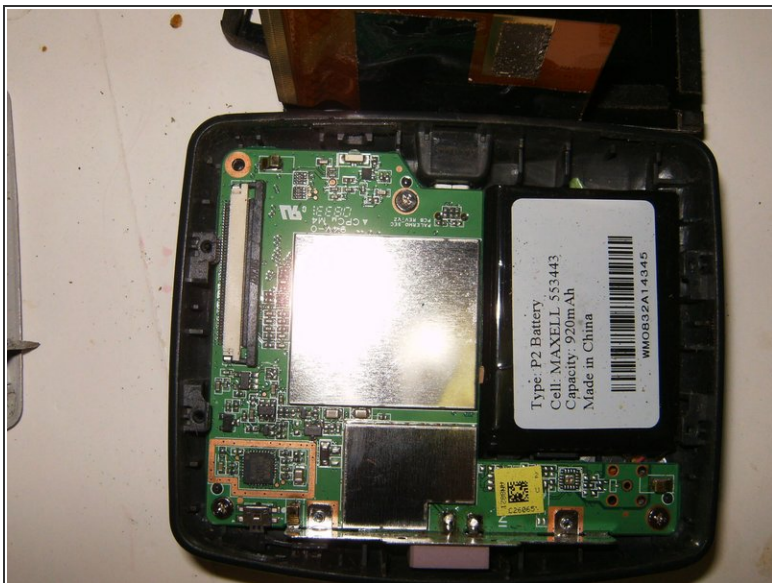
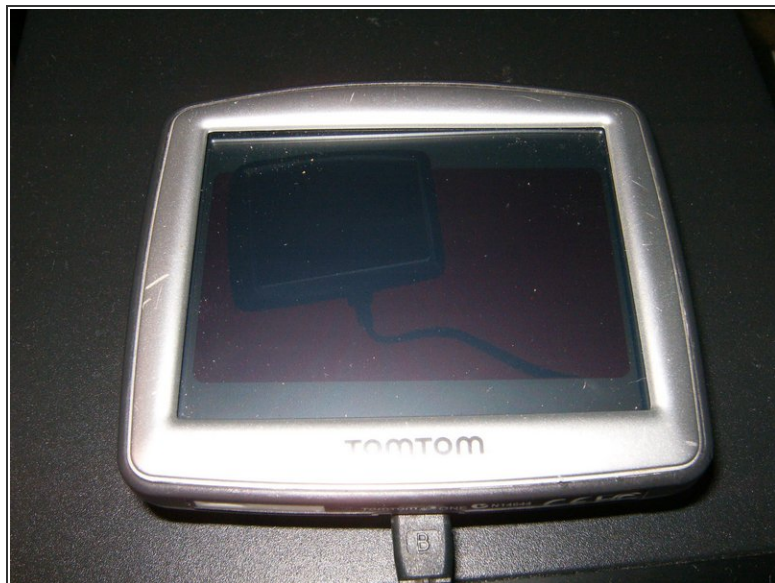
Step 7

- Remove the display assembly. A new display assembly can now be installed.
- Final result is a refreshed looking and working TomTom

To reassemble your device, follow these instructions in reverse order.
