HTC Desire 700 Dual Sim Rear Facing Camera Replacement

Written By: Steven Pate

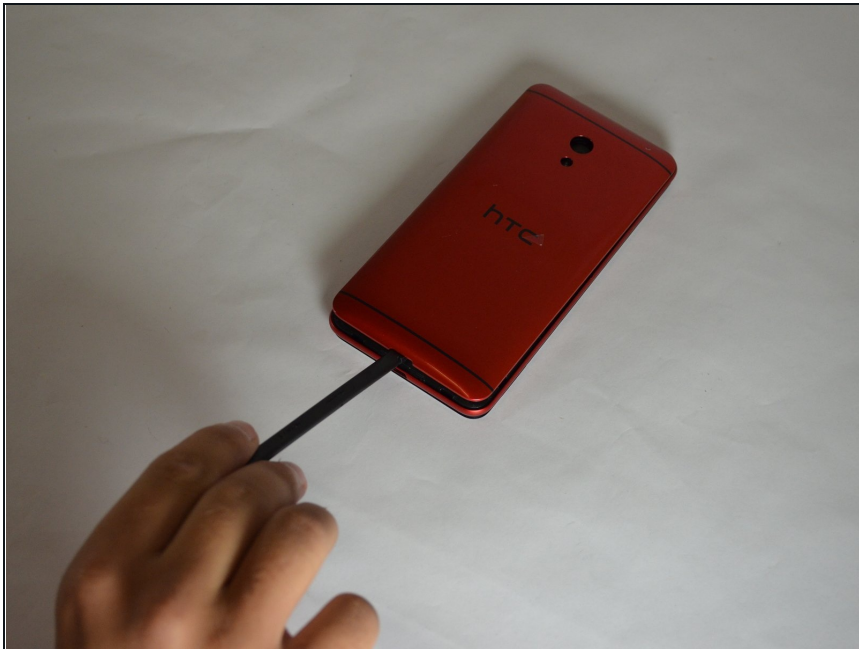
Step 1 — Back Cover

- Use the spudger to pry the back cover off.

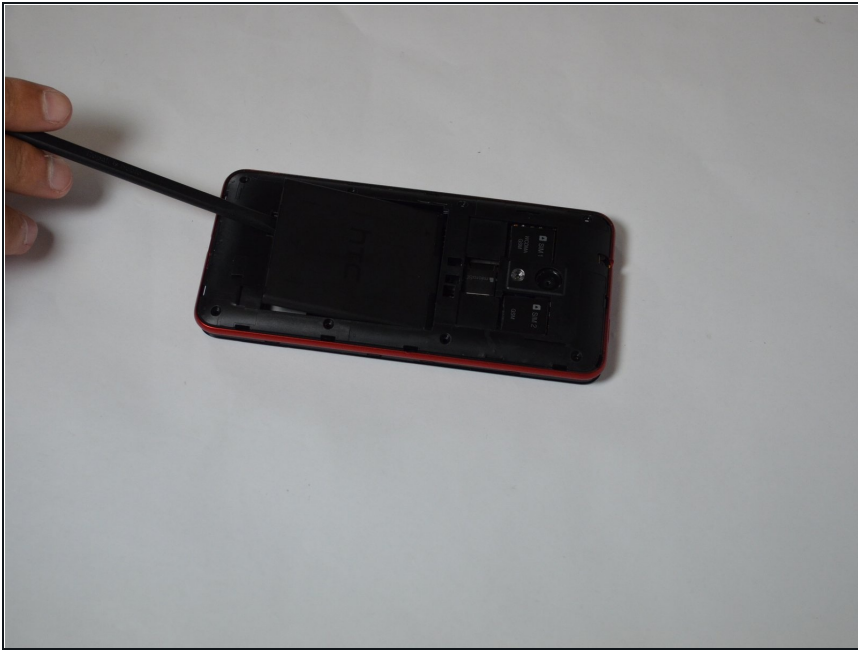
Step 2 — Removing Battery

- Use spudger tool to pry under the battery to lift it up and out.

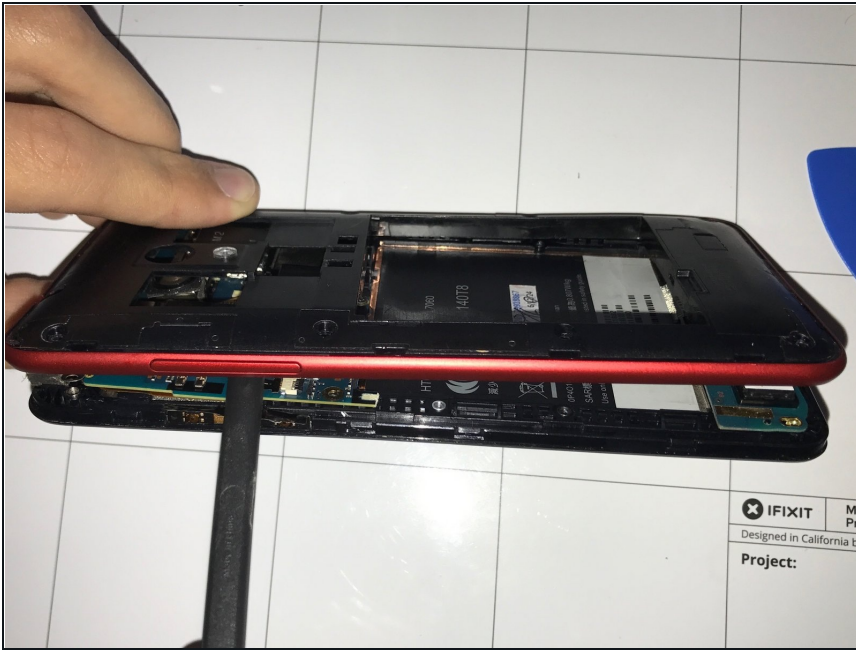
Step 4 — Prying Off Rear Panel

- Pry the back panel of the screen using the plastic opener.
- Work your way gently around the device, using picks as necessary to keep the back panel separated.

⚠ Use caution not to damage the device, as it takes force to remove the rear panel.
