HP Photosmart D5160 printer Disassembly

This guide covers disassembly in order to ease the cover-open linkage or to remove the main logic board for inspection or maintenance. Disassembly and maintenance of the print mechanism is not covered.

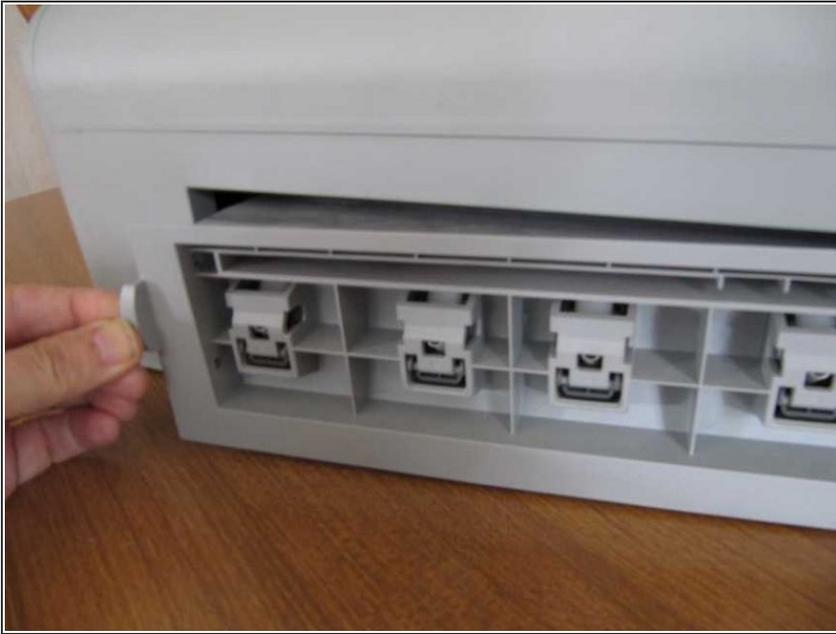
Step 1 — HP Photosmart D5160 printer Disassembly

- Remove any paper from the paper tray.
- Remove the paper guide from the rear of the printer. Check for any jammed paper or torn paper fragments and gently remove them. Blow out any dust and clean the rollers.

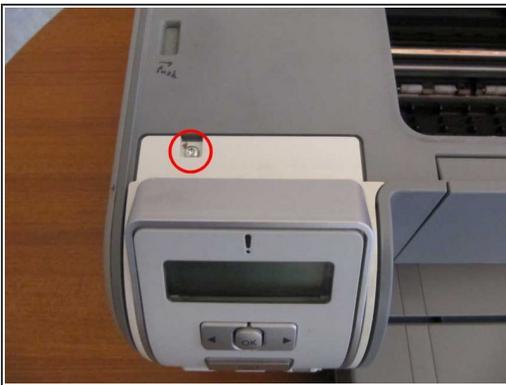
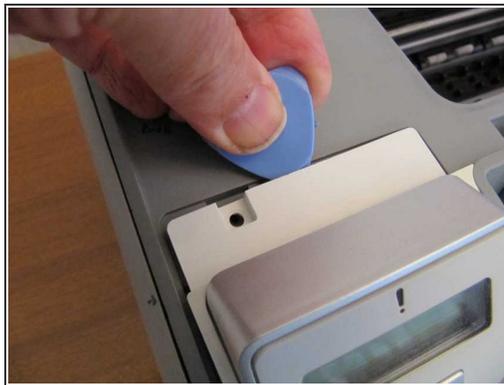
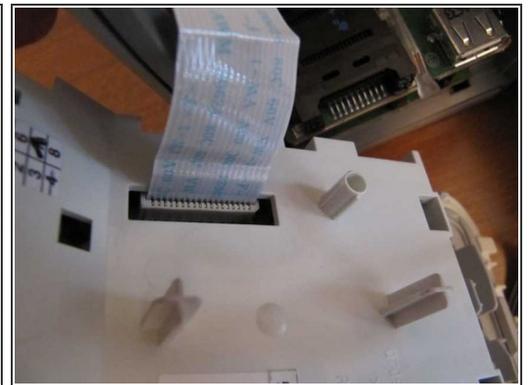
Step 2

- Lift the lid. You will see a single screw at the top of the control panel. Remove this.
- Starting from the top, prise the control panel off.
- Release the ribbon cable from the control panel and put it aside.

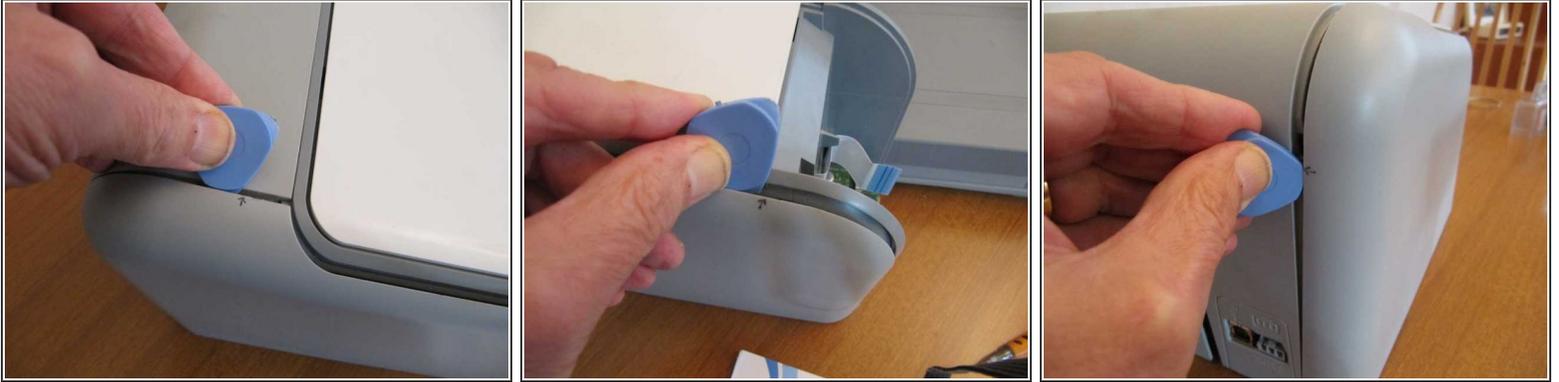
Step 3

- Prise off the left hand side panel. First, release 2 clips at the top and one at the back.

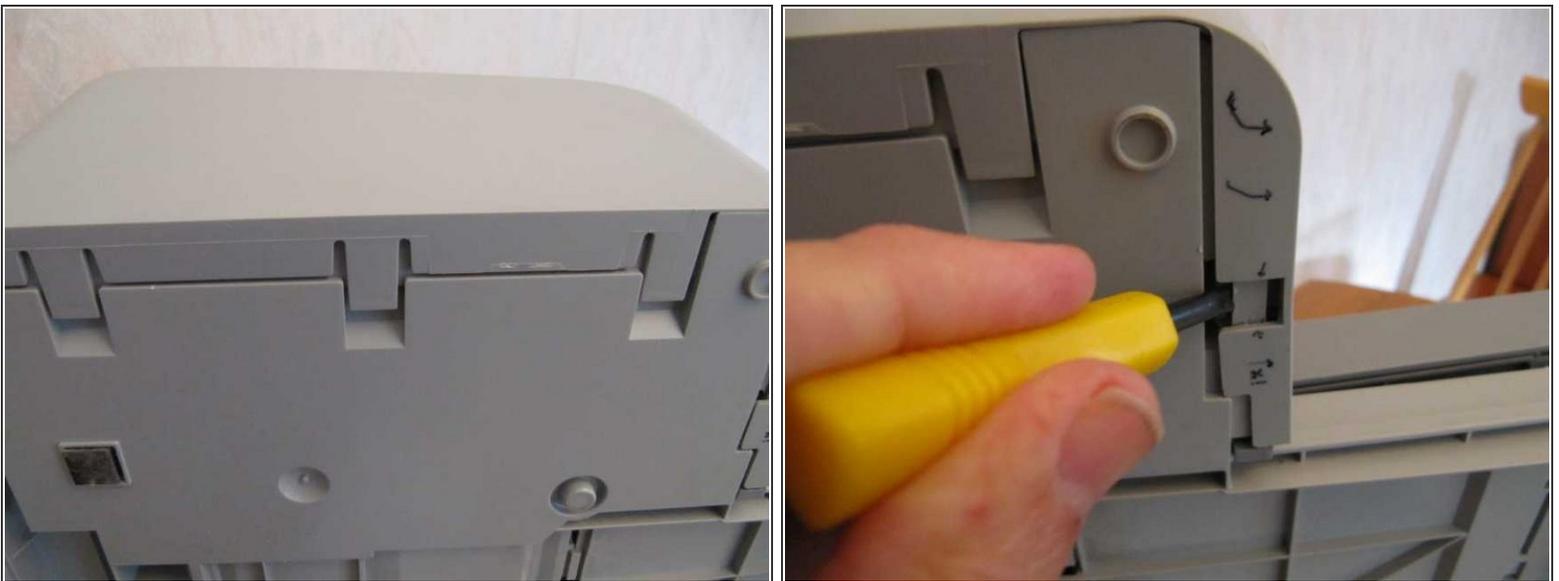
Step 4

- There are 3 more clips underneath. Release these.
- The side panel is still held by a clip underneath where the control panel was. Press it from under the printer with a flat screwdriver. Ease this section of the side panel forwards, making sure it bends at the front corner, not by the clip, where it is relatively weak.
 - (In the photo you can see the arrows I marked to remind me where to bend it and where not to.)
- On reassembly, locate this latter clip before offering up the others.

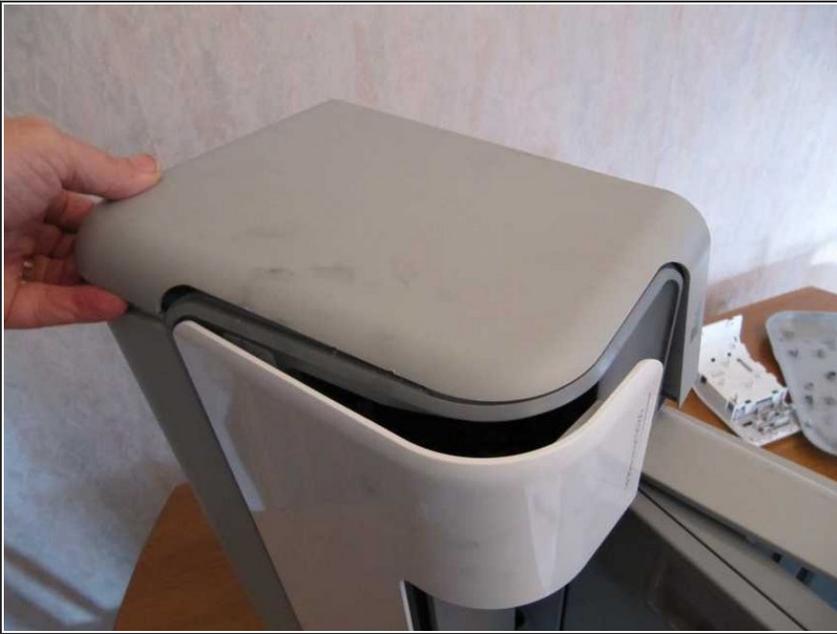
Step 6

- Prise off the right hand end cover. This has clips in the same places as the left hand end cover, and the same procedure can be followed.

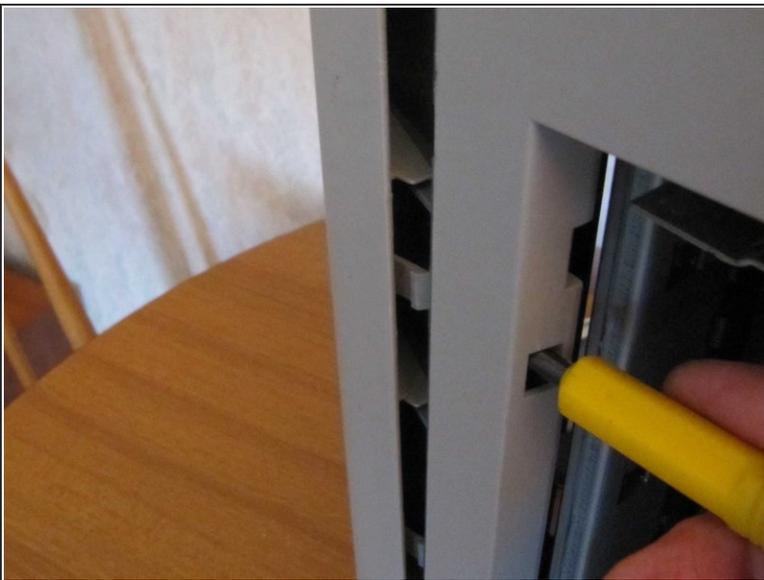
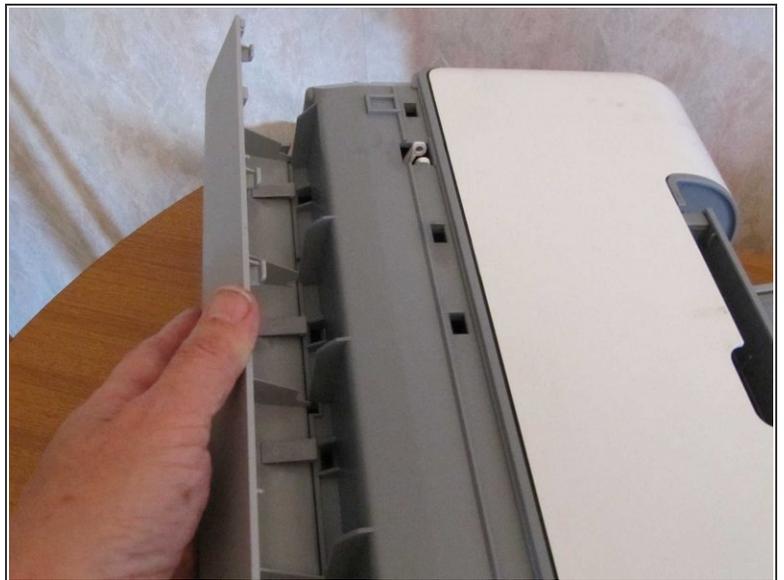
Step 7

- Release the rear top cover. This is secured by 5 clips, the middle 3 of which can be released by inserting a flat screwdriver in the holes underneath them. The other 2 can be popped out quite easily.
- (On reassembly, locate the clips on the top of the printer, then insert the 5 on the back.)
