Blackberry Torch 9810 Rear Facing Camera Replacement

After finishing your guide, your broken camera should not be a problem!

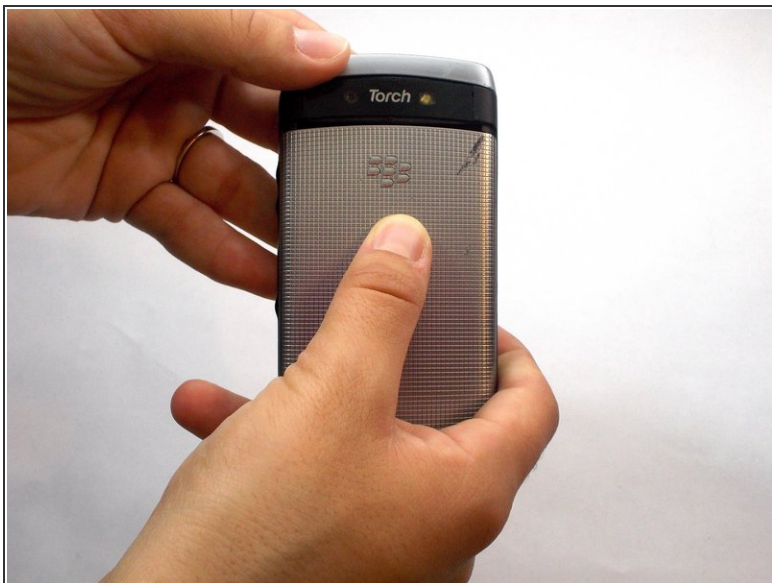
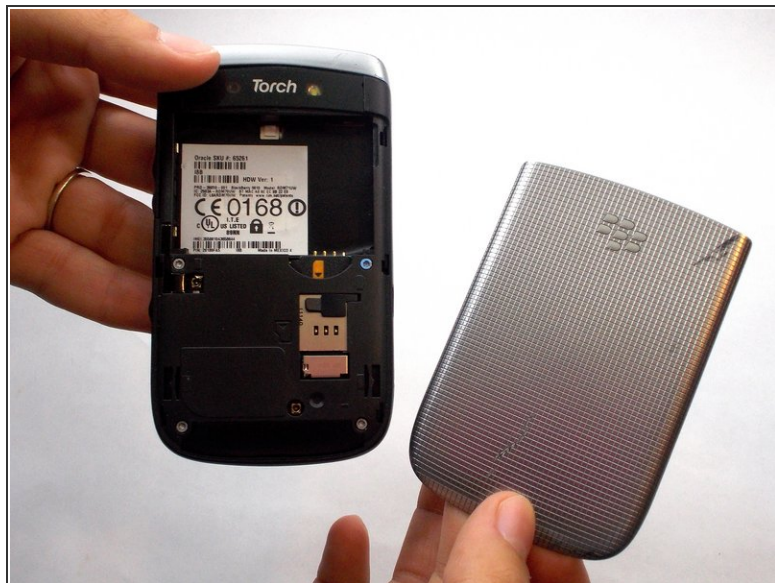
Step 1 — Remove Cover

- Remove the back cover of the phone

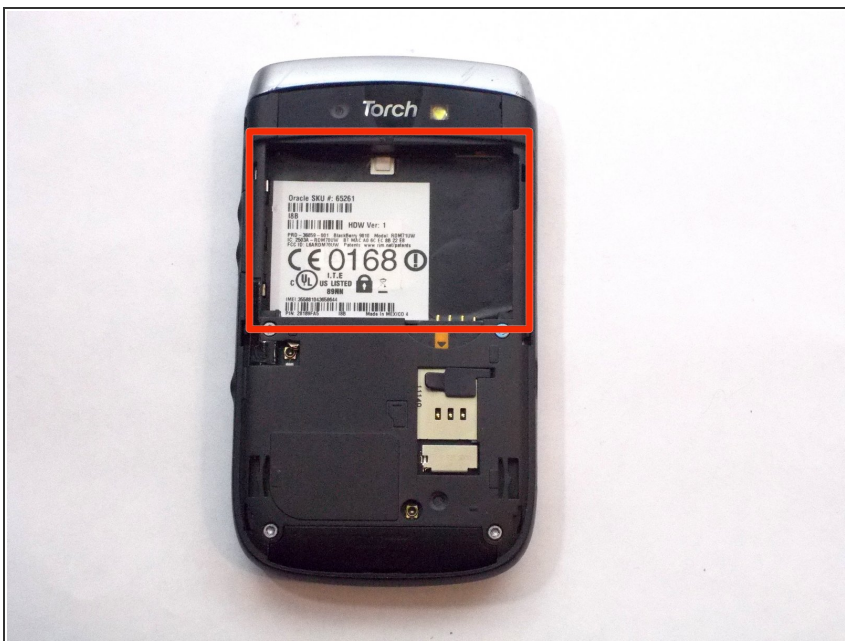
Step 2 — Remove Battery

- Remove the battery
- ❗ Our phone did not come with a battery. This is where it would be located.

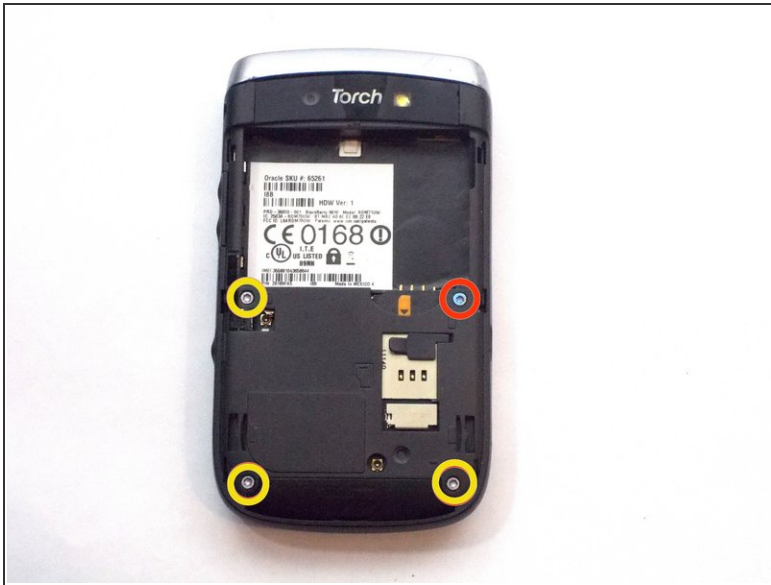
Step 3 — Unscrew Screws

- Unscrew the four screws using the T6 screw driver

⚠ If you remove the screw in red, you void the warranty!

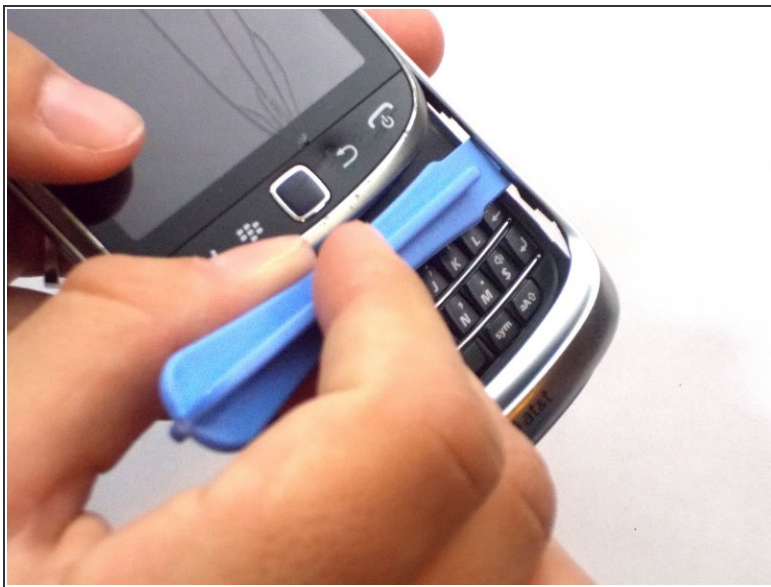
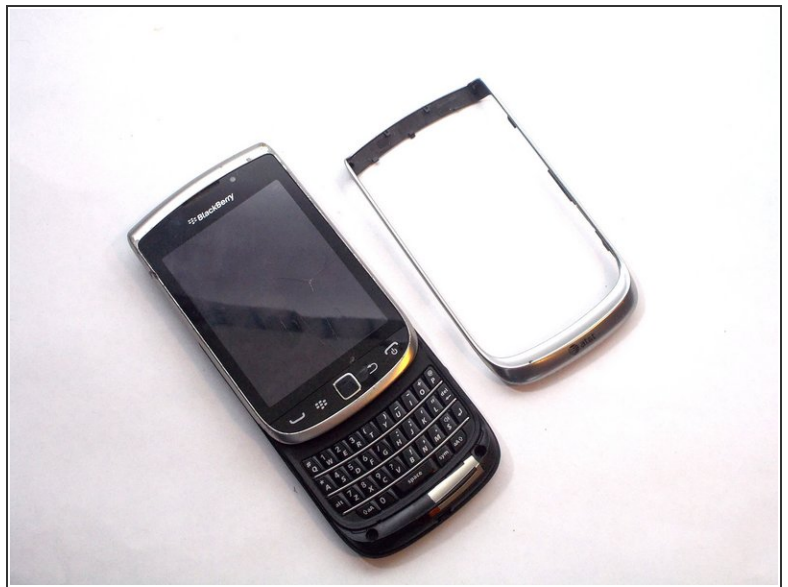
Step 4 — Wiggle Wiggle

- Remove front silver trim by using plastic opening tools and wiggle it off.

⚠ (This is a little difficult to remove) Pull the bottom upward and pull the top downward.

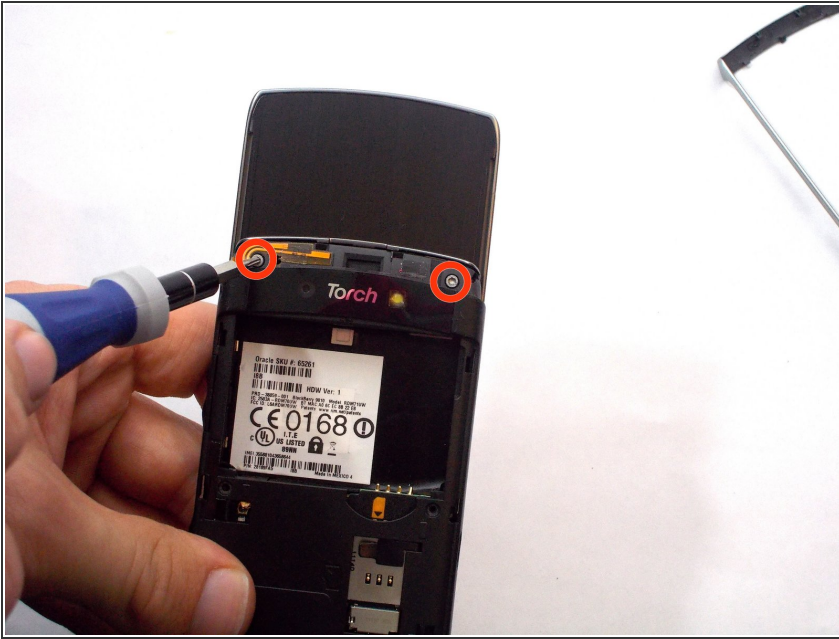
Step 5 — Smaller Screws That Must Go

- Once you remove the rim cover, you should find two more screws on the top. Unscrew them using the T6 screw driver.

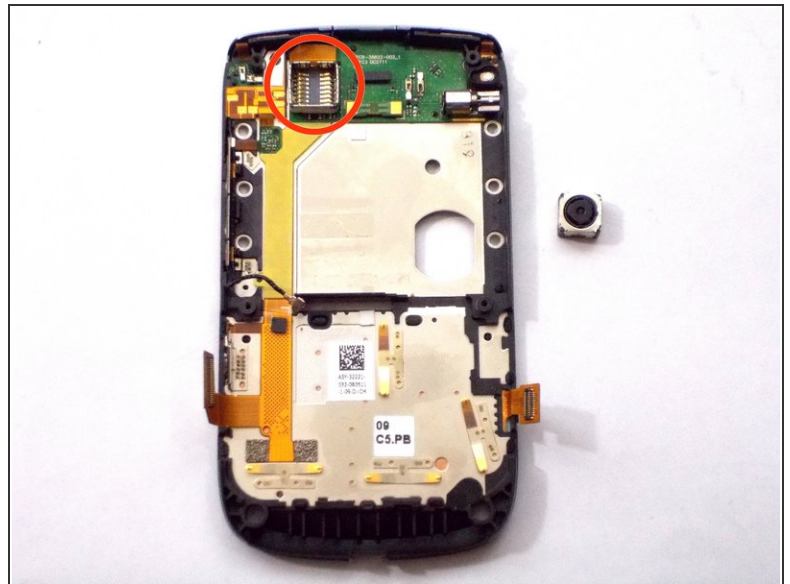
Step 6 — Camera Sensor

- Use the Phillip screw driver to wiggle the camera sensor out.
