Nokia Lumia 900 Front Camera Replacement

How to replace the front facing camera in your Nokia Lumia 900.

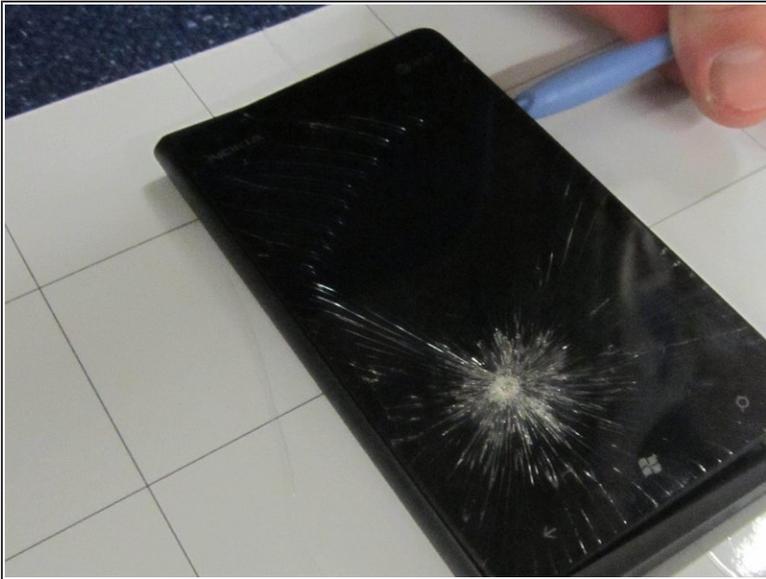
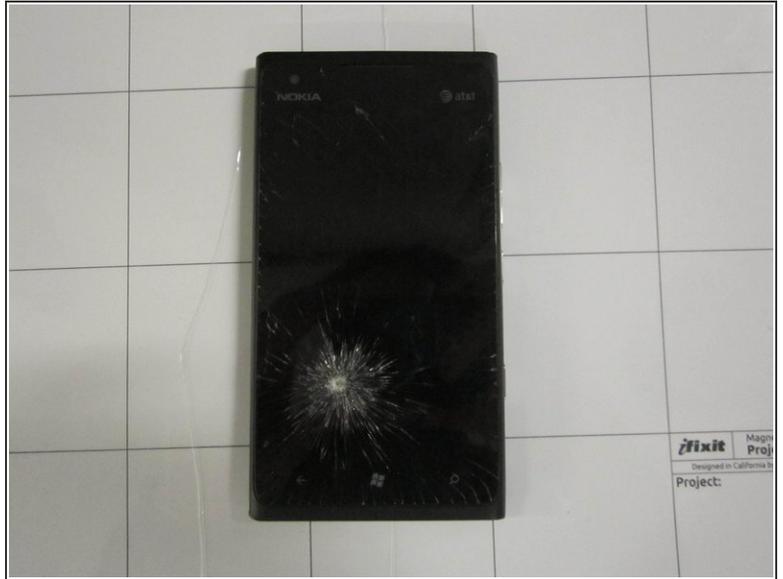
Step 1 — Opening The Phone

- Remove the Sim card tray and locking bar, before applying pressure to to the top right corner of the plastic casing.
- Using the opening tool, pry the screen from the casing until they are separated from each other.

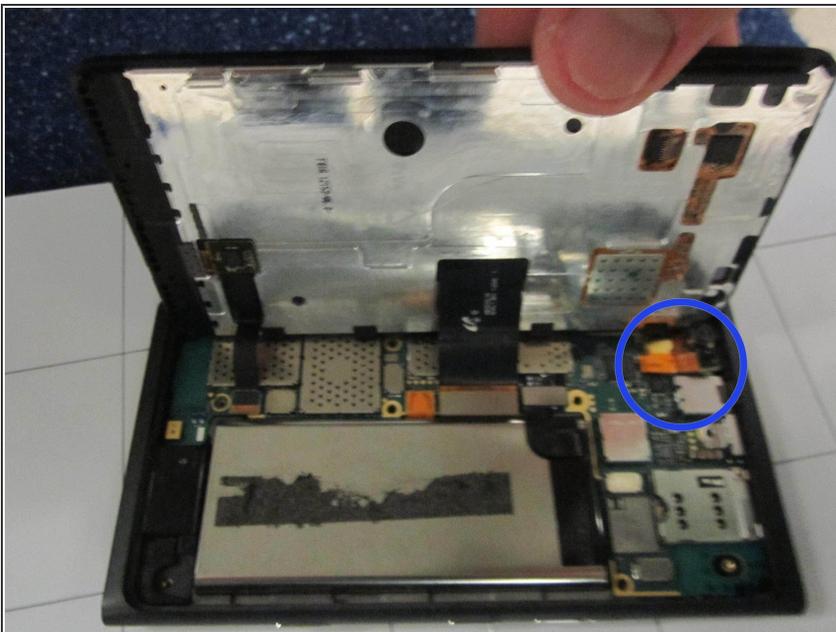
Step 2 — Detach Ribbon

- Detach camera ribbon from motherboard

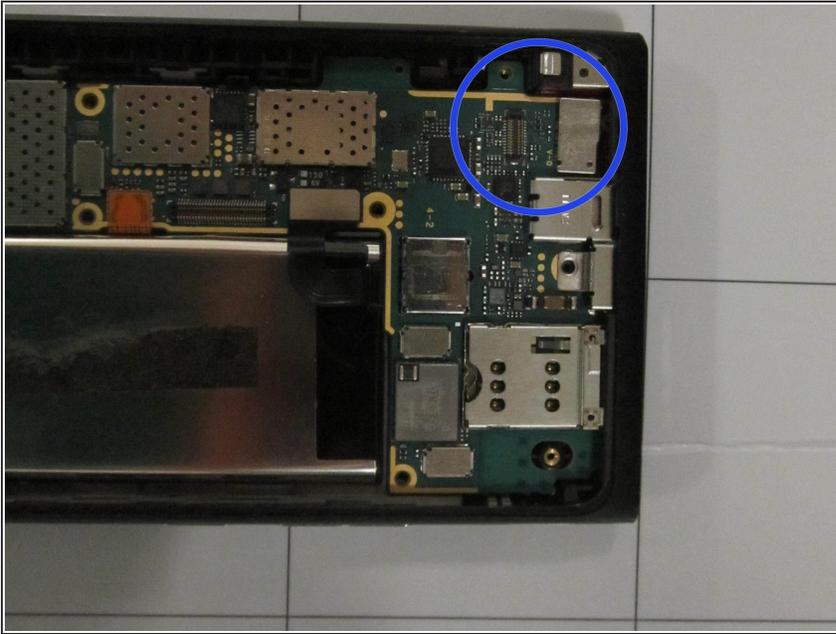
Step 3 — Remove Camera

- Peel camera off of adhesive surface
- ⚠ Use caution when removing camera as it is fragile

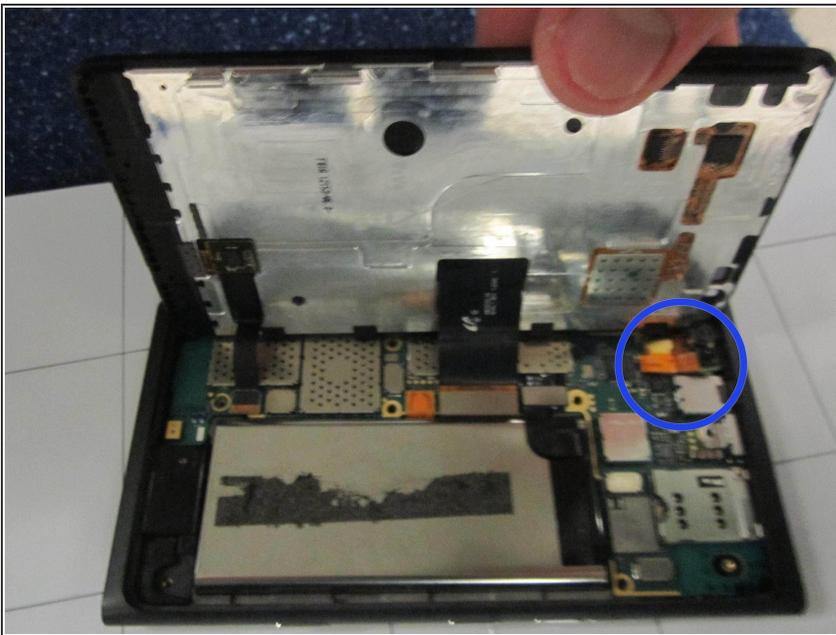
Step 4 — Installing New Camera

- Apply adhesive to back of camera
- Attach ribbon to motherboard
- Press down on camera for 60 seconds
- Let dry for 5 minutes

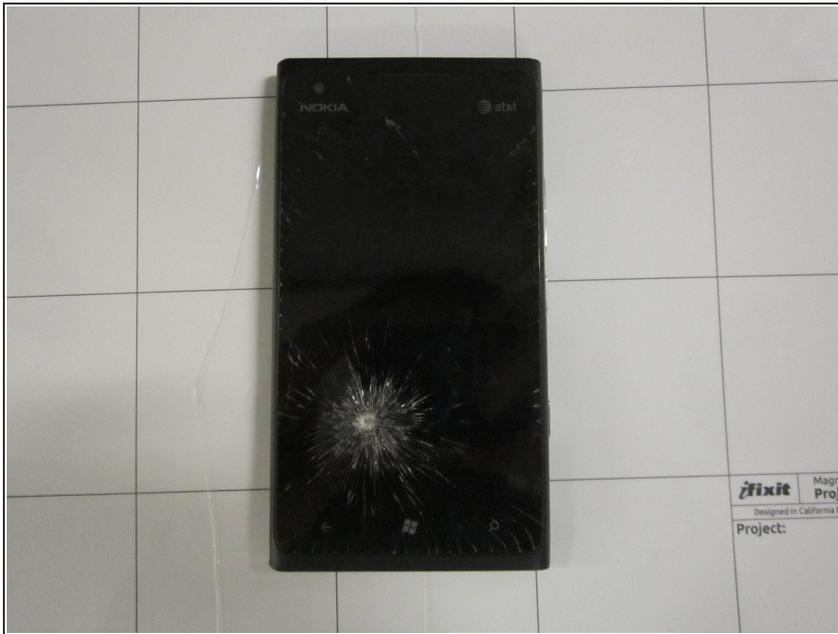
Step 5 — Reassembling Screen

- Slide the hinges of the left side of the screen under the left side of the plastic case
- Clamp the right side of the screen down and make sure screen is flat
- The screen should "click" into place
