Lenovo Tab 2 A10-70 Rear Facing Camera Replacement

This guide will illustrate the remove and replace the Lenovo Tab 2 A10-70 camera.

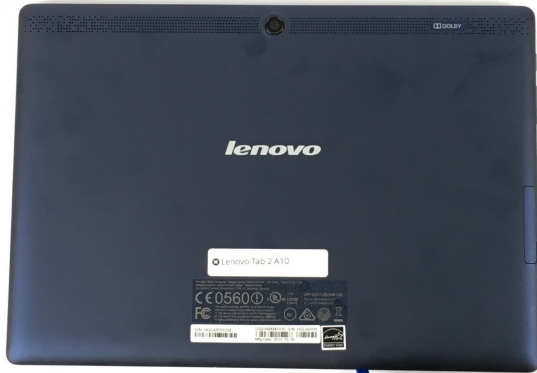
Step 1 — Rear Facing Camera

- ✦ Before removing the camera, make sure the device is powered off
- Use a plastic opening tool to pry open the back cover of the tablet..

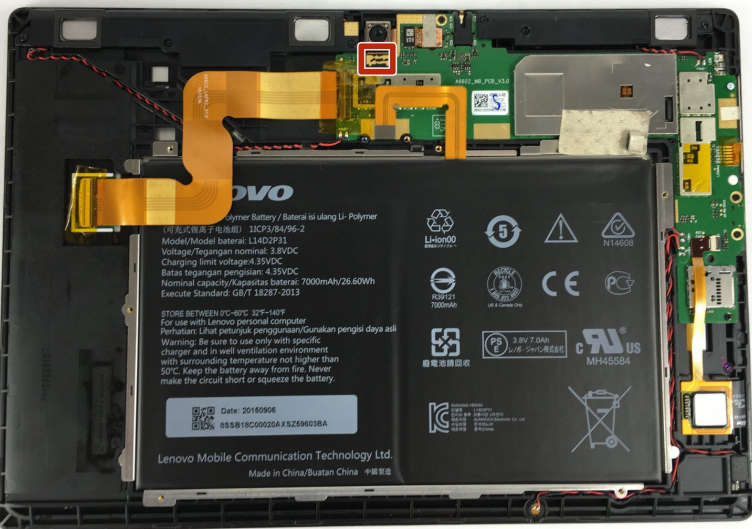
Step 2

- Locate the cable that is connecting the camera to the tablet

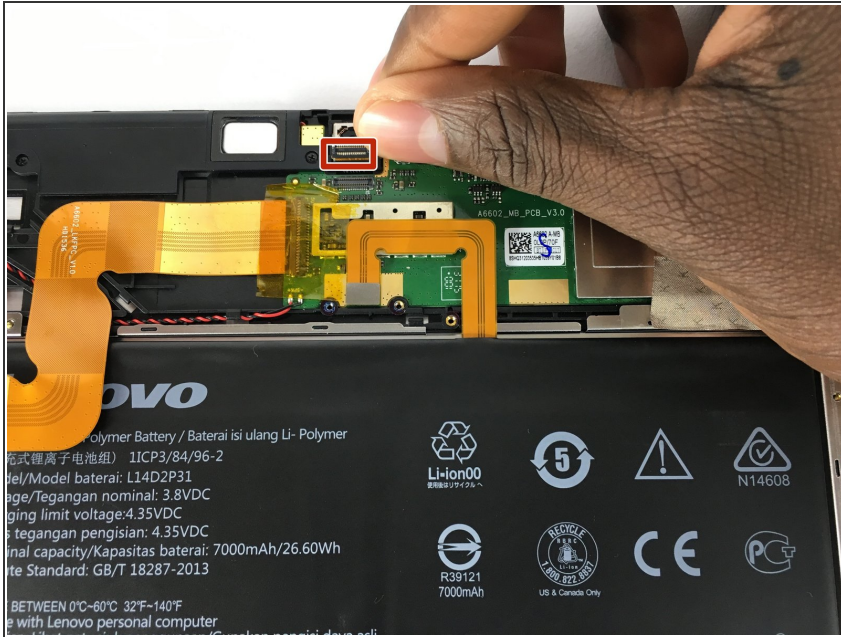
Step 3

- Disconnect the cable that is connecting the camera to the tablet

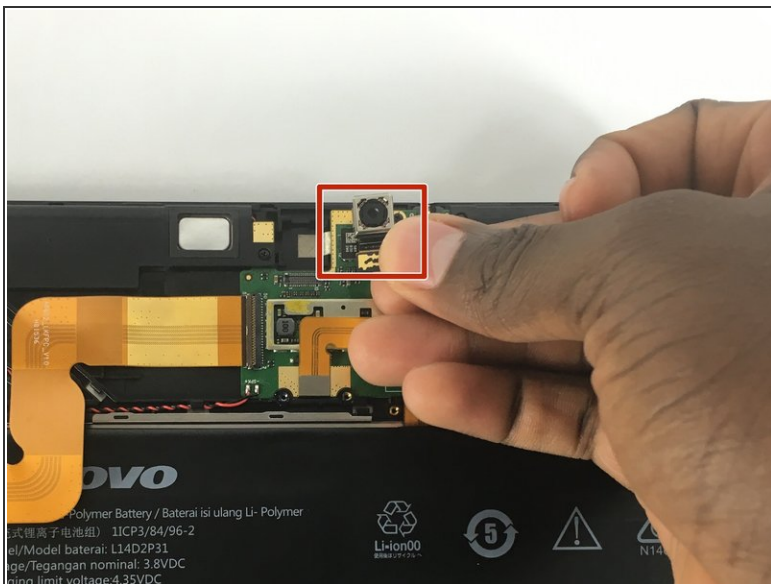
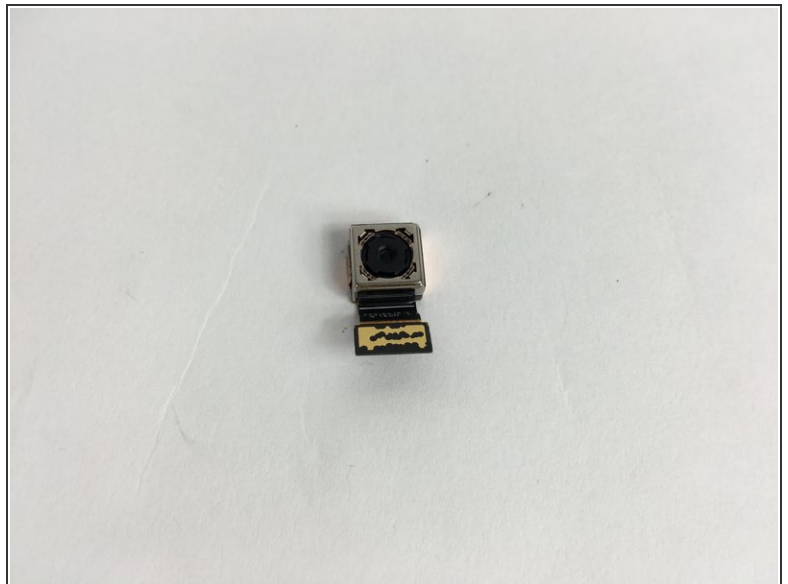
Step 4

- Simply remove the camera from the tablet by lifting it up
- Repeat Steps in reverse order with a new camera for reassembly
