Acer Aspire 7736Z-4809 CD/DVD Disk Drive Replacement

CD/DVD disk drive does not read the disk properly. Replacing the CD/DVD disk drive may solve this problem.

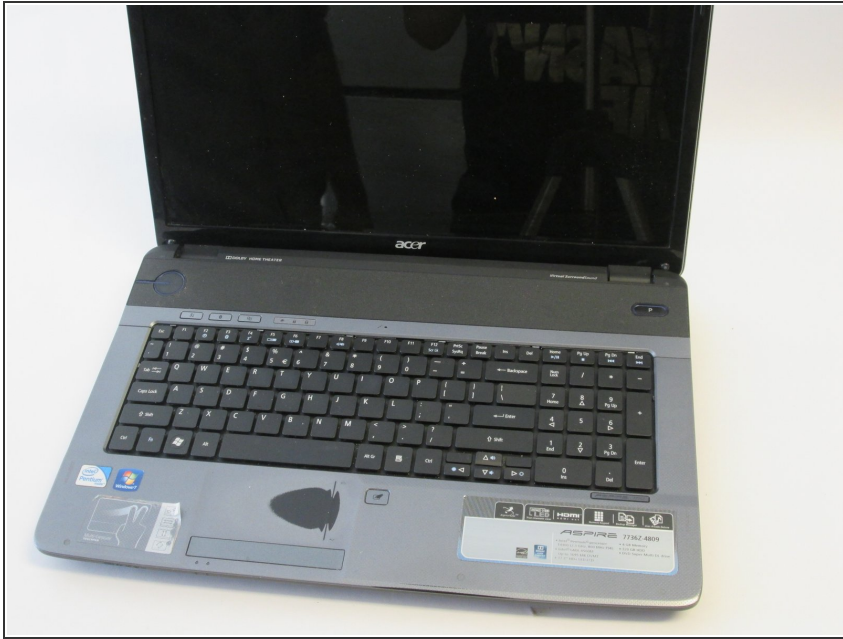
Step 1 — Acer Aspire 7736Z-4809 Repair Preparation

- Unplug and power off the laptop.
- ⓘ If the battery is still connected to the laptop, remove the battery.

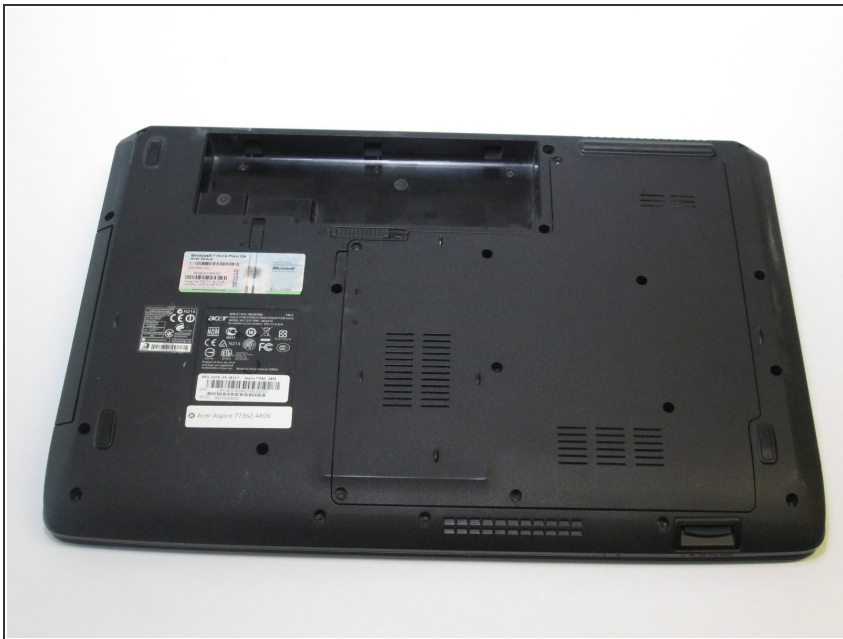
Step 2

- Flip over the laptop so that the back panel of the laptop is facing up.

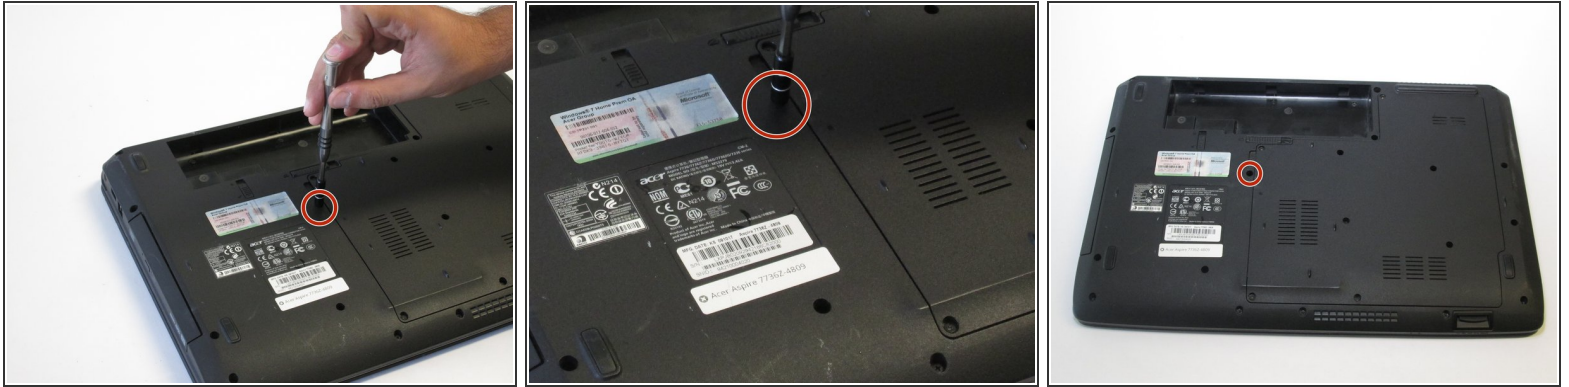
Step 3 — CD/DVD Disk Drive

- Use the Phillips #1 screwdriver to remove the 6.5mm Phillips #1 screw.

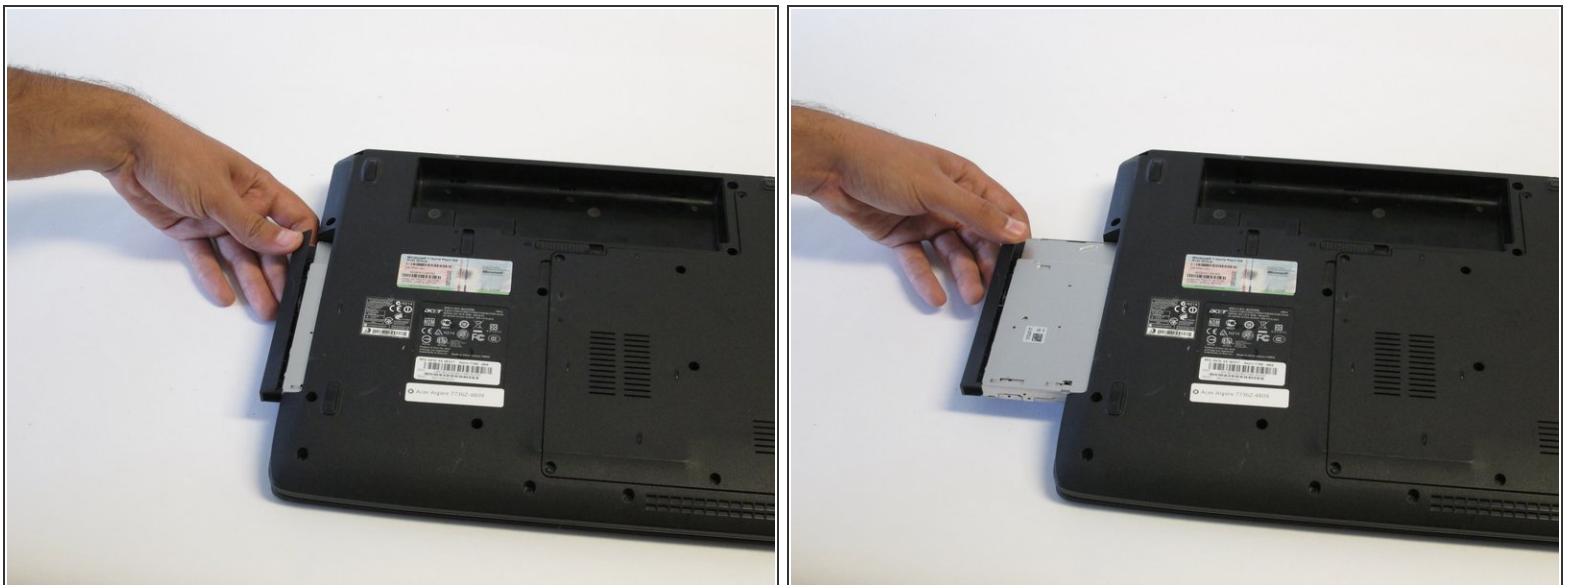
Step 4

- Remove the CD/DVD disk drive from the slot.

To reassemble your device, follow these instructions in reverse order.
