Canon 7210 Fan Replacement

Replace the cooling fan in case of damage or malfunction.

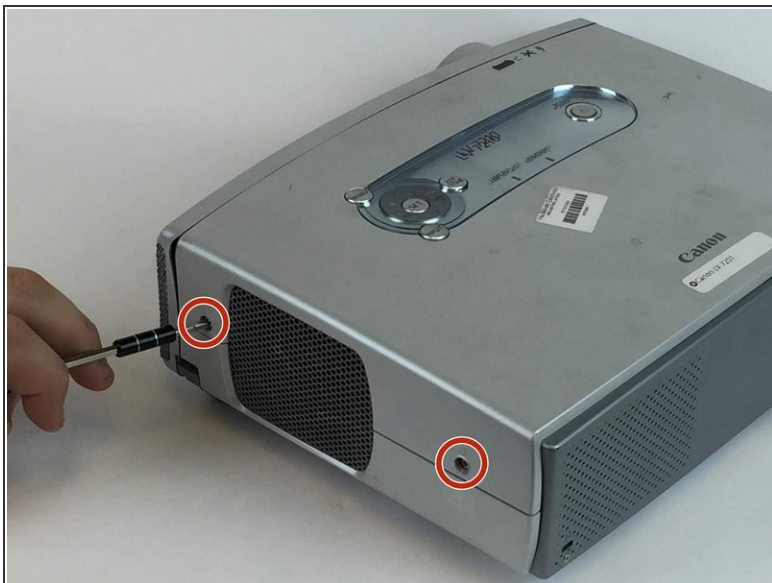
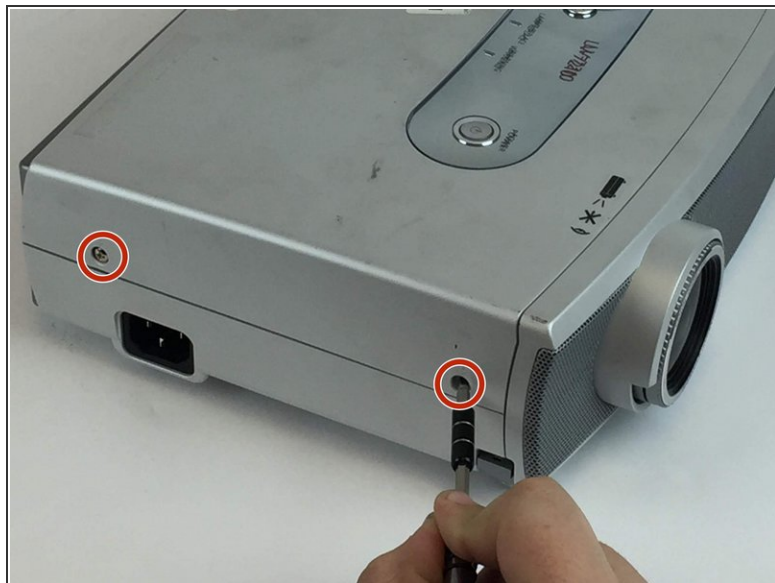
Step 1 — Exterior Shell

- Remove the 4 exterior 9mm Phillips #0 screws. They are located on the sides of the projector.

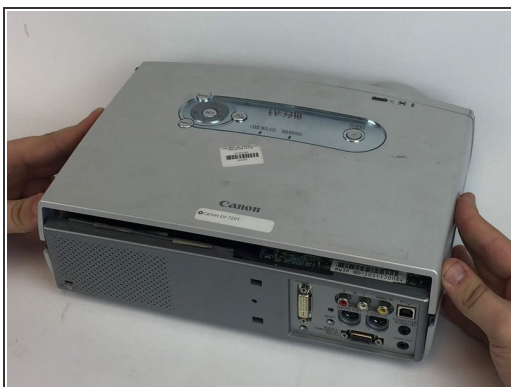
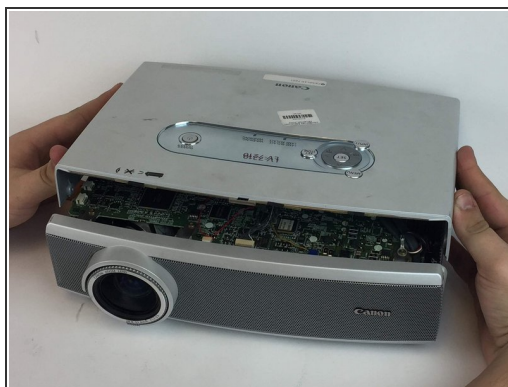
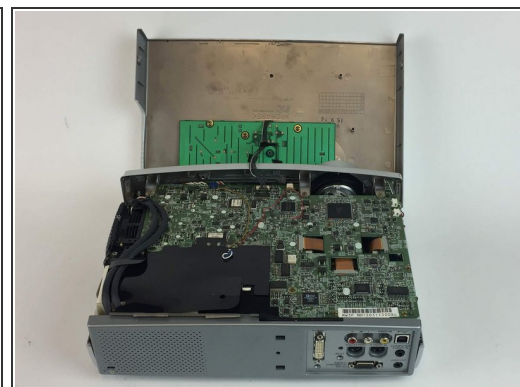
Step 2

- Gently lift up on the shell with both hands, from the back to the front.

i The shell will still be attached by a small cord in the front, so be careful not to tear it loose.

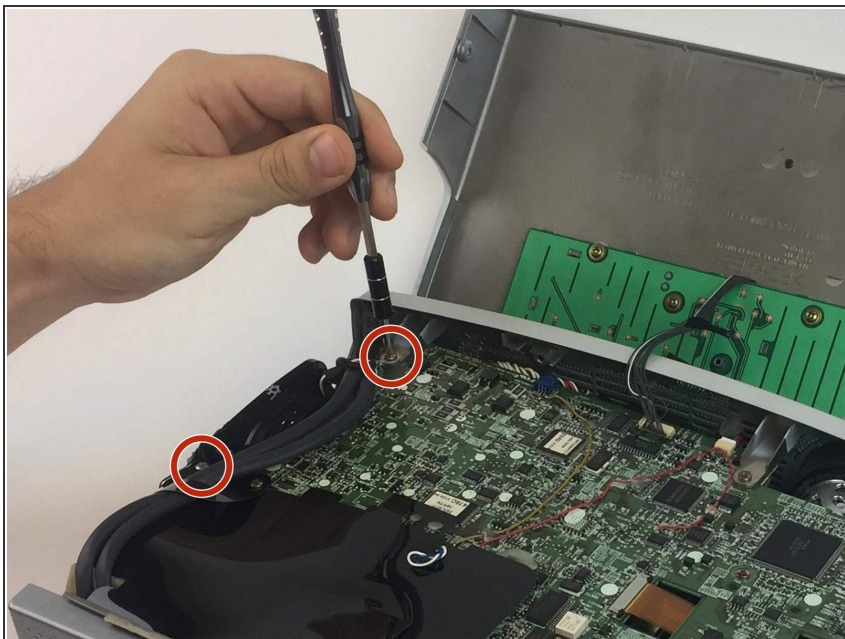
Step 3 — Fan

- Remove the two 7mm Phillips #0 screws that attach the fan to the motherboard of the projector.

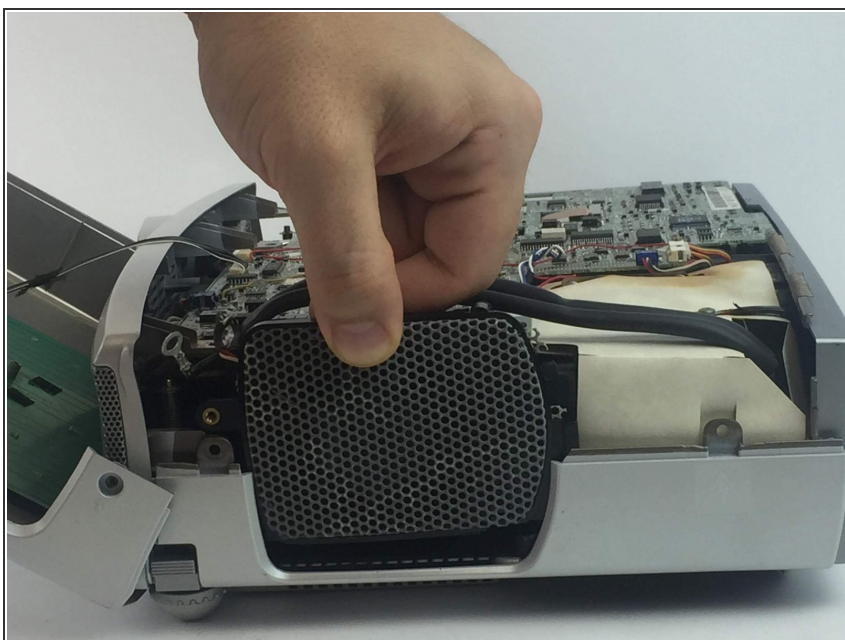
Step 4

- Remove the fan by pulling up gently from the top.
- ⓘ Be careful to not pull too hard or quickly, since the fan is still attached to the projector with some other wires.

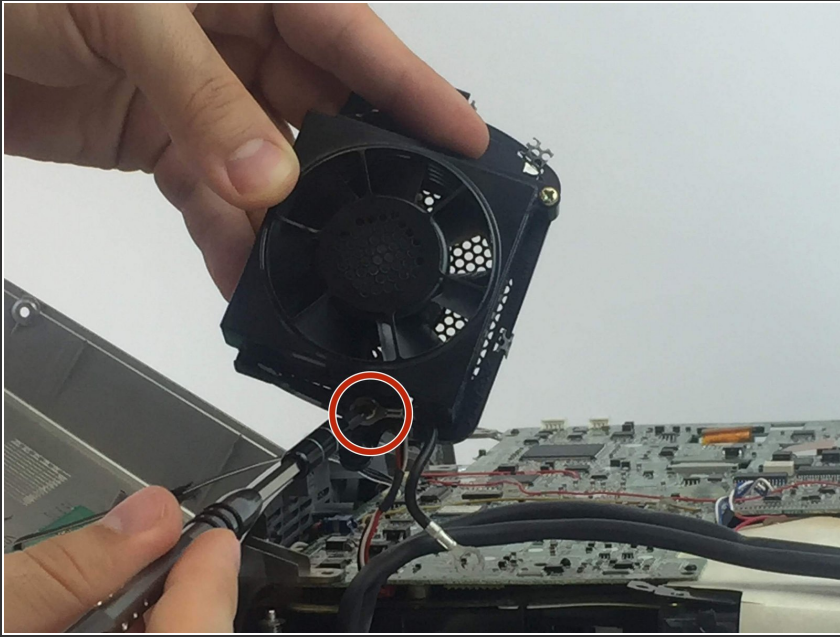
Step 5

- Remove the 7mm Phillips #0 screw that fastens the black ground wire connected to the fan and the projector.

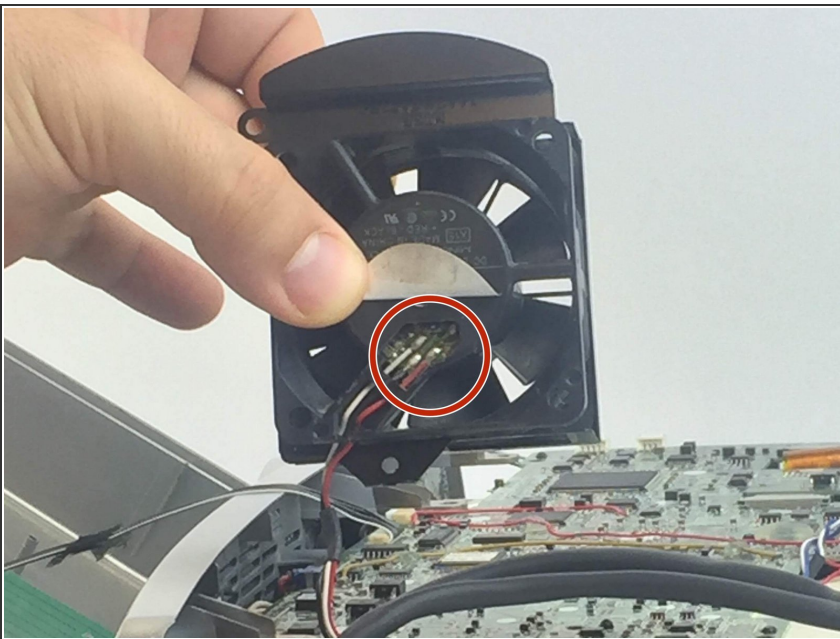
Step 6

- Peel the sticker up on the back of the fan to expose the port where the red, white, and black wires are attached.
- The wires will need to be cut with small wire cutters in order to completely remove the fan.
