## **Dell Inspiron 1525 Bottom Cover Replacement**

Written By: Miroslav Djuric

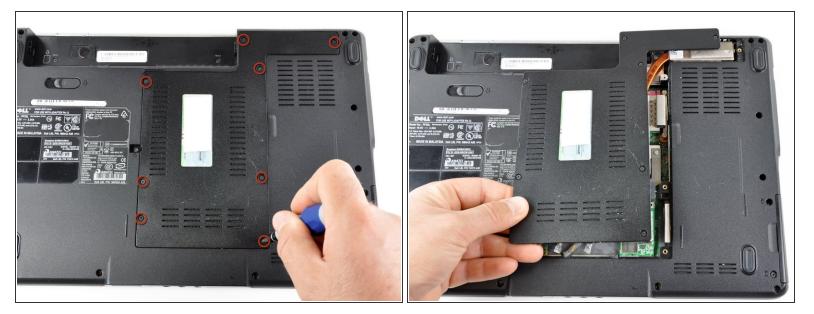
## Step 1 — Bottom Cover

- Remove/loosen the eight 4.80 mm Phillips #1 screws securing the bottom panel.
  - The screws may only need to be loosened, as they are generally retained by plastic washers.
- Remove the bottom panel.

To reassemble your device, follow these instructions in reverse order.
