SmartNav 4 false contact repair

Use this guide if the module behaves...

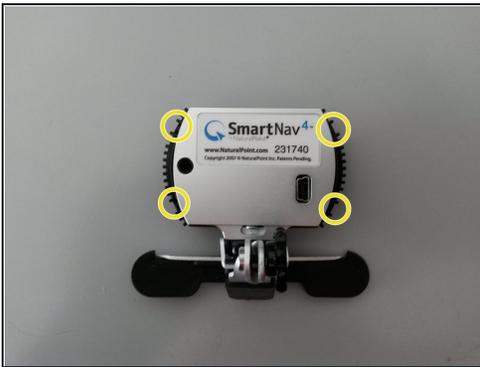
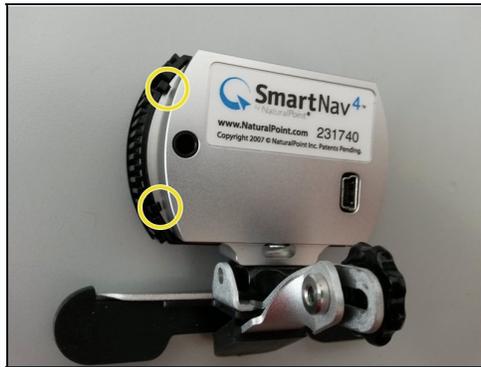
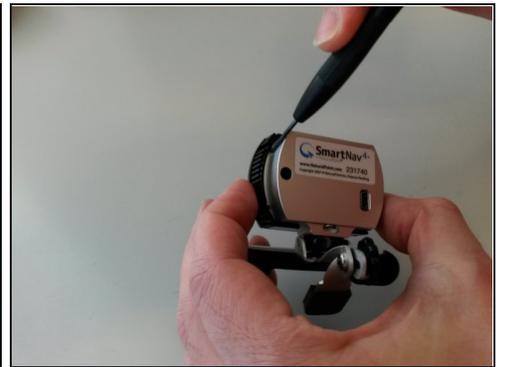
Step 1 — Device disassembly

- Gently open the four tabs with a small flathead screwdriver.

Carefully remove the black and silver cover.

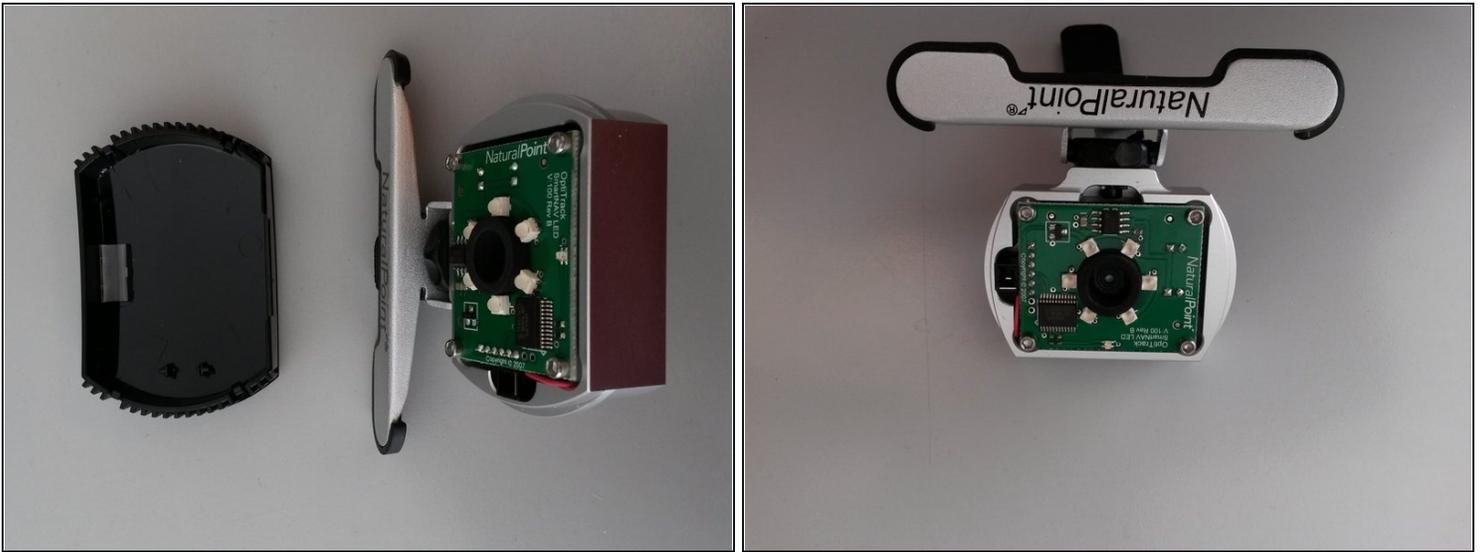
Step 2

- After detaching the two parts.
- Unscrew the four hex screws with the 2mm hex key.

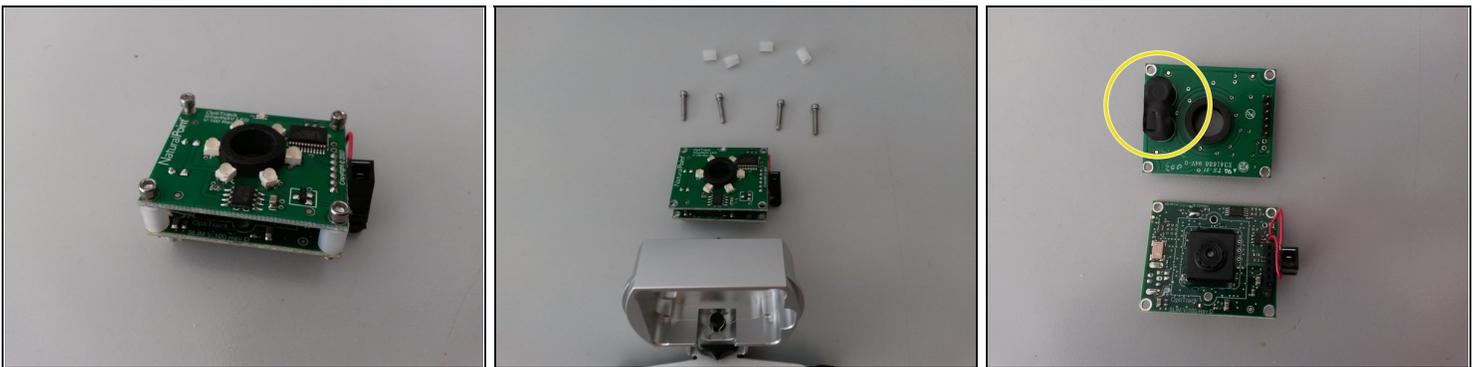
Step 3

- Remove and separate the components
- ⓘ The problem is caused by the black insulating film between the two boards which appears to be pierced through.
