# Sony Vaio SVT131A11L Hard Drive Replacement

How to replace the hard drive in the Sony Vaio SVT131A11L laptop.

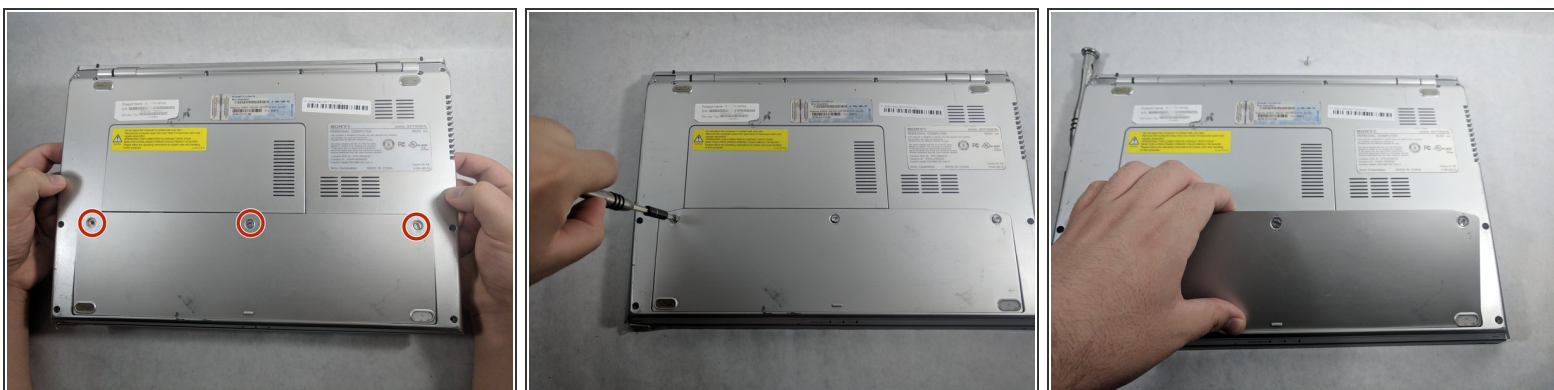
## Step 1 — Battery

- Carefully grab the edges of the laptop and flip it over to reveal the back panel.
- The battery is located on the lower half of the back panel, and contains three 10mm flat-head screws.
- Unscrew the three 10mm flat-head screws using a flat-head screw driver.
- Lift the battery from the lip closest to the middle screw to remove the battery entirely.

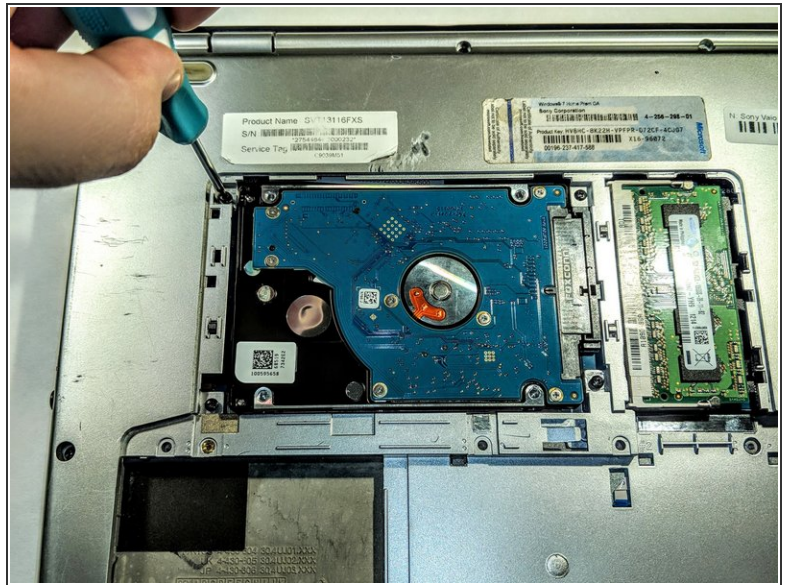
## Step 3

- Remove the three 5mm Phillips head screws that secure the Hard Drive bay to the back panel.

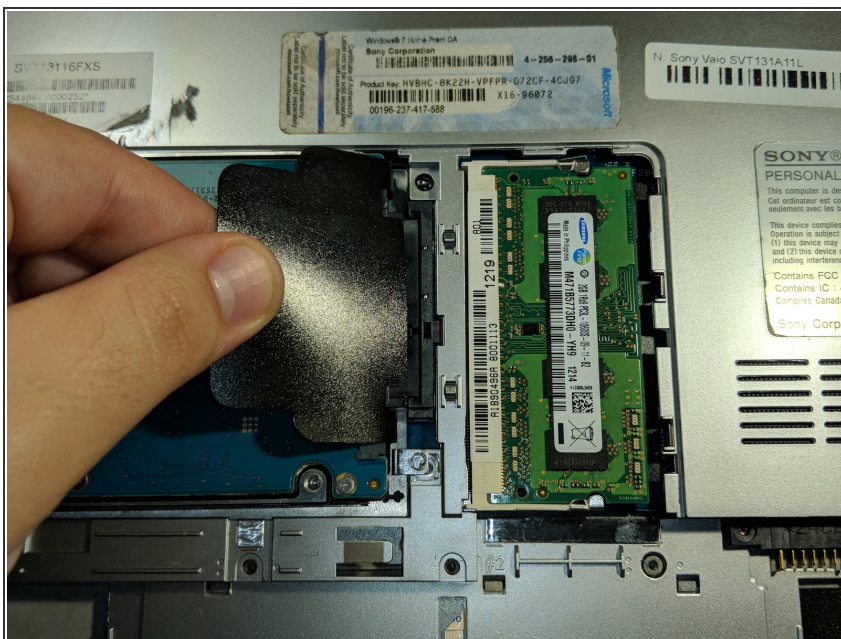
## Step 4

- Remove the Hard Drive bay by gently pulling the black plastic tab away from the SATA connector.
- ⚠ When removing the hard drive bay, it is important not to pull the black tab too hard, it may rip off/cause damage to the SATA connector, resulting in much bigger issues.
- ① Using a plastic pry-tool to push the drive away from the SATA connector can also help at this step.
